**SANTA YNEZ RIVER
BANK PROTECTION EVALUATION**

City of Lompoc, CA

January 20, 2011

PREPARED BY: Penfield & Smith
111 East Victoria Street
Santa Barbara, California 93101
(805) 963-9532

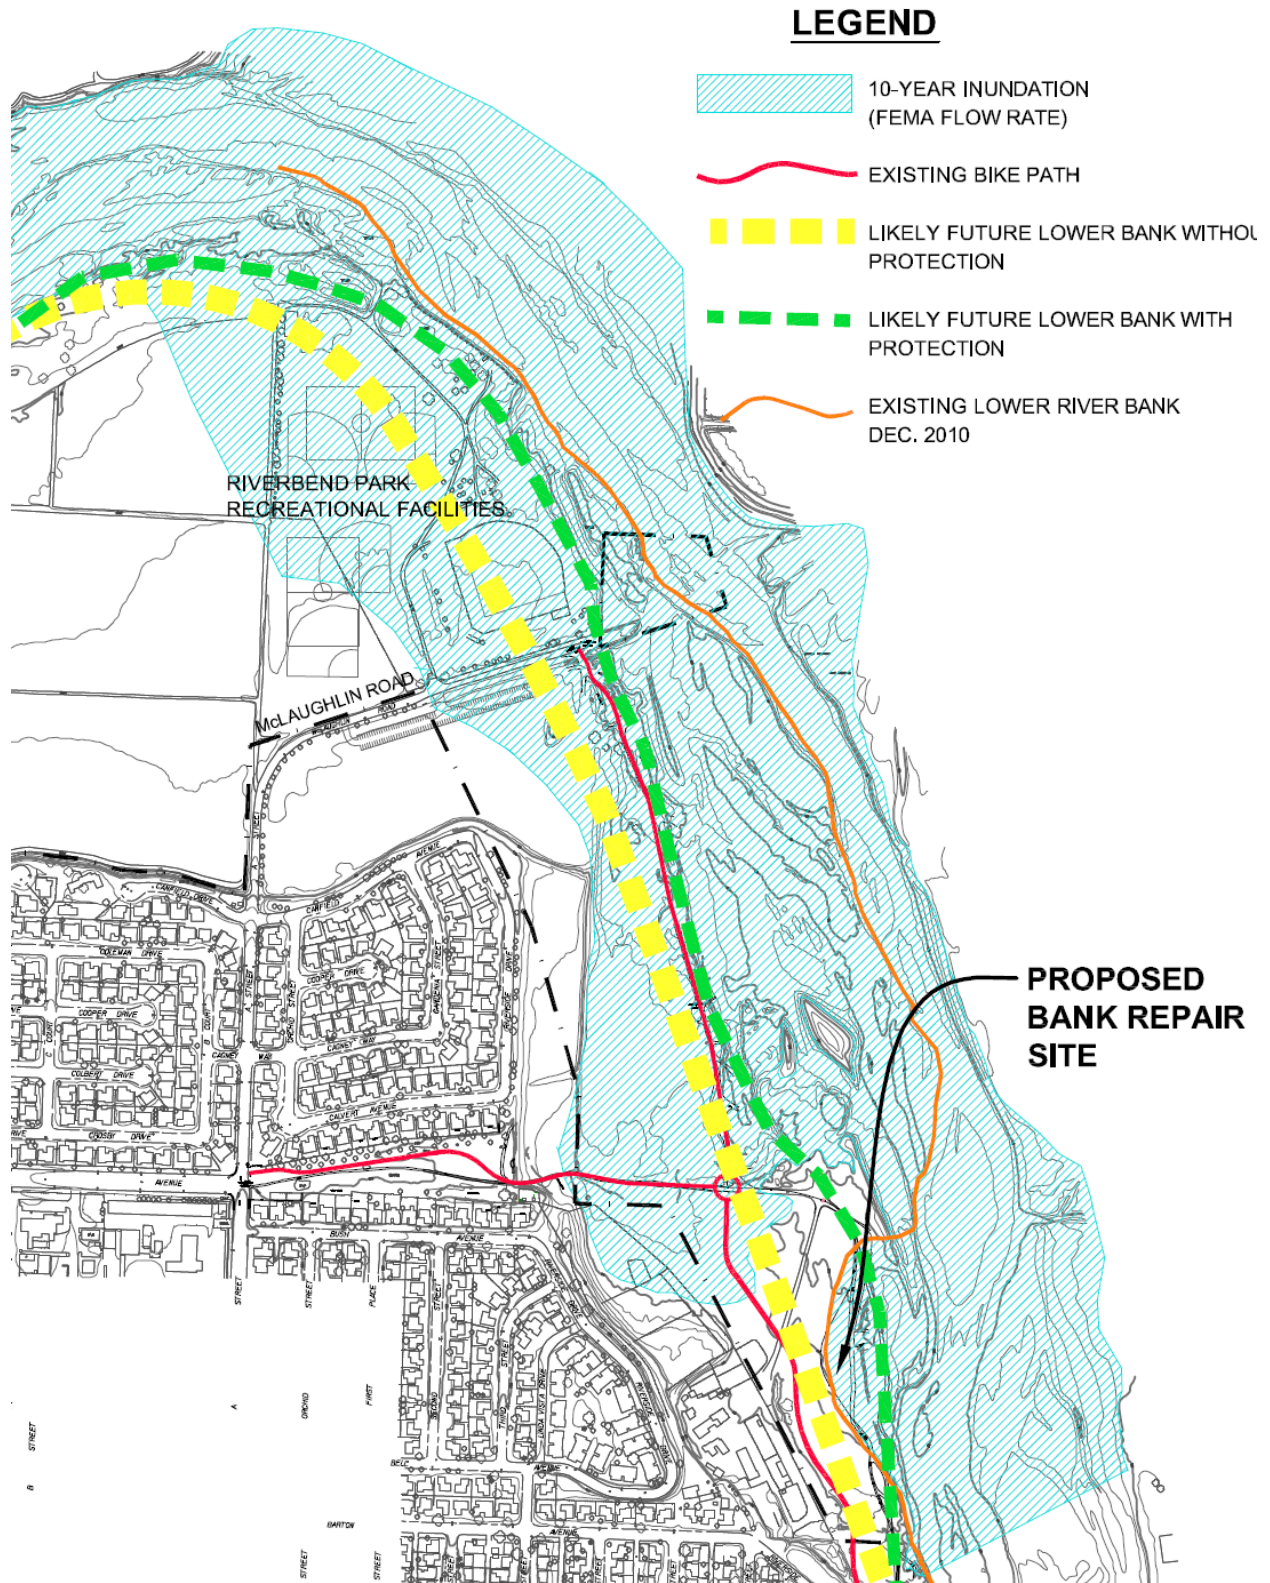
Figure D - Likely Top of Bank Locations After Many Years

“Based strictly on the past behavior of this bend, continued downstream translation would be the likely dominant erosion process, with an outer boundary perhaps similar to the “LIKELY PATH OF BANK EROSION” line shown on the drawing “Bank Erosion Progression.pdf”... (Figure D), although progressing much more slowly than suggested by the extent of that line. Absent any remedial action and assuming a continuation of past channel-migration rates based on a typical frequency of large floods, erosion would reach the vicinity of McLaughlin Road only after many decades (>50 years). This estimate ignores any retardation from the scrap metal at the downstream end of the present bend, which is unengineered and of unknown long-term stability, that would further slow the rate of migration. Some relocation of a portion of the bicycle trail, however, would probably be needed after the next one or two large (i.e., >5-year recurrence) floods.”

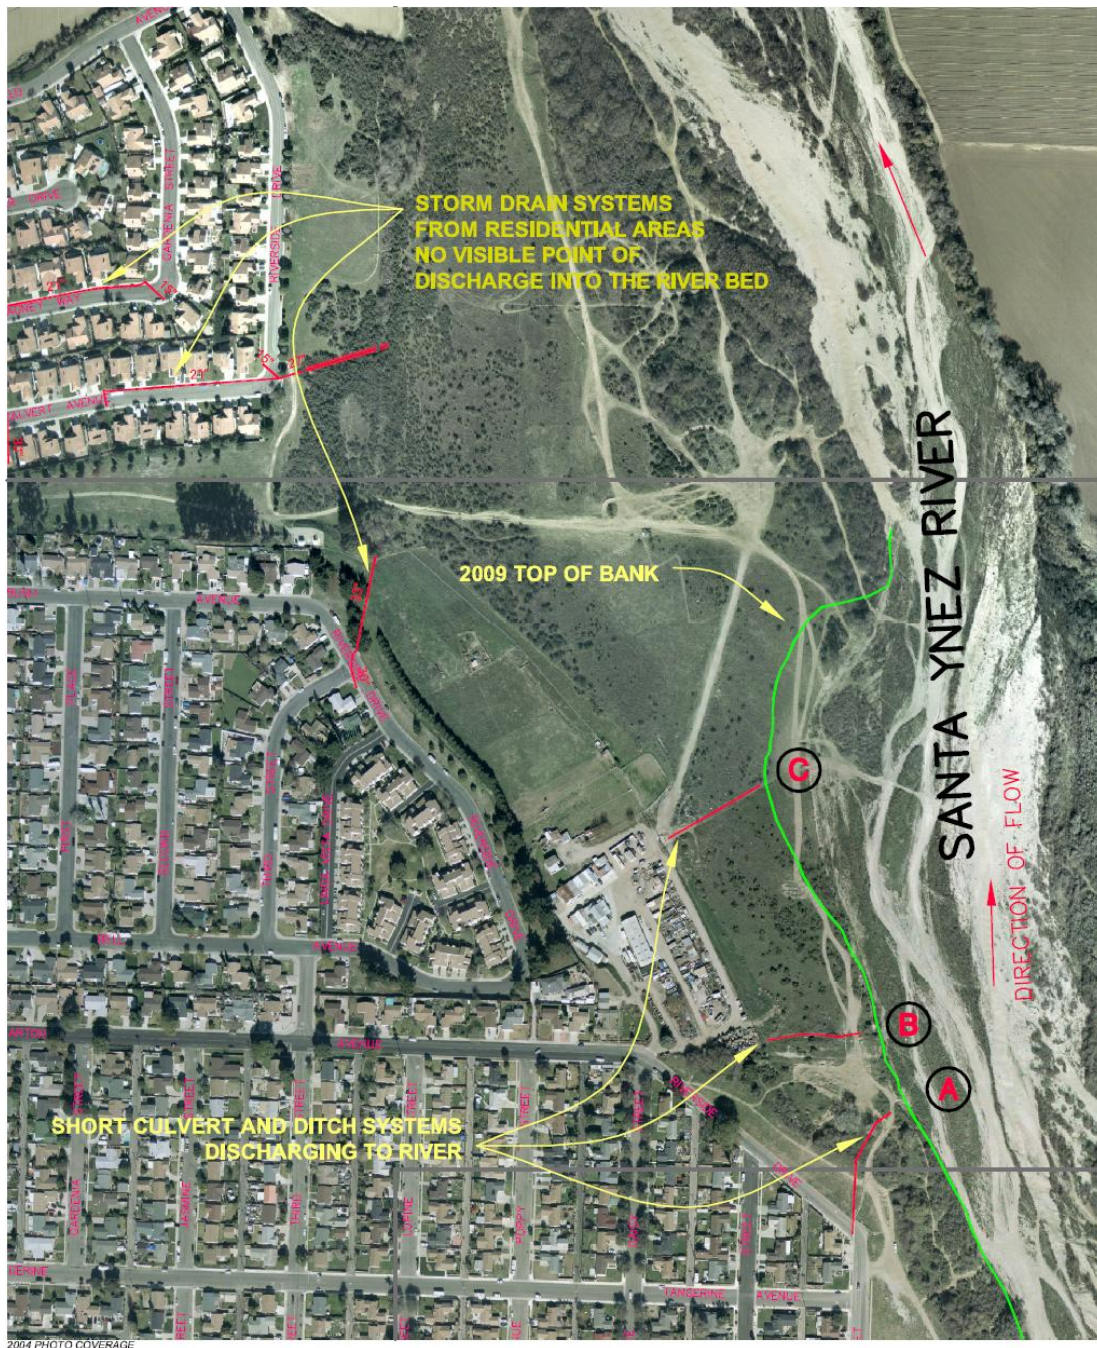
Figure G - Storm Water Outfalls

Storm Drain Designation	Tributary Area acres	Downstream Condition
A	5	Minor erosion evident at downstream outlet. No significant impact to bank.
B	13	Minor erosion evident at downstream outlet. No significant impact to bank.
C	7	Discharges to river bottom. No impact to bank.
