**RIVERSIDE DRIVE BANK
EROSION EVALUATION**

Lompoc, California

January 20, 2011

CLIENT: City of Lompoc

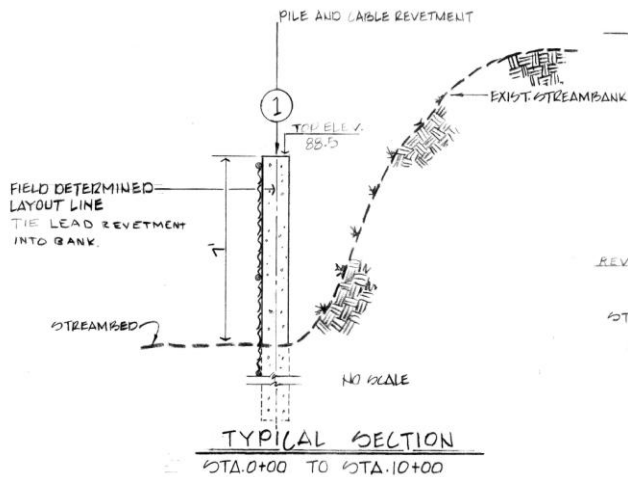
Figure D - Typical Section of 1979 Pile and Cable Revetment

2. Constructing 1,000 feet of pile and cable revetment parallel to the toe of the bank. The piles were 35 feet long and constructed of pre-cast concrete and were installed every 10 feet. The top 7 feet of the pile was left exposed above the river bottom. The piles were connected together with three sets of 3/4-inch diameter wire rope (cable). Then 2" x 4" wire mesh was attached to the piles and cables. See Figure D.

Comparing the pile and cable revetment plans to the 2010 conditions we observed, it appears that there has been very little retreat of the slope. That is, the remaining portion of the pile and cable revetment still appears to be located at the toe of the bank just as shown in the 1979 plans.

The revetment design should be modified from the original by omitting the use of the 2" x 4" wire mesh and by adding a tie-back pile and cable every 100 feet.

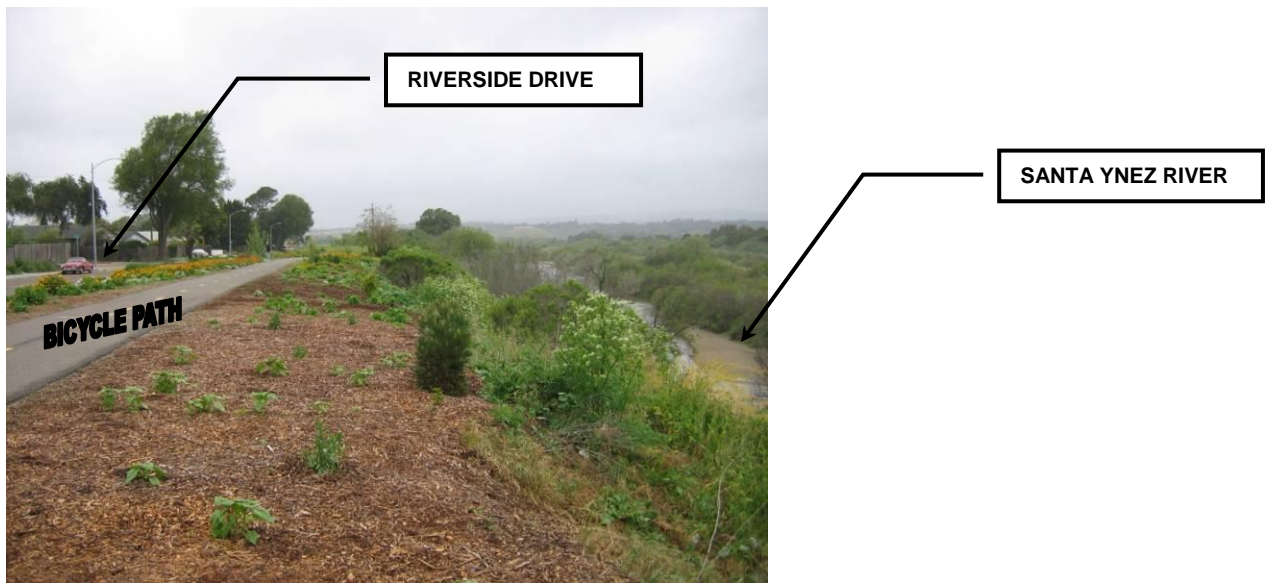
In the ensuing years, the vegetation on the riverbank has filled in. See Photo 1 and Photo 2. Recently, as the City has reviewed the area, it was noted that the five piles had failed and were laying horizontally in the river bed at the upstream end of the remaining pile revetment. Additionally, the City could only identify a line of approximately 70 remaining piles (about 700 feet of pile revetment) from North Avenue to Cherry-Oak Alley. If 1,000 feet of revetment was constructed as the plans indicate, then 300 feet of this may have washed out. It is anticipated that much of the loss may have occurred at the upstream end between Cherry-Oak Alley and pine-Cherry Alley. The City has requested Penfield & Smith to evaluate:

Photo 1 - Top of Bank, April 2010

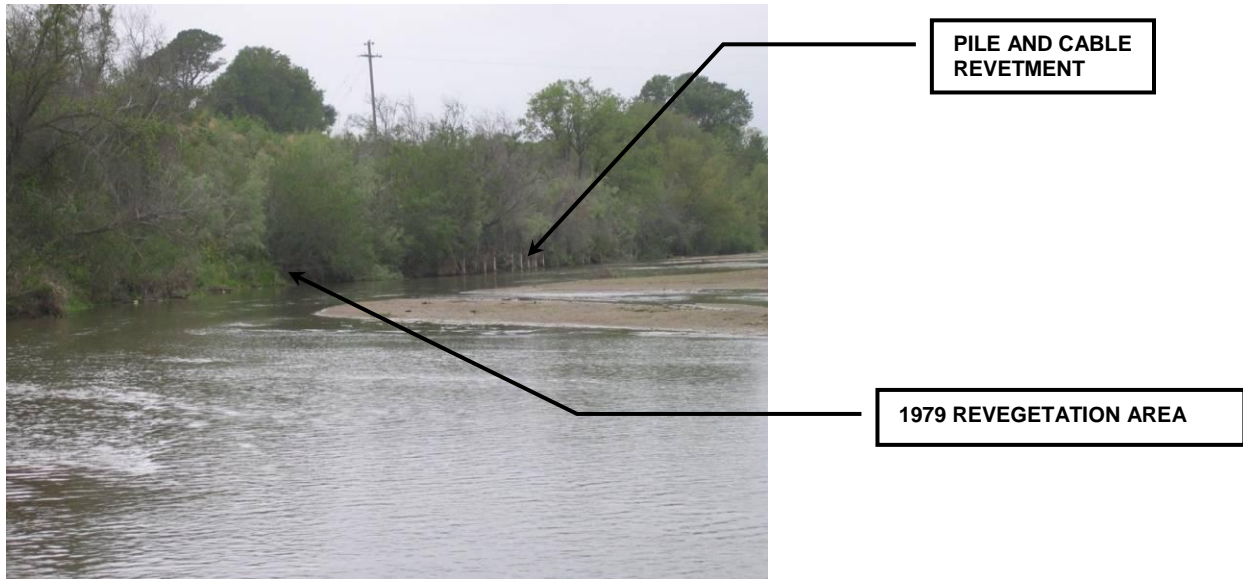
Photo 2 - Face of Bank, April 2010

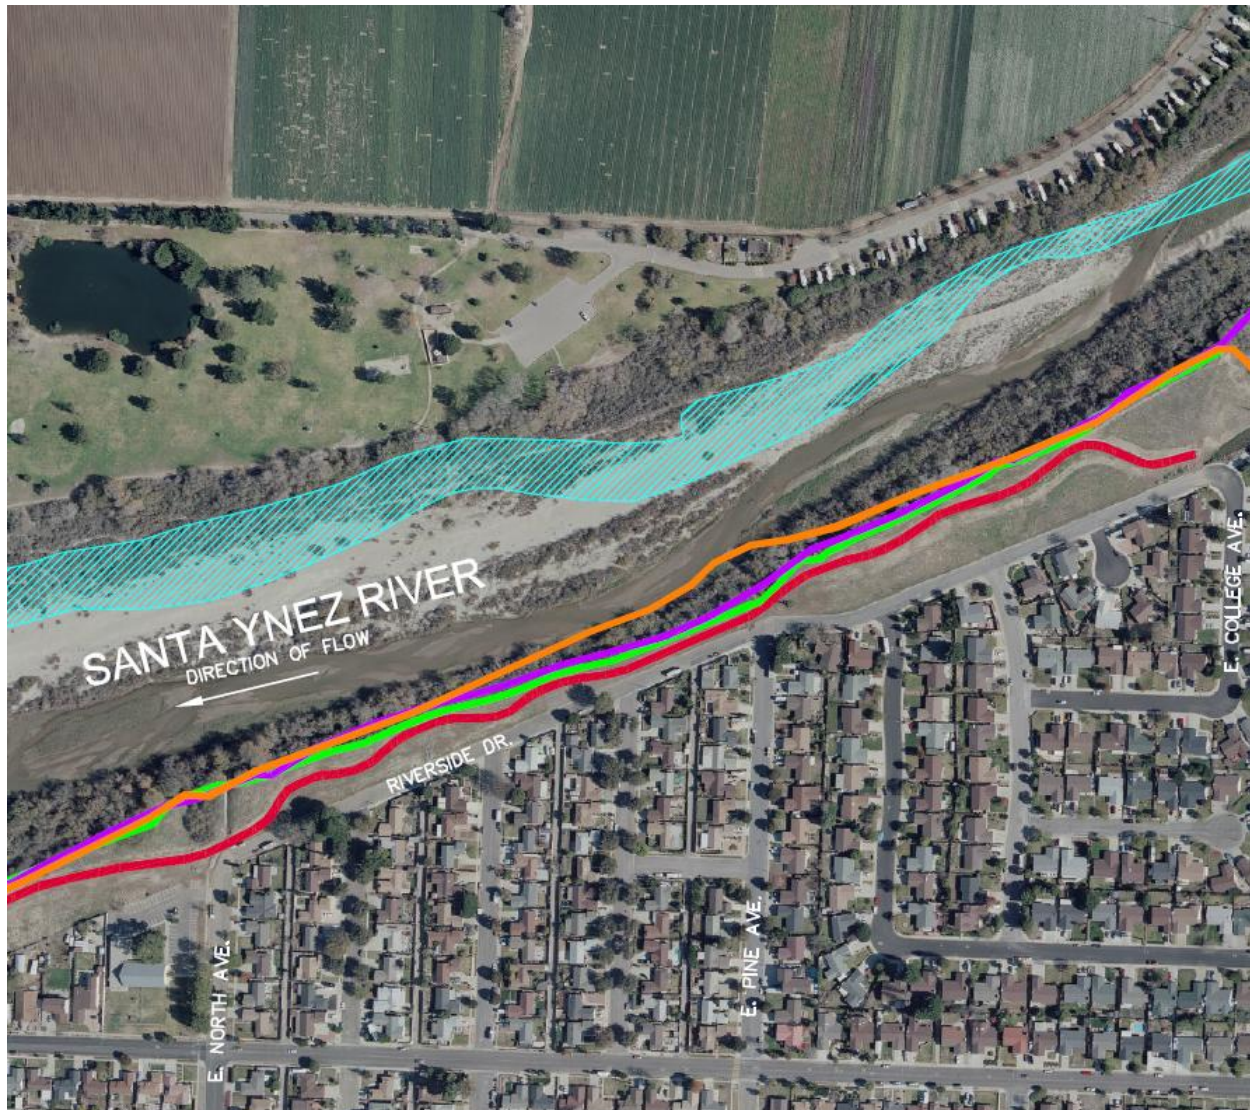
Based on the review of historical photographs, it appears that this portion of the Santa Ynez River bank tends to be generally well established. The flood flows of 1969 appear to have removed a significant amount of the riverbank within the evaluation site area. However, since the flood of 1969, estimated to be between a 20-year and 50-year runoff event, the top of bank

has remained mainly in the same location, even after the significant, though smaller flood of 1978. See Photo 3.

Photo 3 - Historical Photograph Analysis
