2021 Annual Inspection Report

Wood Dump and Former Army Landfill

Environmental Long-Term Monitoring and Inspection

Former U.S. Disciplinary Barracks (USDB)

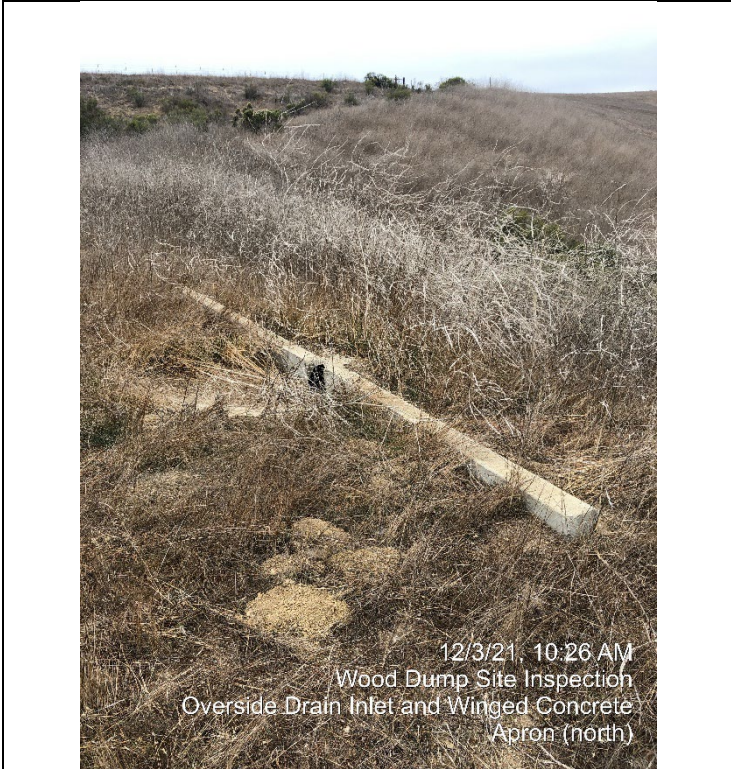
The cover of the Wood Dump is well vegetated, with minimal animal burrows (Photos 13-15). Woody vegetation is encroaching on the cover on all sides, with some medium-sized vegetation located on the cover. Erosion control ditches were difficult to identify during the inspection and consisted of a slight depression with areas where erosion control netting was visible. Woody vegetation is present along erosion control ditches (west and east; Photo 11 and Photo 12). A few areas of inspection (concrete v-ditches (Photo 7 and Photo 8), drain inlets (Photo 9 and Photo 10), overside drain inlets (Photo 1 and Photo 2)) had sediment and debris buildup.

Photo 1: Oversight drain inlet and winged concrete apron (north side of Site), facing northeast.

It is recommended that any sediment buildup and debris be removed from ditches and drain inlets and that woody debris be removed from the Wood Dump Cover.

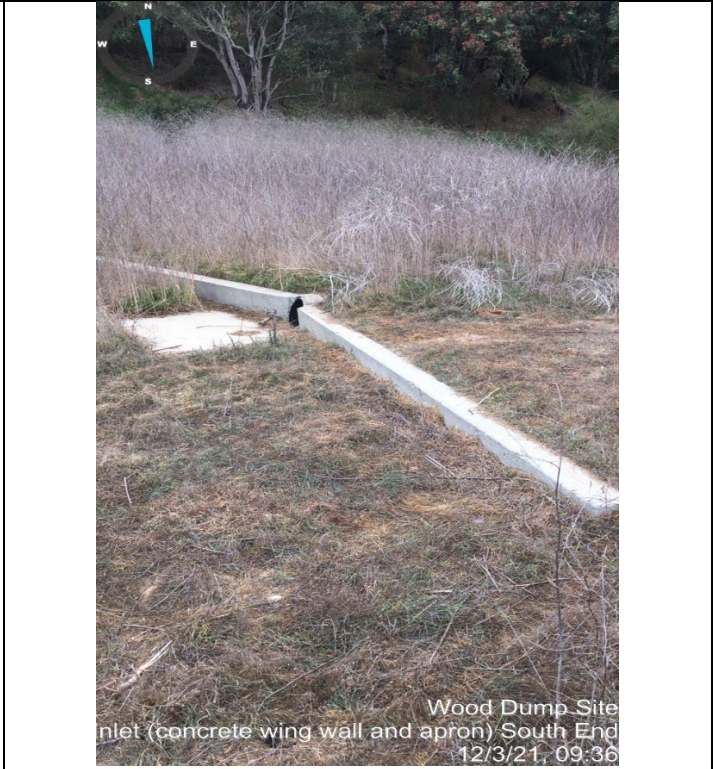
Photo 2: Oversight drain inlet and winged concrete apron (south side of Site), facing southwest.

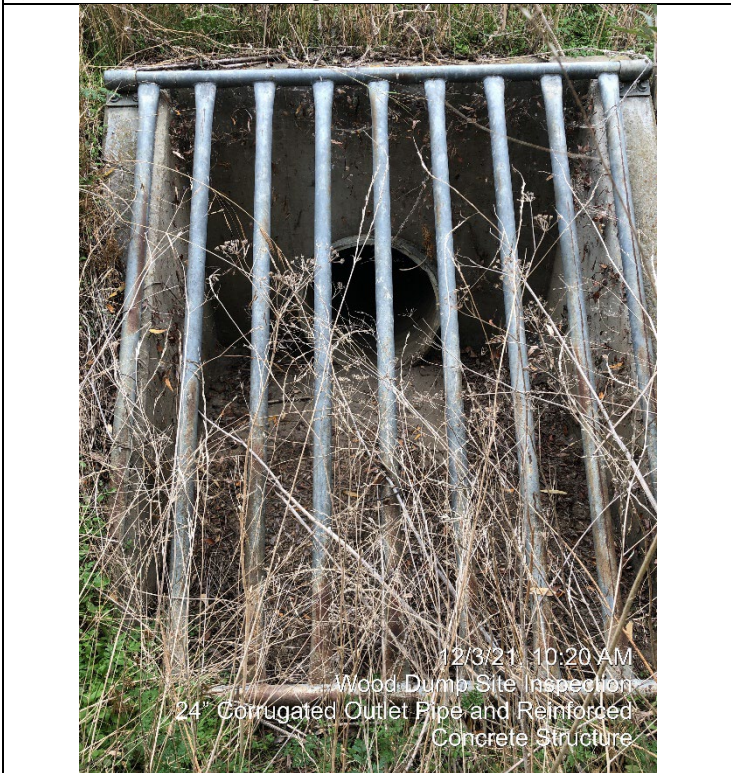
Photo 3: 24-inch corrugated outlet pipe and reinforced concrete structure (north side of Site), facing south.

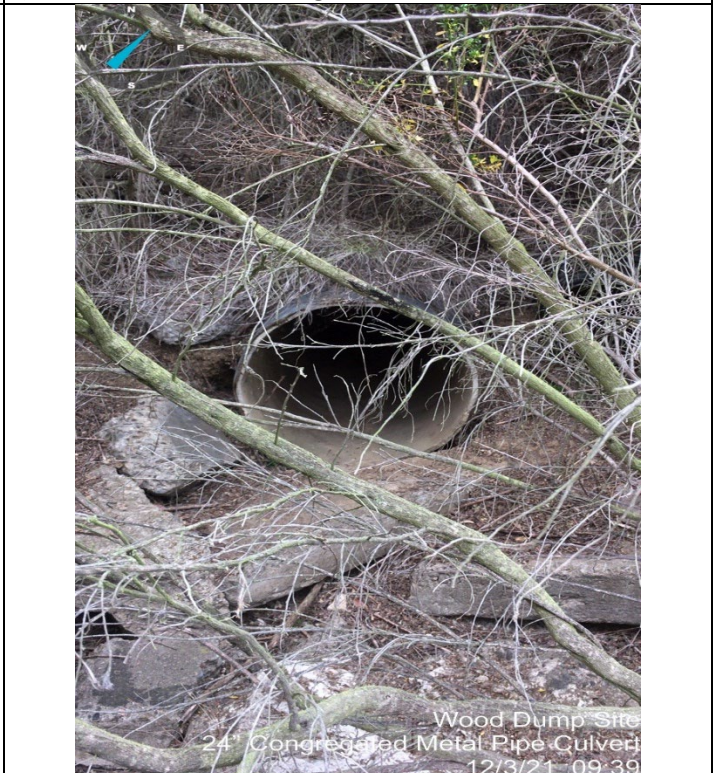
Photo 4: 24-inch corrugated outlet pipe and reinforced concrete structure (south side of Site), facing northeast.

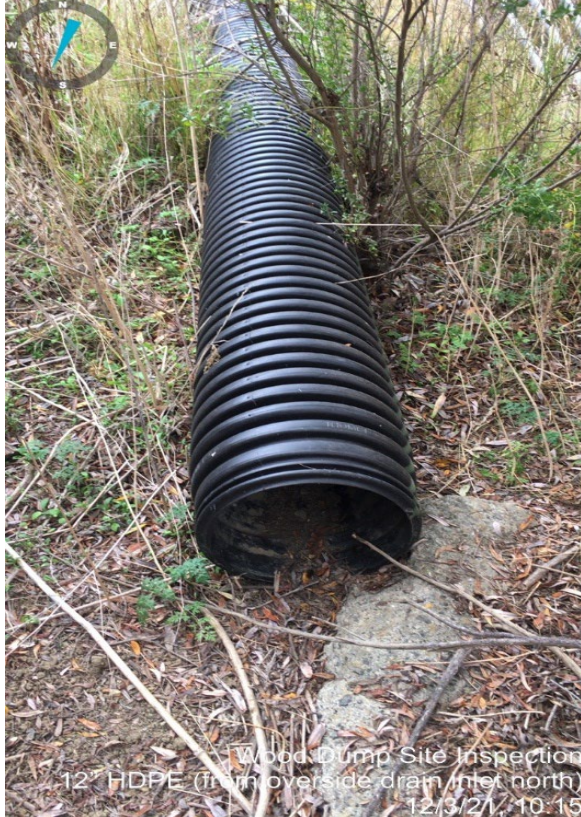
Wood Dump Site Inspection
12" HDPE (from overside drain inlet north)
12/3/21, 10:15

Photo 5: 12-inch HDPE drainpipe (north side of Site), facing southwest.

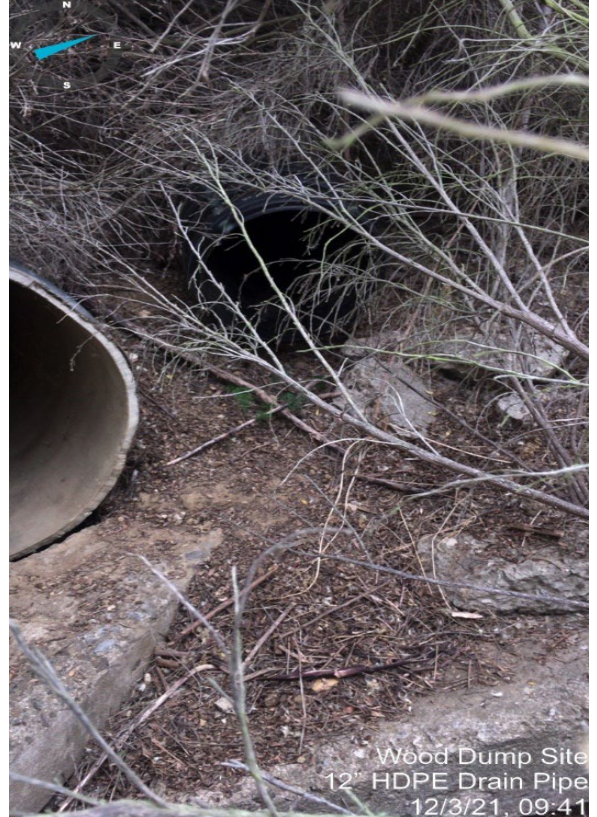
Wood Dump Site
12" HDPE Drain Pipe
12/3/21, 09:41

Photo 6: 12-inch HDPE drainpipe (south side of Site), facing northeast.

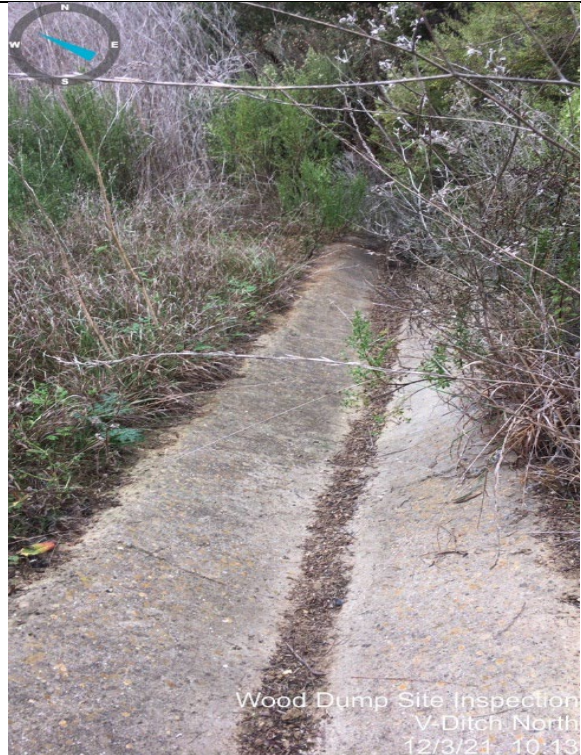
Wood Dump Site Inspection
V-Ditch North
12/3/21, 10:13

Photo 7: Concrete v-ditch (north side of Site), facing northwest.

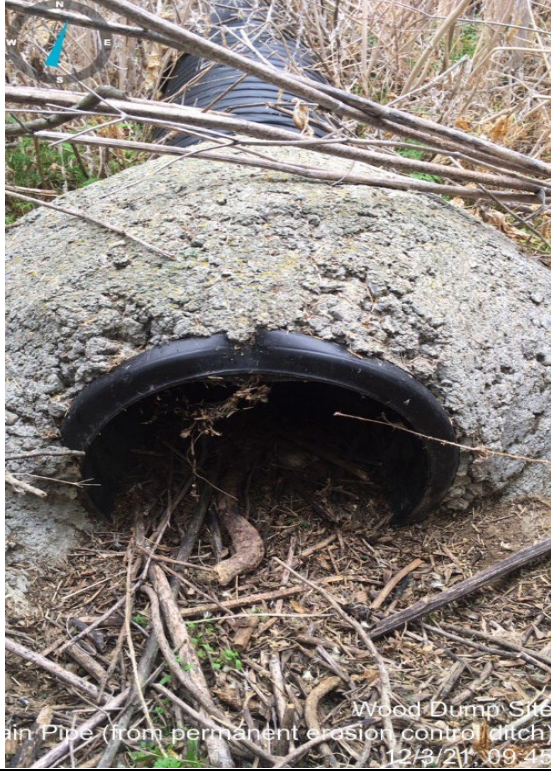
Wood Dump Site
Drain Pipe (from permanent erosion control ditch)
12/3/21 09:45

Photo 9: Drain inlet (western opening), facing north.

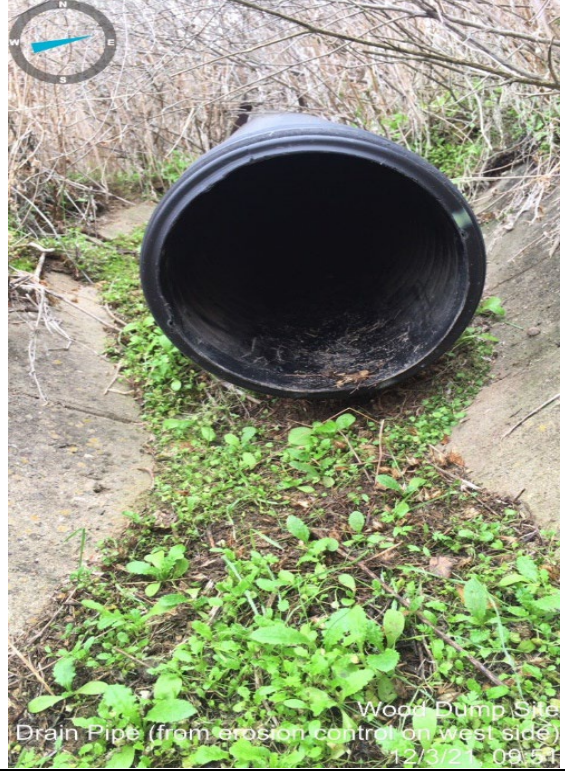
Wood Dump Site
Drain Pipe (from erosion control on west side)
12/3/21 09:51

Photo 10: Drain inlet (eastern opening), facing northeast.

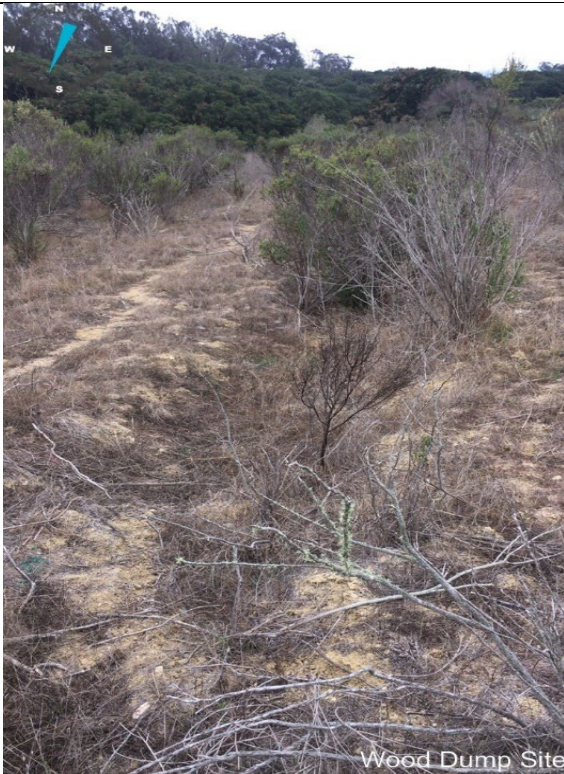
Wood Dump Site

Photo 11: Erosion control lined ditch (west side of Site), facing south.

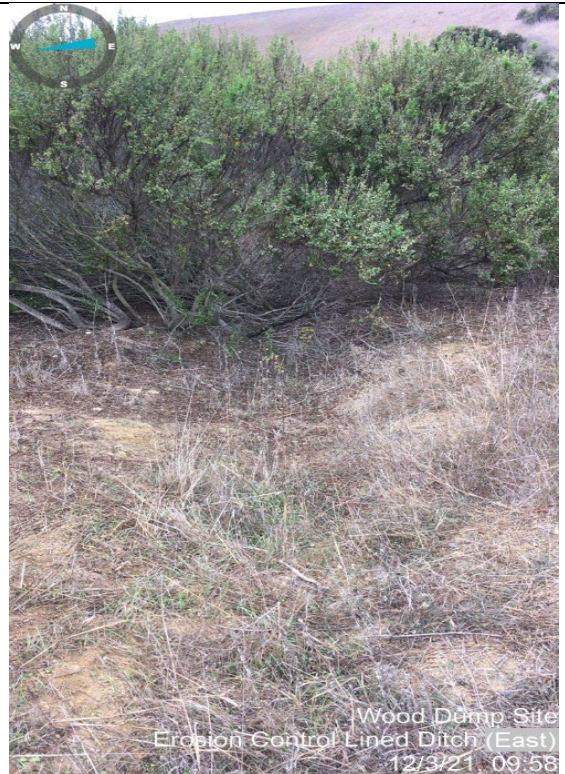
Wood Dump Site
Erosion Control Lined Ditch (East)
12/3/21 09:58

Photo 12: Erosion control lined ditch (east side of Site), facing west.

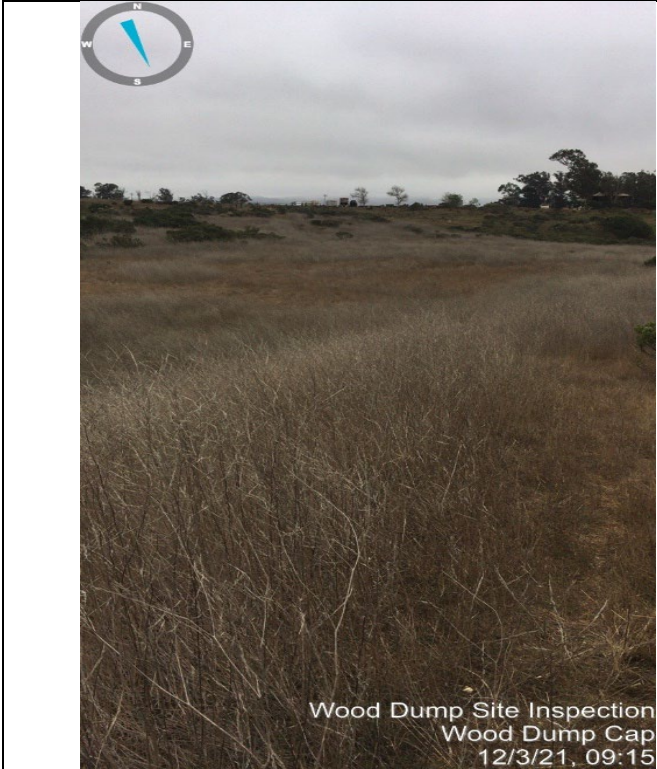
Photo 13: Wood Dump cap (deck), facing southeast.

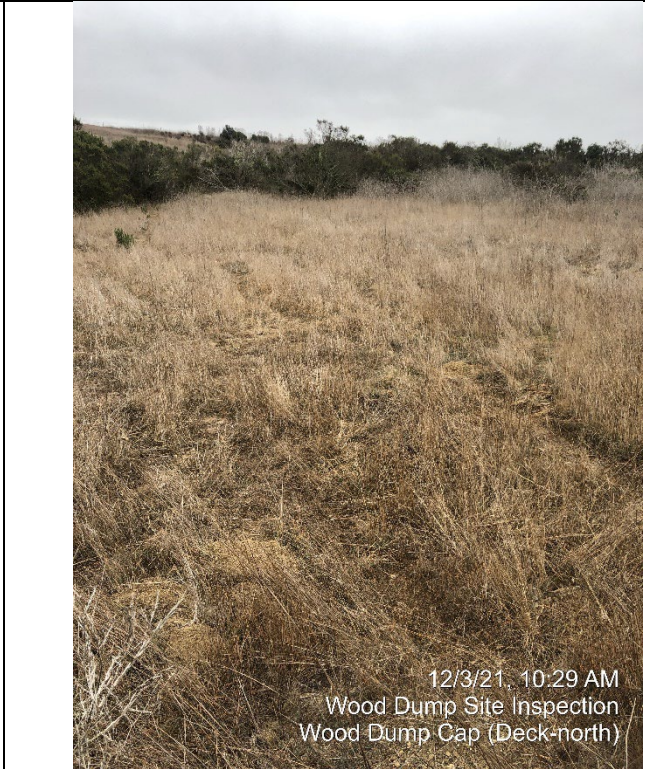
Photo 14: Wood Dump cap (deck), facing north.

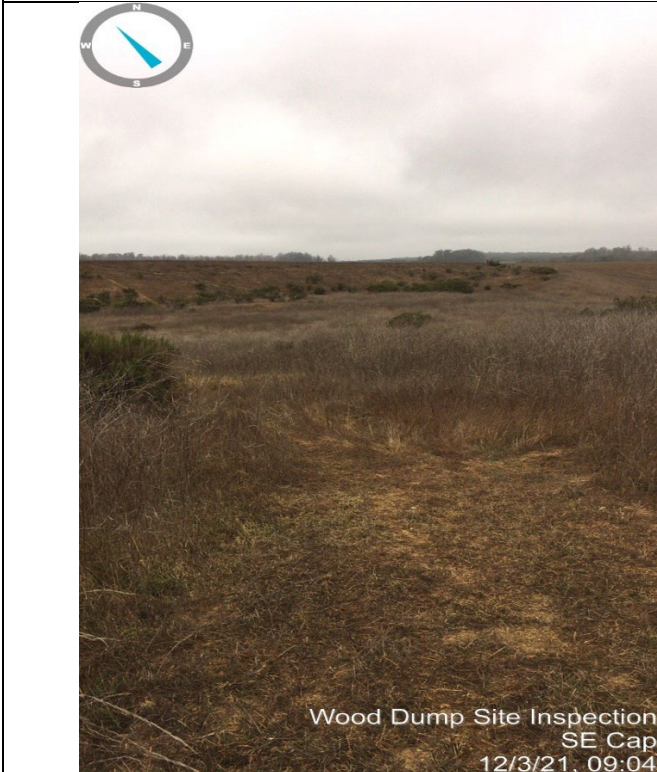
Photo 15: Wood Dump cap (deck), facing northwest.

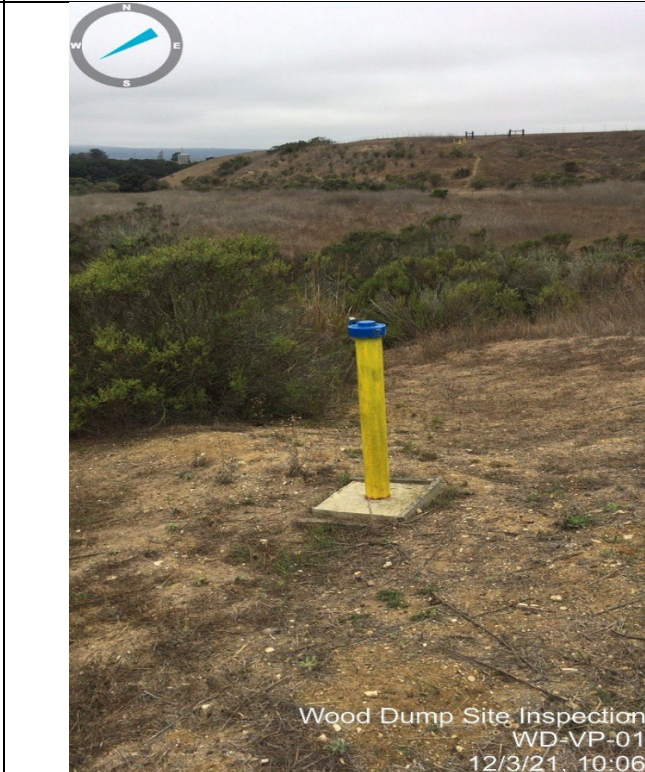
Photo 16: Vapor probe, WD-VP-01, facing southwest.

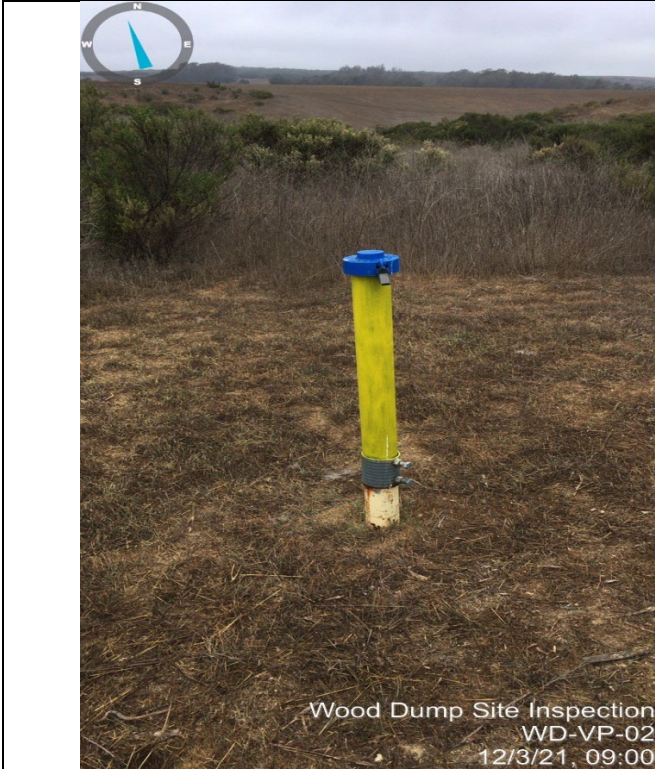
Methane was detected at WD-VP-02 (0.2%/v) during the first semiannual inspection in June 2021. During the October inspection, methane was detected at 0.1%/v at all four probes (Appendix A). Field measurements were collected using the GEM5000 multi-gas meter which has a manufacturer-reported uncertainty of $\pm 0.3\%/v$ (LANDTEC, 2017).

Photo 17: Vapor probe, WD-VP-02, facing north.

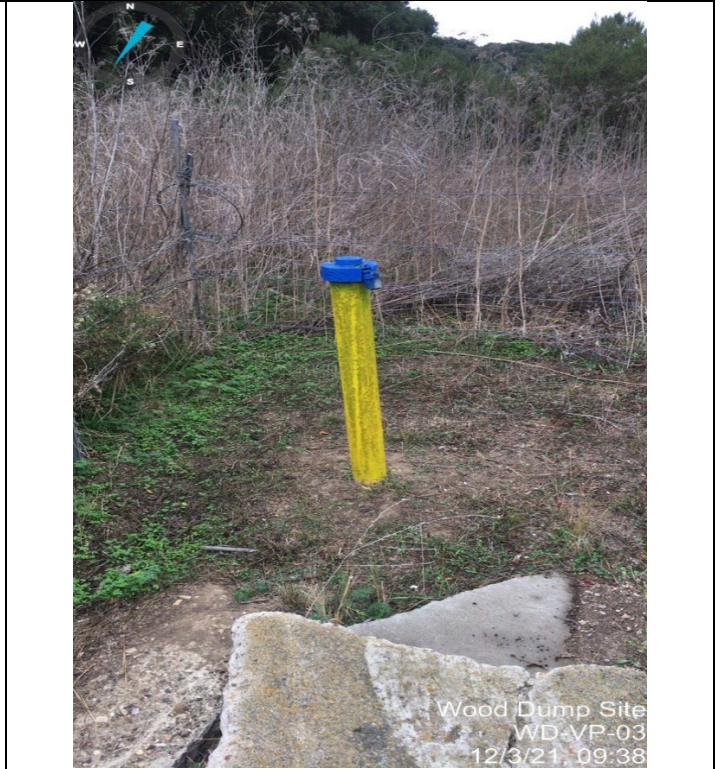
Photo 18: Vapor probe, WD-VP-03, facing southwest.

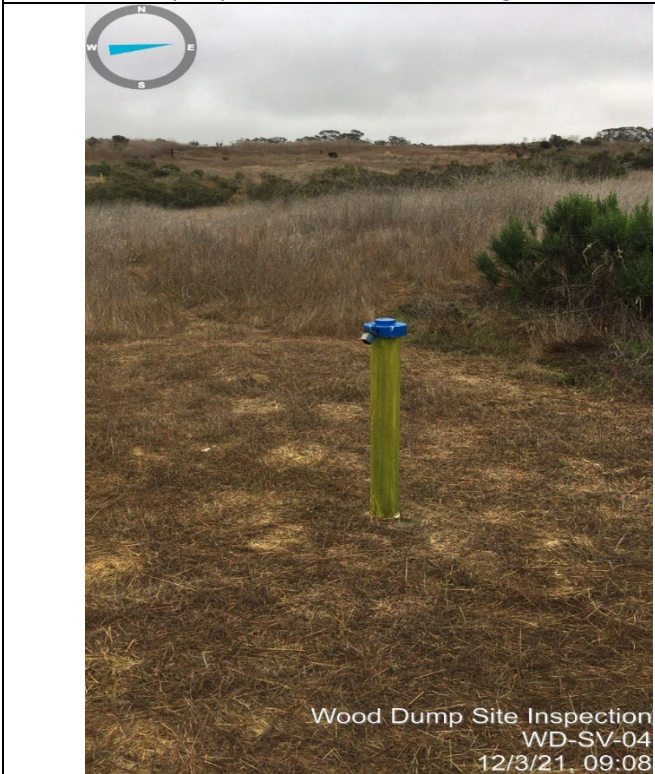
Photo 19: Vapor probe, WD-VP-04, facing east.

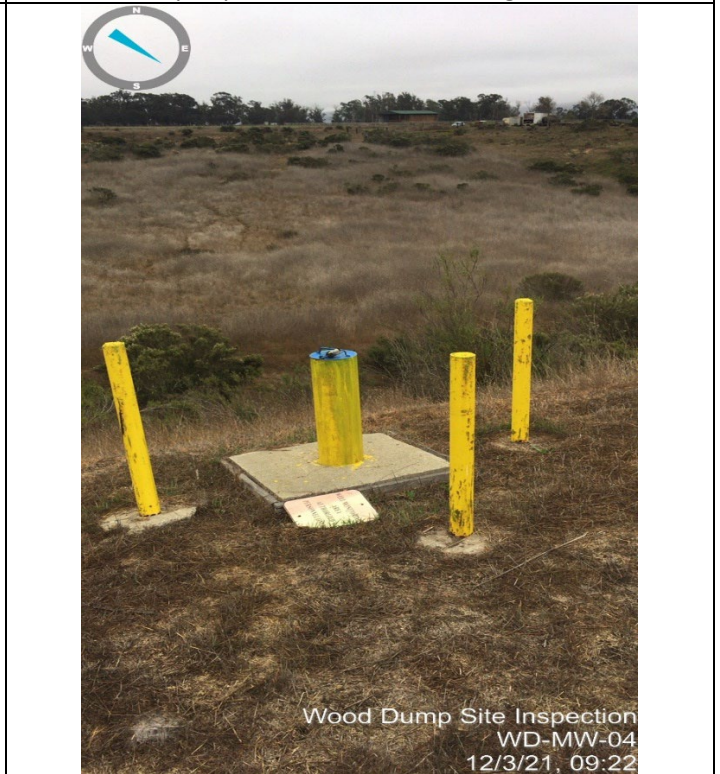
Photo 20: Groundwater monitoring well, WD-MW-04, facing southeast.

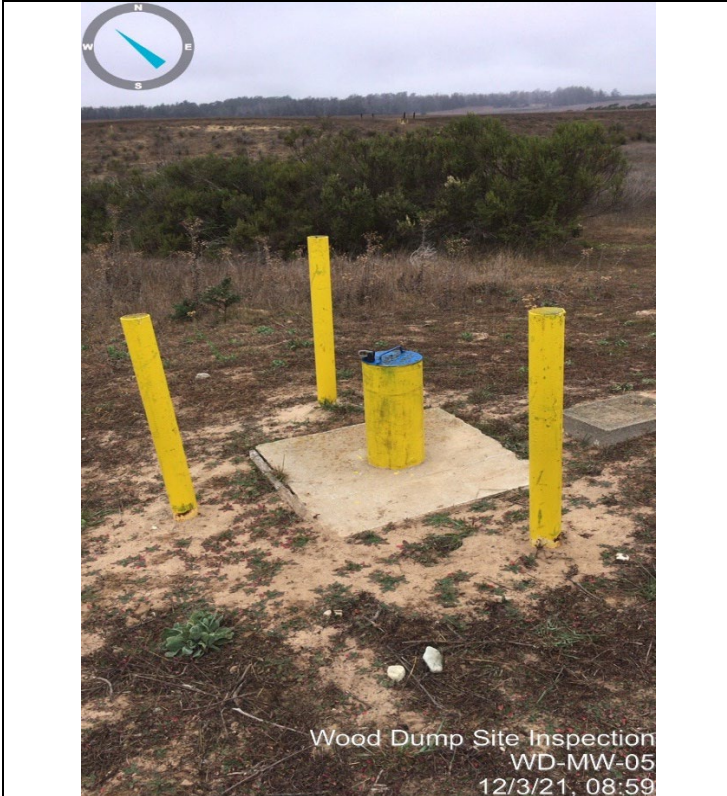
Photo 21: Groundwater monitoring well, WD-MW-05, facing northwest.
