Technical Memorandum

Date: December 21, 2023
To: Project File (Project No. 21044.006.01.000)
From: Sommer Carter/Ahtna Program Manager
Subject: **Technical Memorandum – Site Maintenance Work Plan, Former USDB, Lompoc, California**

Site Maintenance Work Plan
 Environmental Long-Term Monitoring
 Former USDB
 Lompoc, California

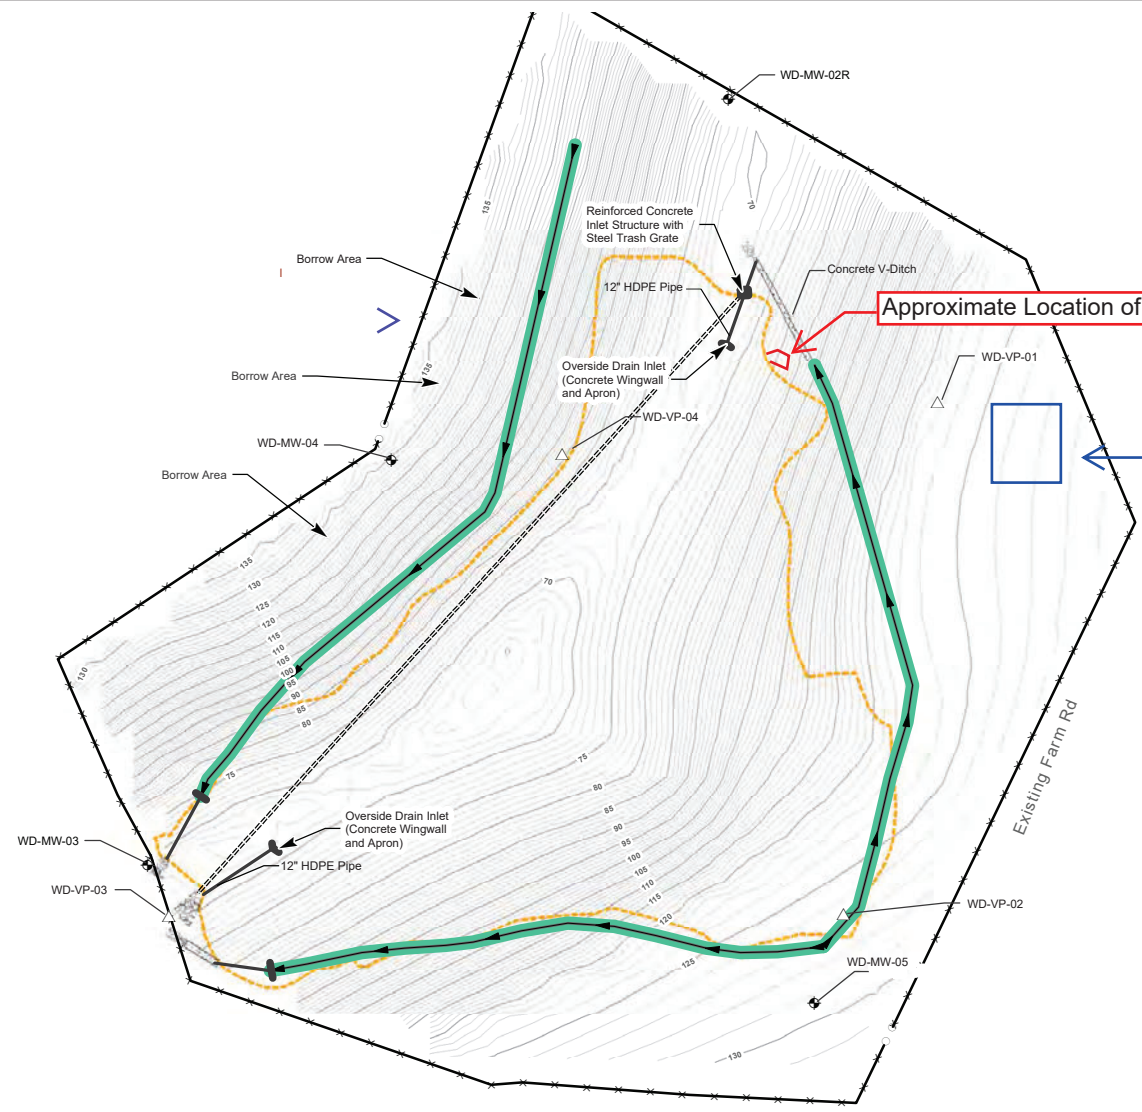
Approximate Location of Erosion

As part of the ongoing maintenance of the Wood Dump area of the Former USDB, minor erosion repairs at the northern slope will be performed to ensure continued slope stability (Figure 2). Before intrusive activities, a geophysical survey using ground penetrating radar and electromagnetic (EM) devices will ensure buried utilities are not disturbed/impacted. The geophysical survey results will be incorporated into the daily field reports, including color-filled contour maps showing EM anomalies (if present).

Earthwork equipment such as a backhoe will excavate up to 15 tons of suitable soil from the approved onsite borrow area. Workers will ensure adequate dust control by adding moisture during earthwork activities. The excavated soils will be transferred to the repair areas, and the borrow area will be smoothed out by the excavation equipment to ensure the area is stable before departure. Borrowed soils placed in existing erosion rills will be track compacted, and moisture from a nearby onsite hydrant will be added to achieve approximately 85-90% relative density. The field team will visually confirm compaction, and results will be documented in daily field reports.

After erosion rills are filled in and compacted, 100 ft of biodegradable straw wattles will be installed across the repaired areas to reduce stormwater flow velocity. Wattles will be installed following the *California Department of Transportation Construction Site Best Management Practices Manual* (Caltrans, 2017).

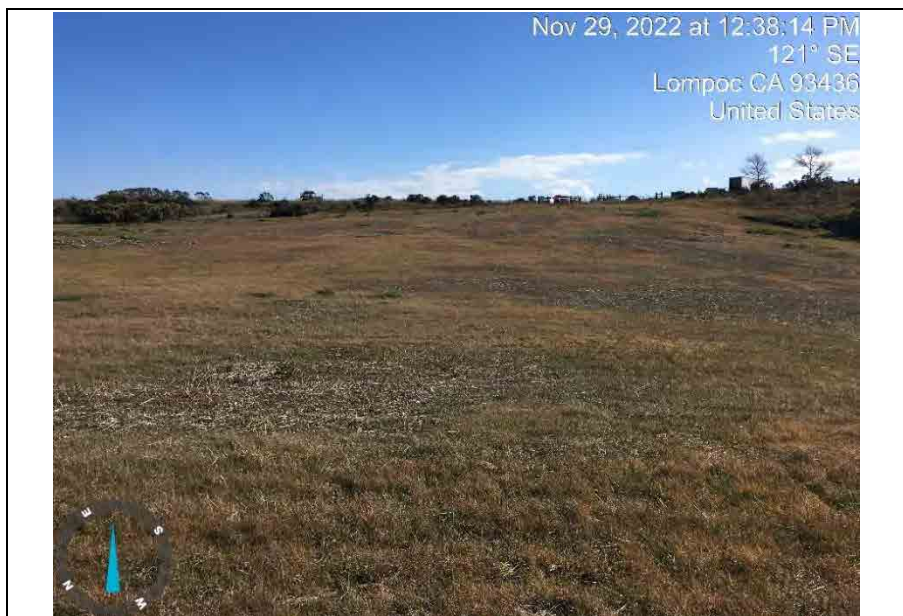
Photo 1: Wood Dump cover maintained/vegetated (facing southeast)

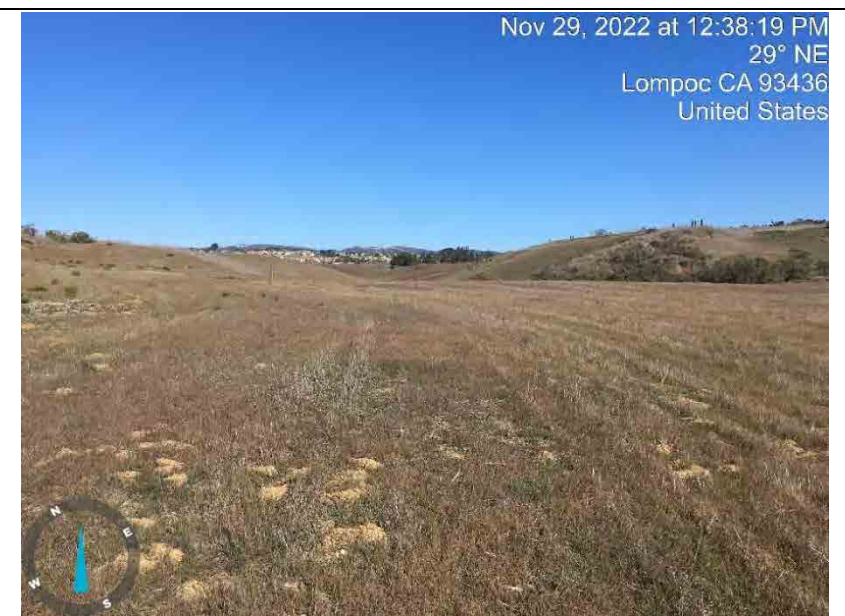
Photo 2: Wood Dump cover maintained/vegetated (facing northeast)

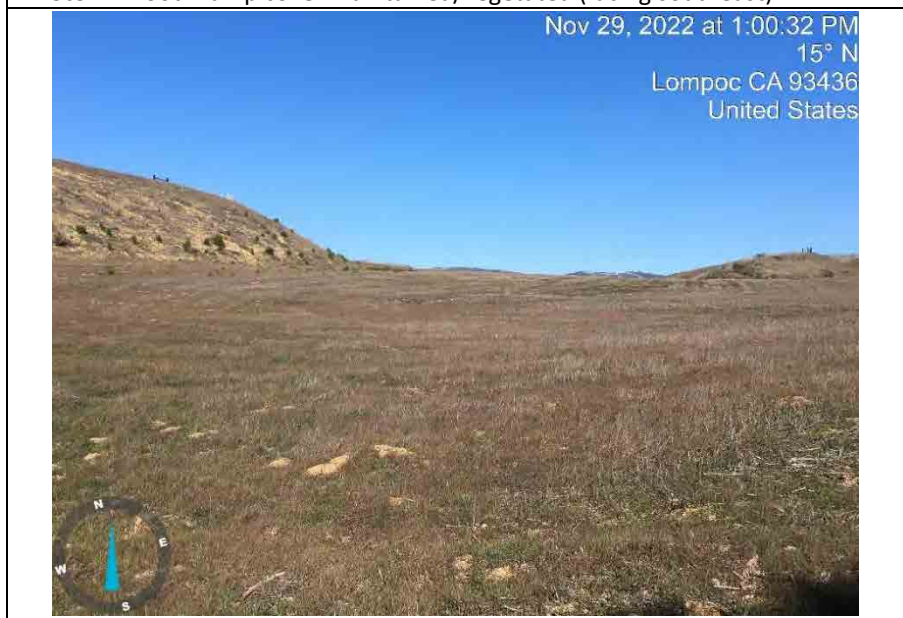
Photo 3: Wood Dump cover well maintained/vegetated (facing north-northeast)

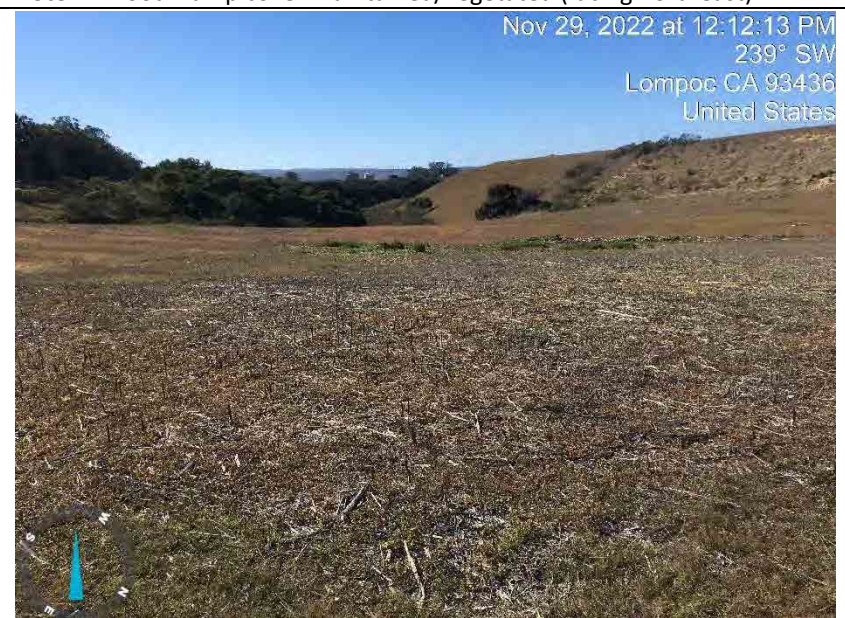
Photo 4: Wood Dump cover maintained/vegetated (facing southwest)

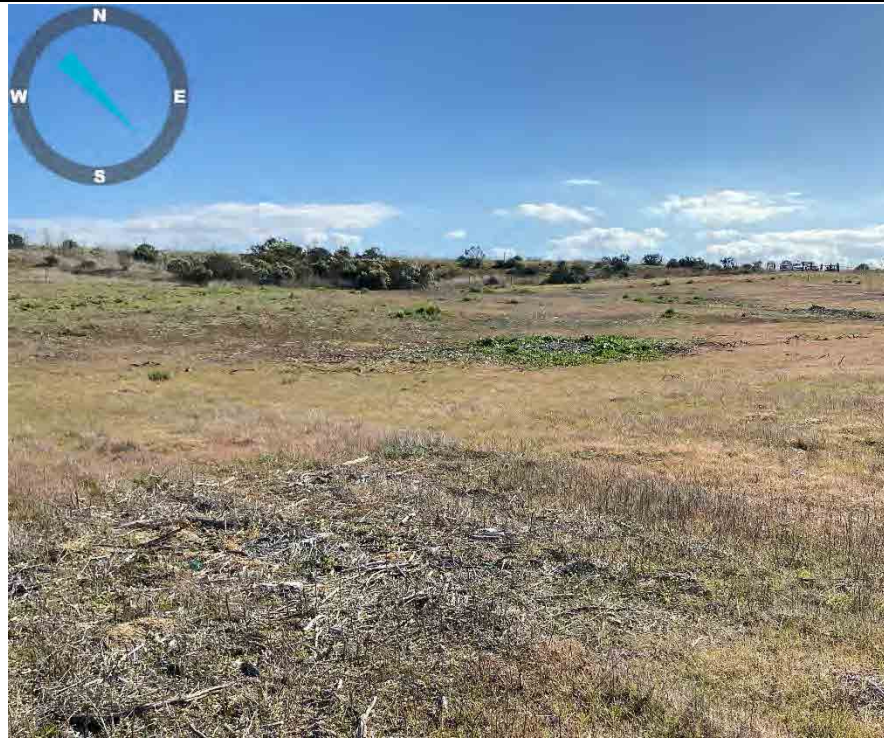
Photo 5: Wood Dump cover maintained/vegetated (facing southeast)

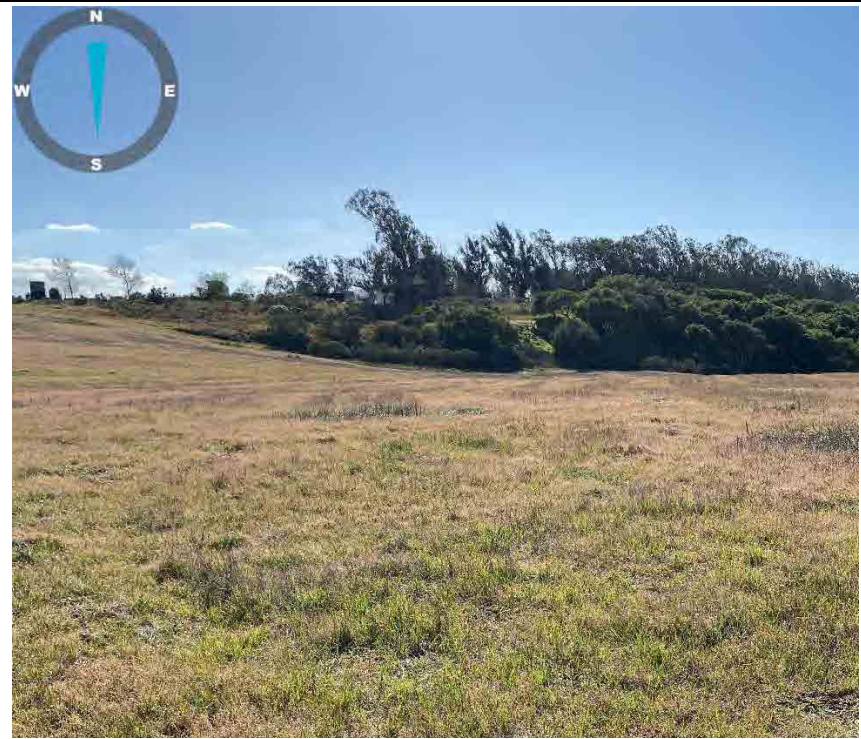
Photo 6: Wood Dump cover maintained/vegetated (facing south)

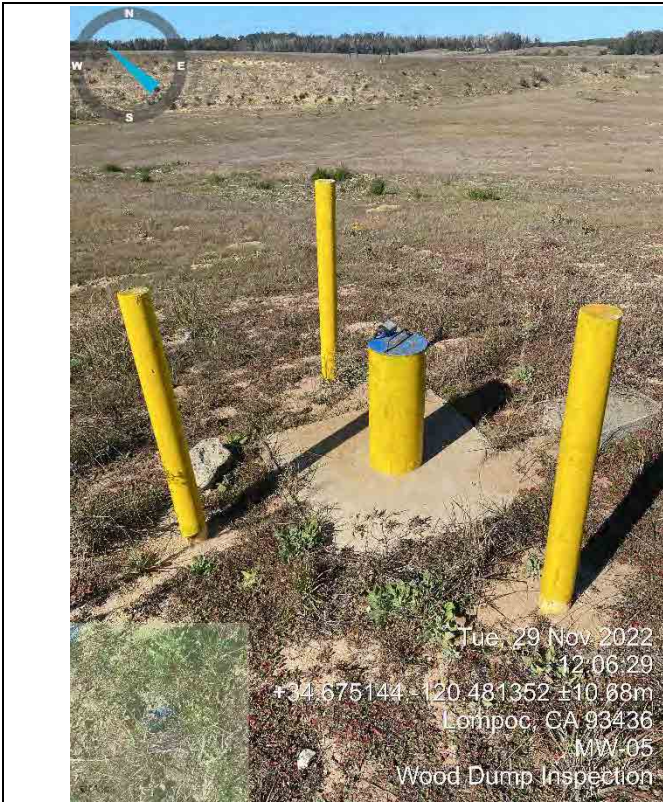
Photo 7: WD-MW-05 in good condition (facing northwest)

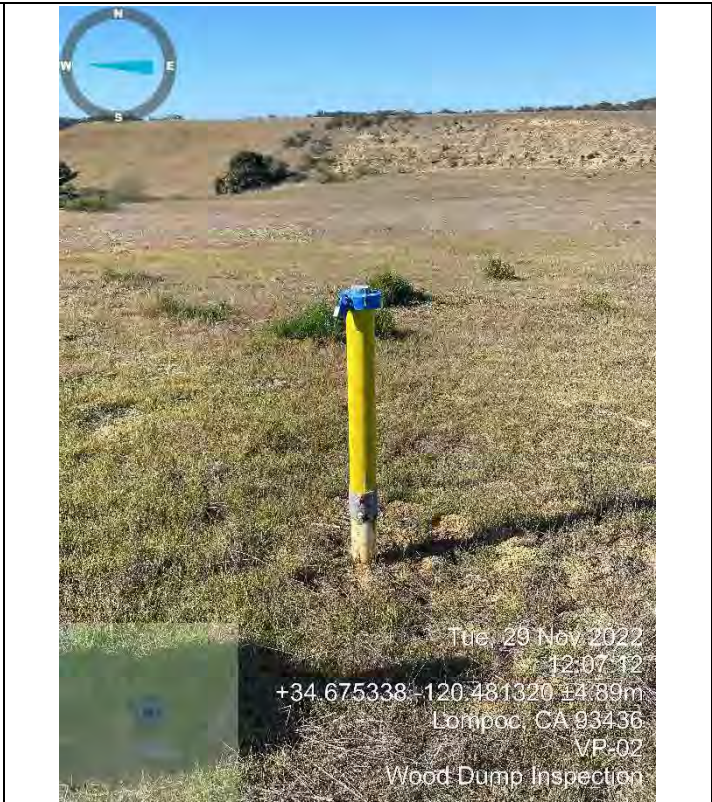
Photo 8: WD-VP-02 in good condition (facing west)

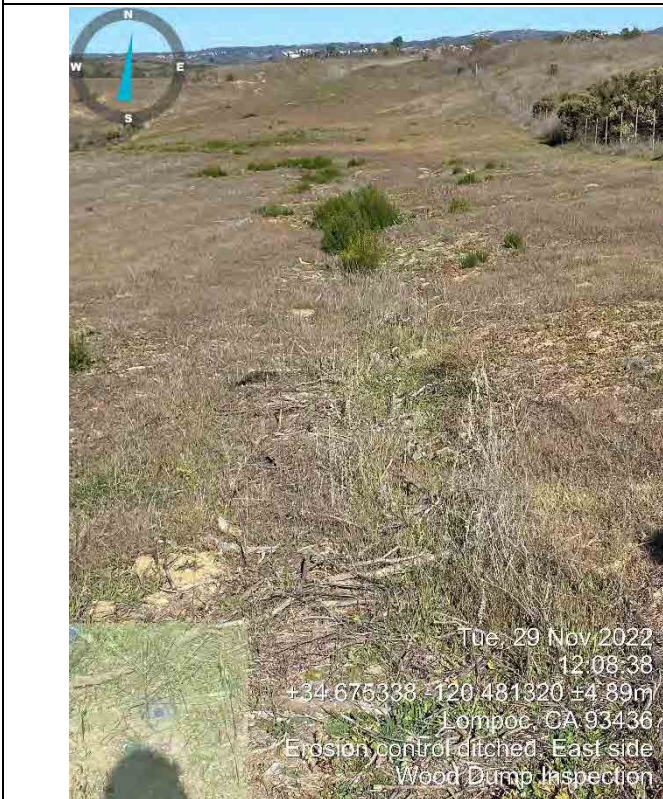
Photo 9: Eastern Erosion Control Lined Ditch - smooth grade and minimal obstructing vegetation (facing north)

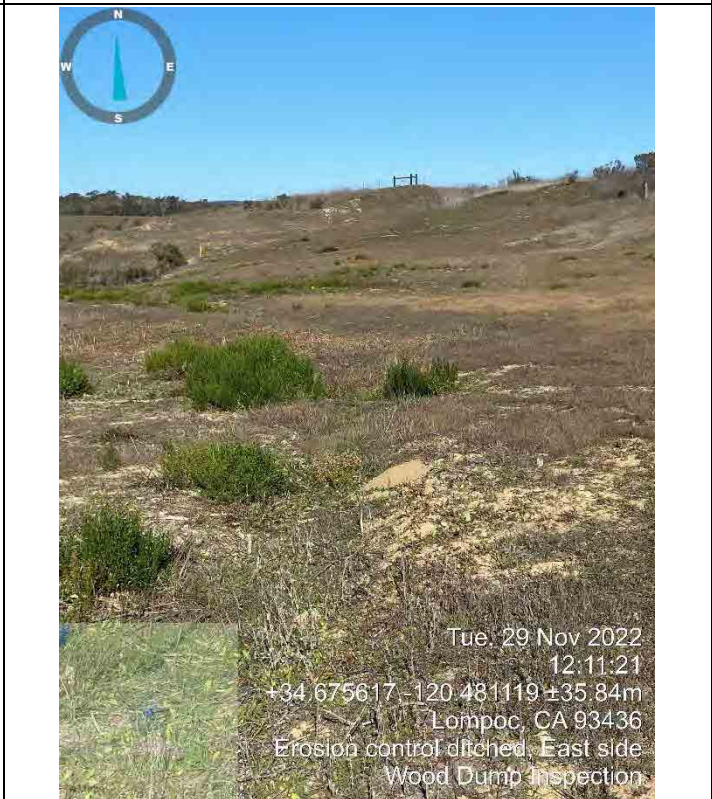
Photo 10: Eastern Erosion Control Lined Ditch - smooth grade and minimal obstructing vegetation (facing north)

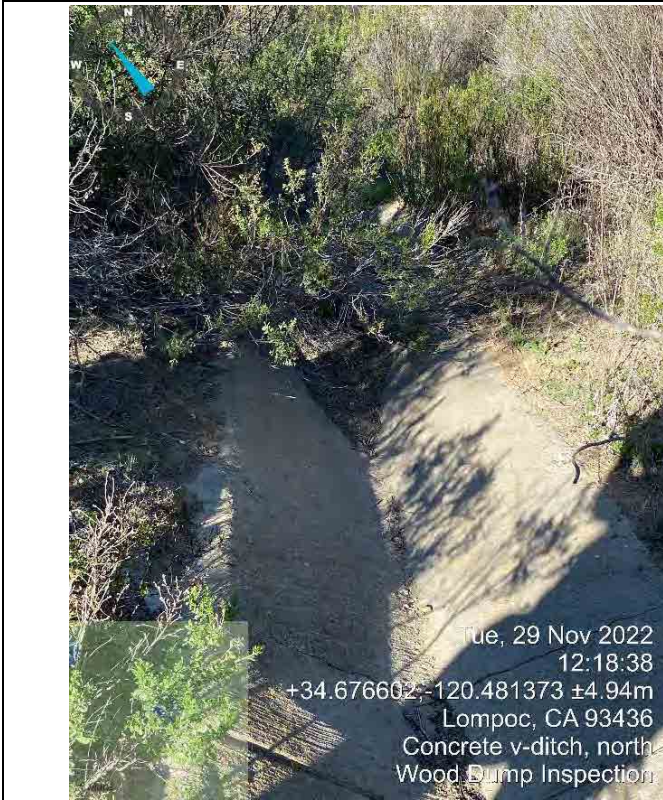
Photo 11: Northeastern Concrete V-Ditch – concrete in good condition, partially obstructed by soil and vegetation (facing northwest)

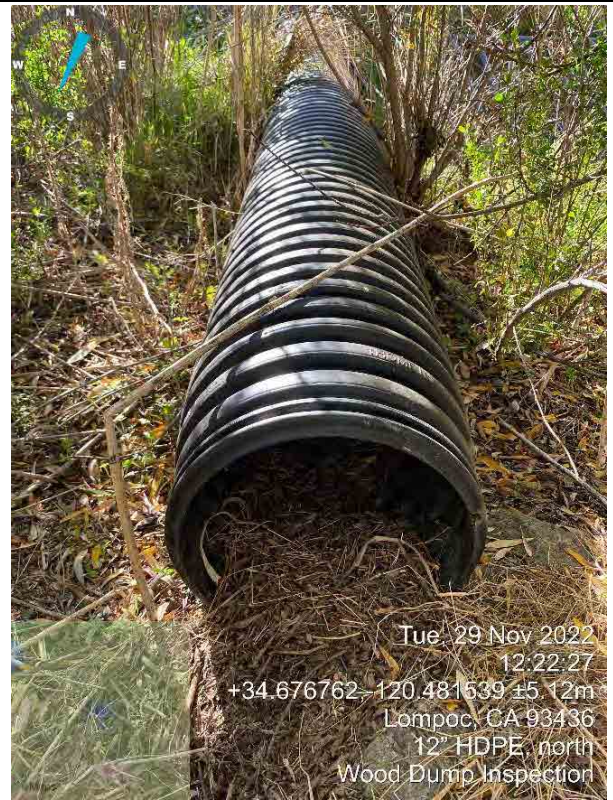
Photo 12: Northern 12" HDPE Drainpipe Outlet – pipe in good condition with minimal debris buildup at outlet (facing southwest)

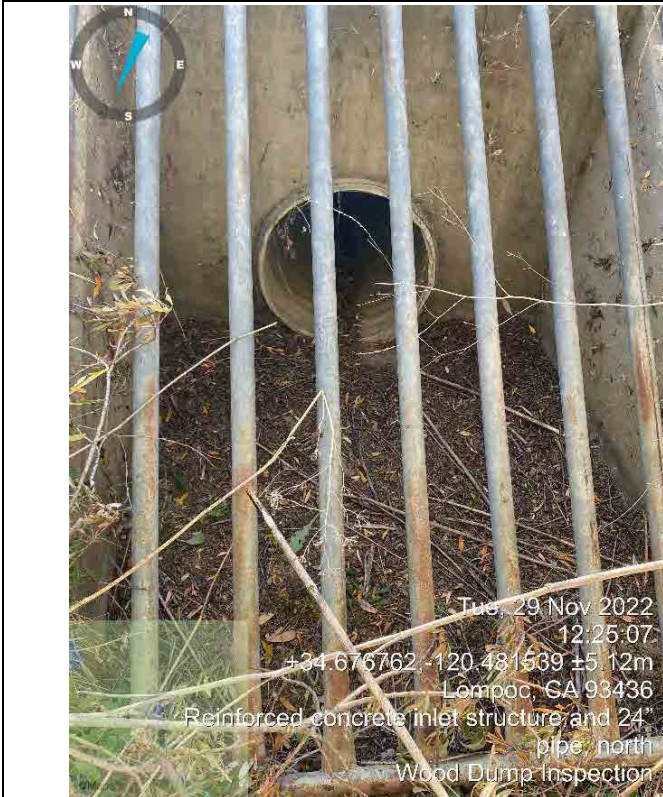
Photo 13: Reinforced Concrete Inlet Structure and 24-inch Corrugated Metal Pipe – all features in good condition and unobstructed (facing southwest)

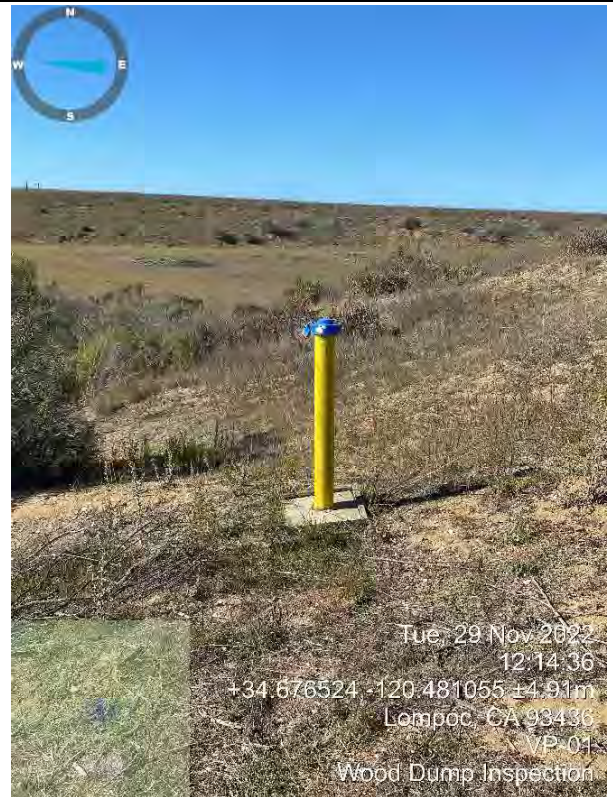
Photo 14: WD-VP-01 in good condition (facing west)

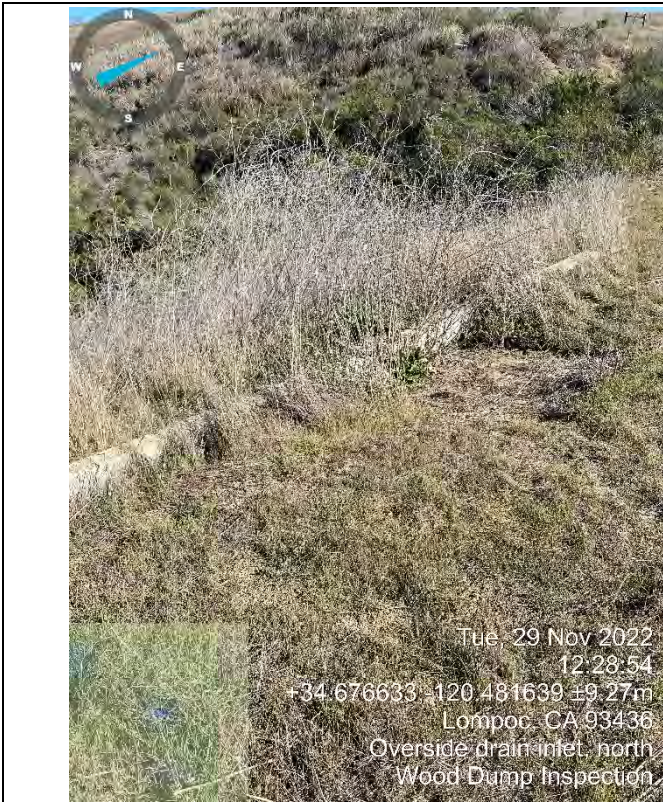
Photo 15: Northern Overside Drain Inlet and Wingwall – concrete in good condition (facing northeast)

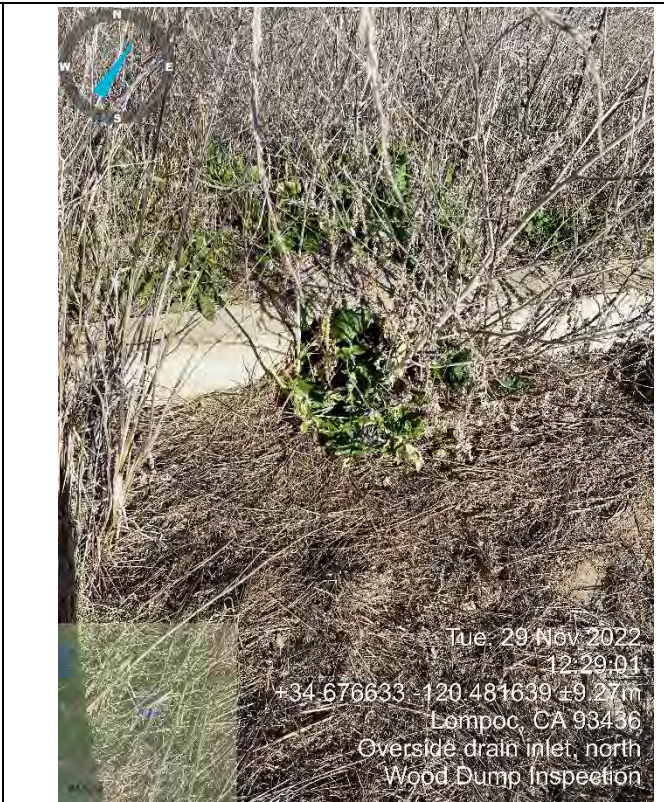
Photo 16: Northern Overside Drain Inlet obstructed by vegetation (facing northeast)

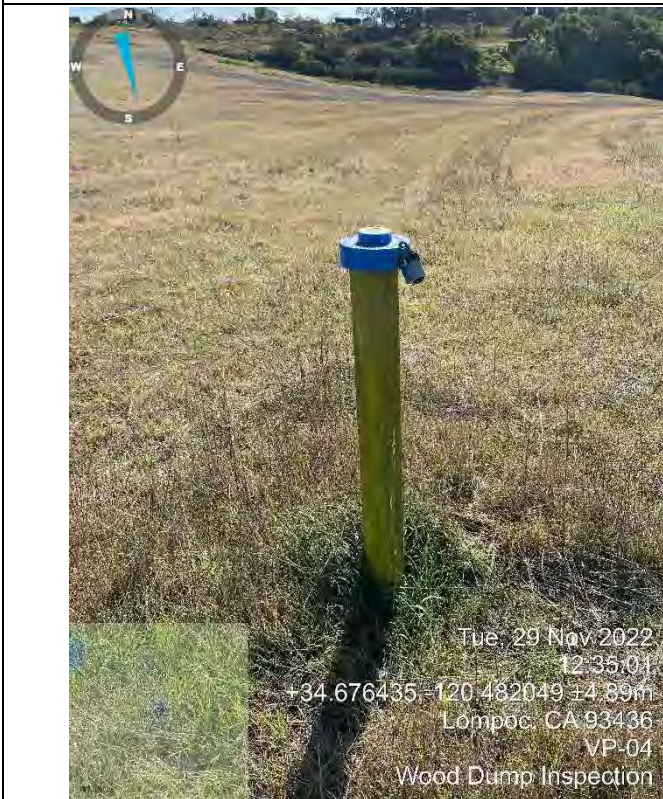
Photo 17: WD-VP-04 in good condition (facing south-southeast)

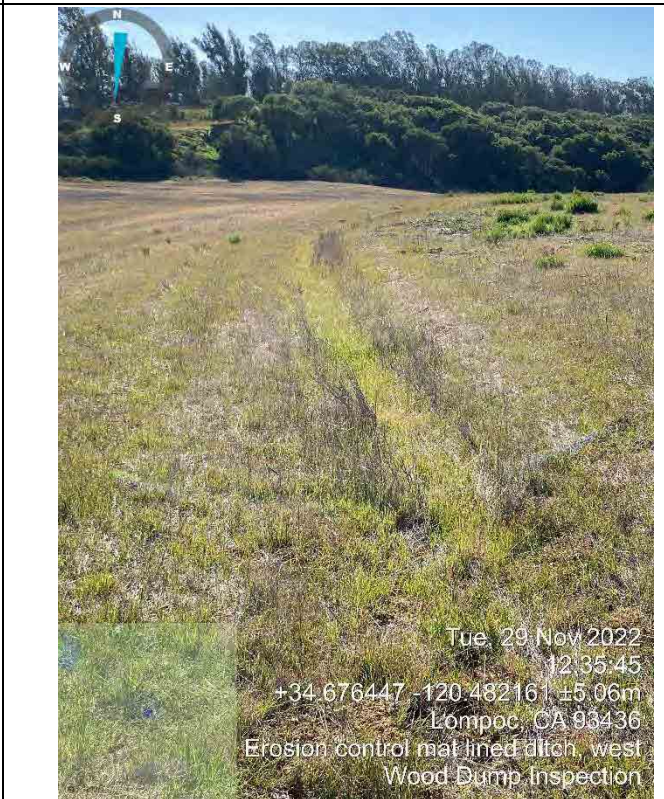
Photo 18: Western Erosion Control Lined Ditch - smooth grade and no signs of erosion rills (facing south)

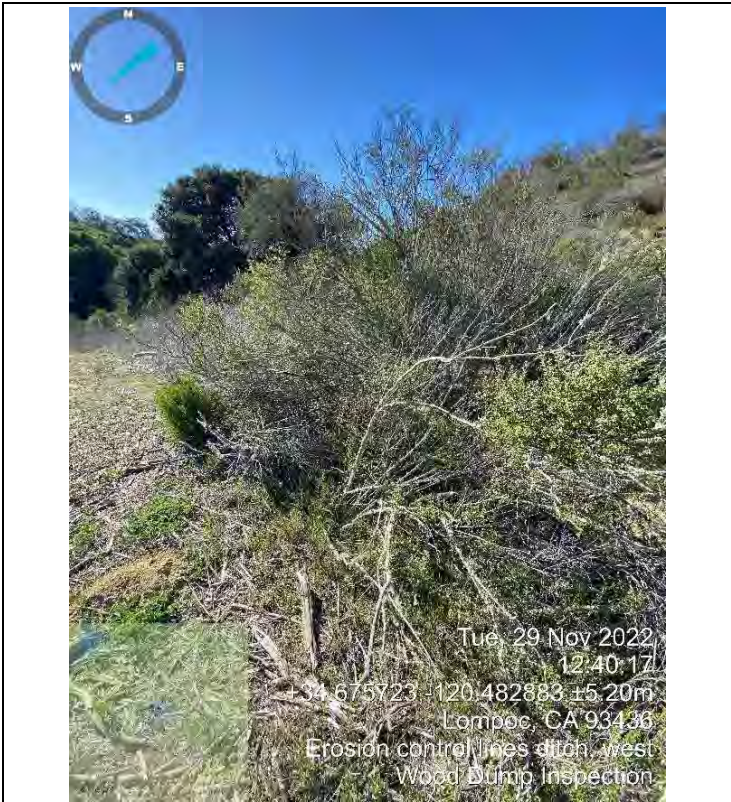
Photo 19: Western Erosion Control Lined Ditch – woody vegetation obstructing ditch at southern end (facing southwest)

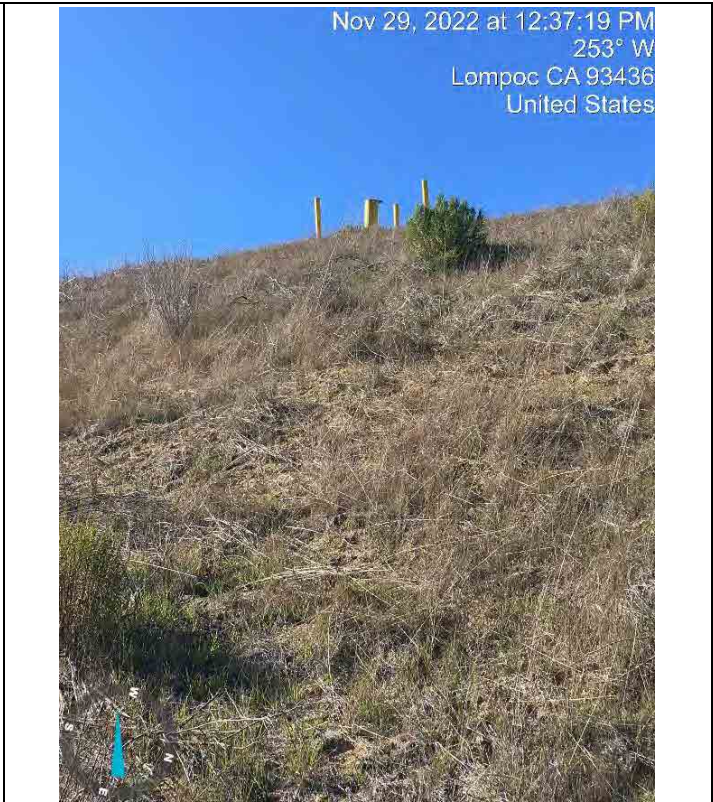
Photo 20: Western slope leading up to WD-MW-04 well vegetated (facing west-southwest)

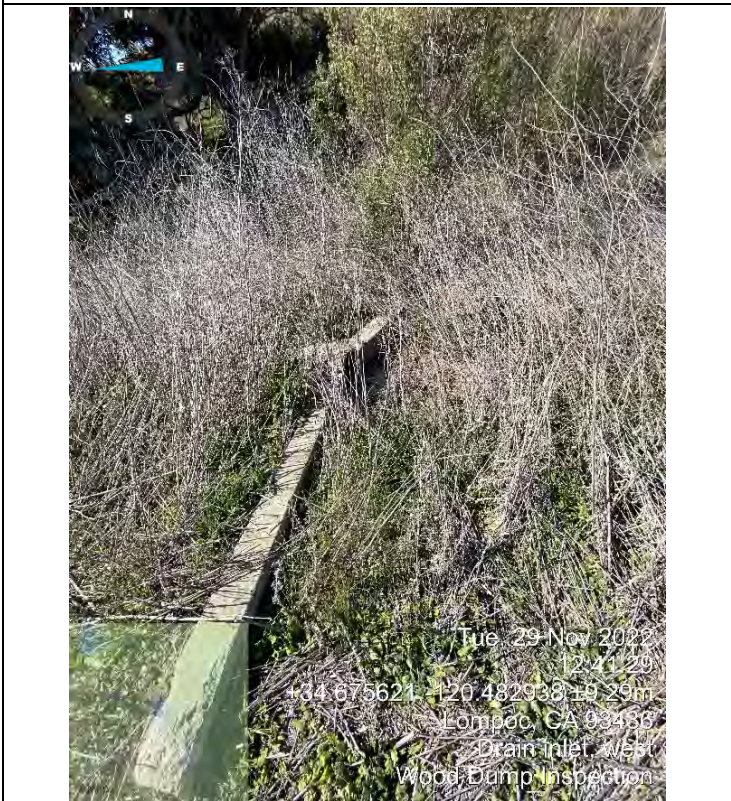
Photo 21: Southwestern Overside Drain Inlet and Wingwall – concrete in good condition, but inlet area is overgrown with vegetation (facing west)

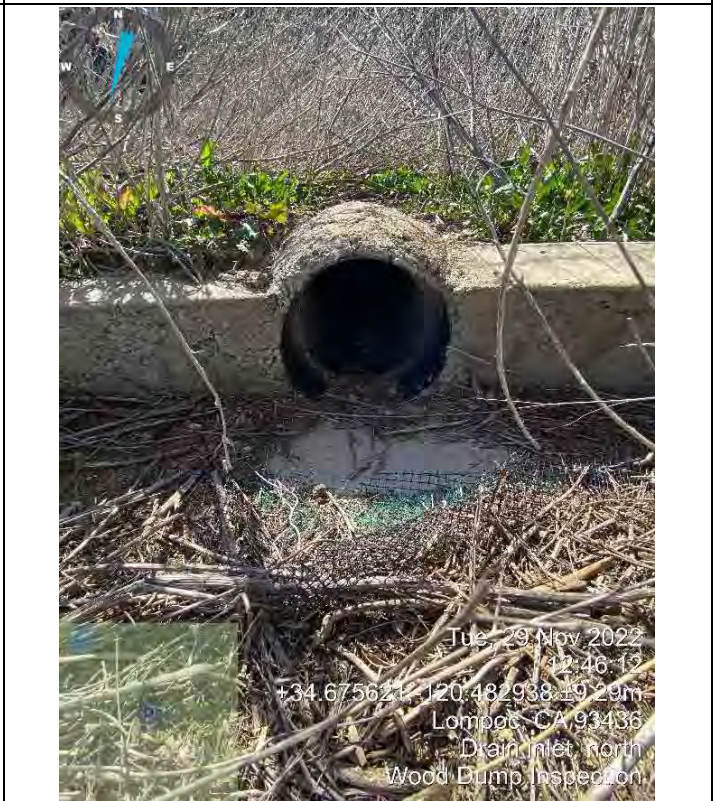
Photo 22: Southwestern Overside Drain Inlet – pipe is in good condition with no signs of obstruction at the opening (facing south-southwest)

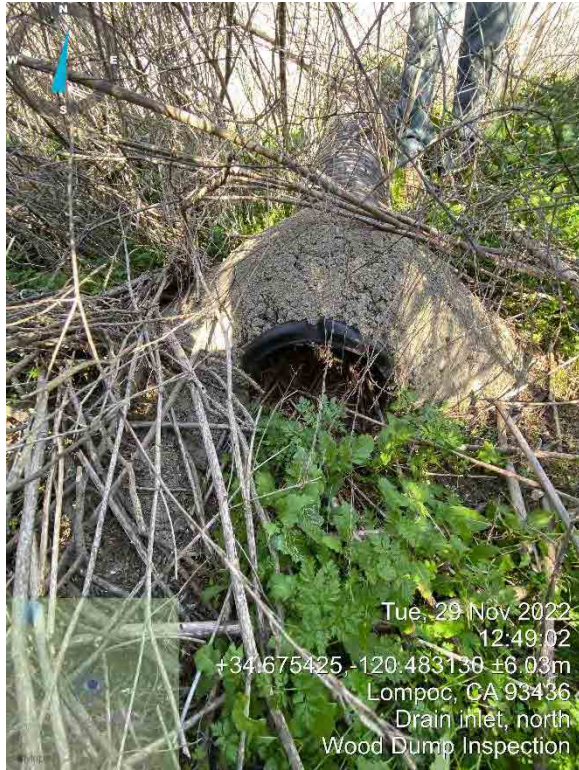
Photo 23: Southwestern Overside Drain Outlet – pipe is in good condition, but the opening is obstructed by vegetation and soil buildup (facing north)

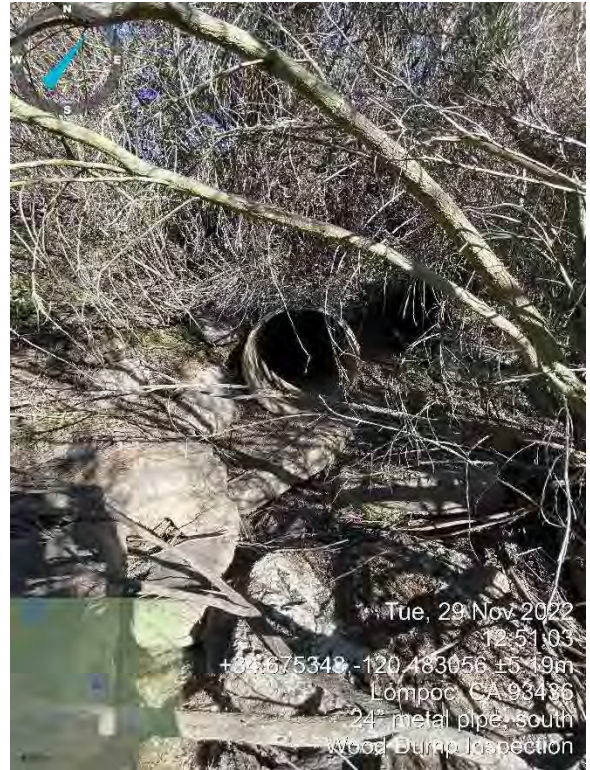
Photo 24: Southern Outlet of 24" Corrugated Metal Pipe – an area near the outlet is overgrown with woody vegetation, but the pipe is in good condition and unobstructed (facing northeast)

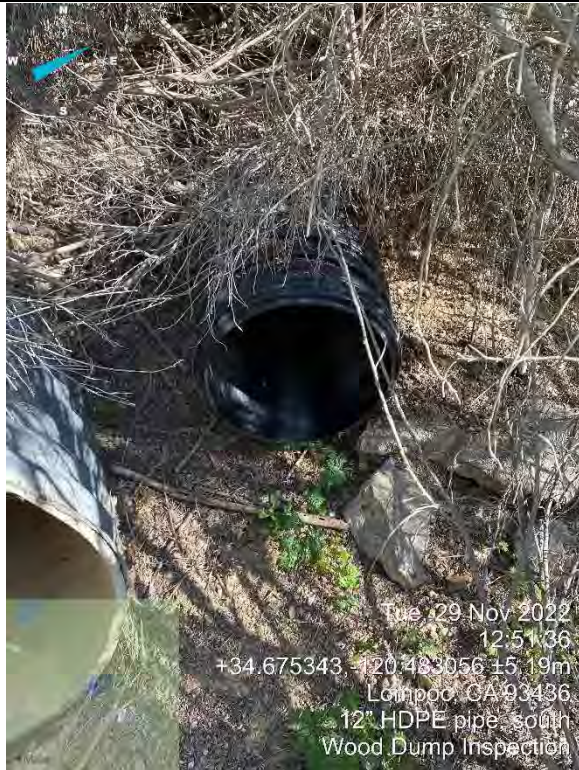
Photo 25: Southern 12" HDPE Pipe Outlet – pipe in good condition and unobstructed (facing northeast)

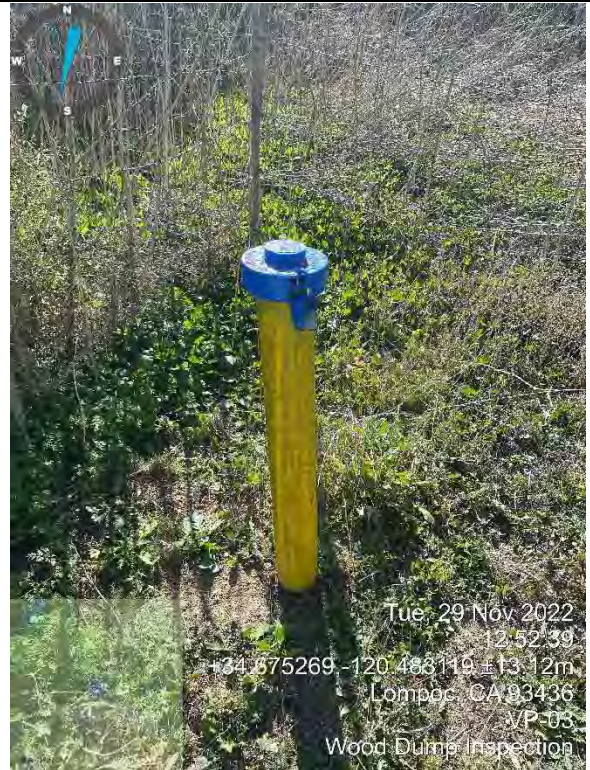
Photo 26: WD-VP-03 in good condition and unobstructed (facing south)

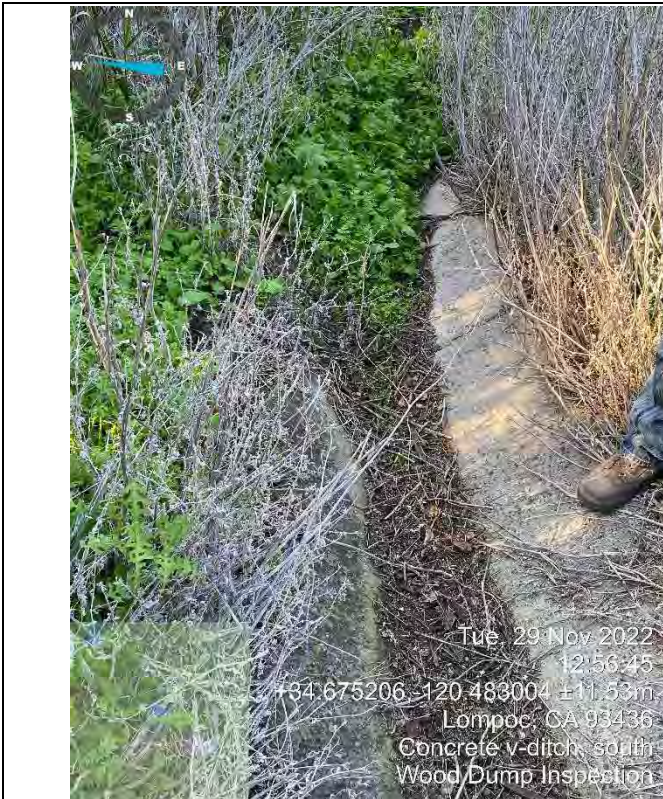
Photo 27: Southern Concrete V-Ditch – concrete is undamaged but obstructed by soil and vegetation buildup (facing west)

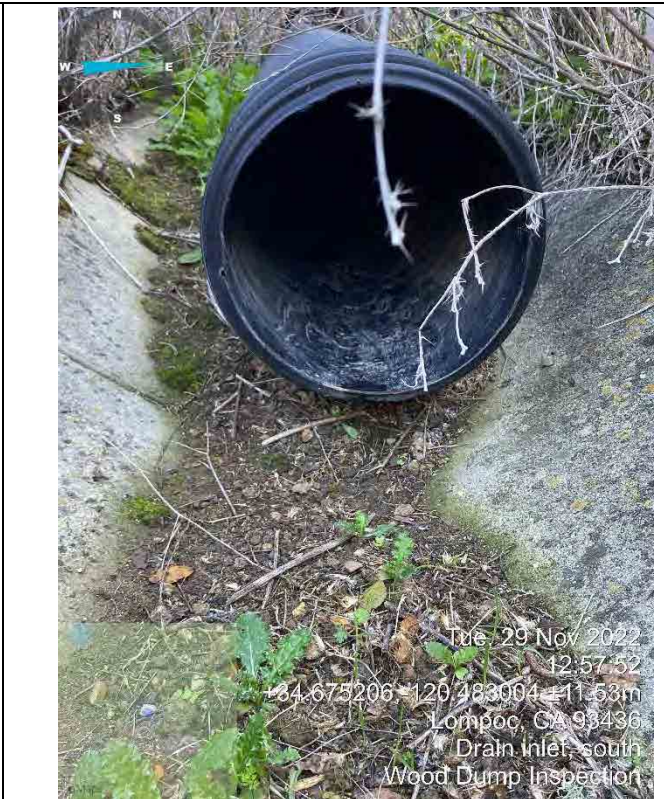
Photo 28: Southern 12" HDPE Pipe Outlet Within V-Ditch– pipe in good condition and unobstructed (facing east)

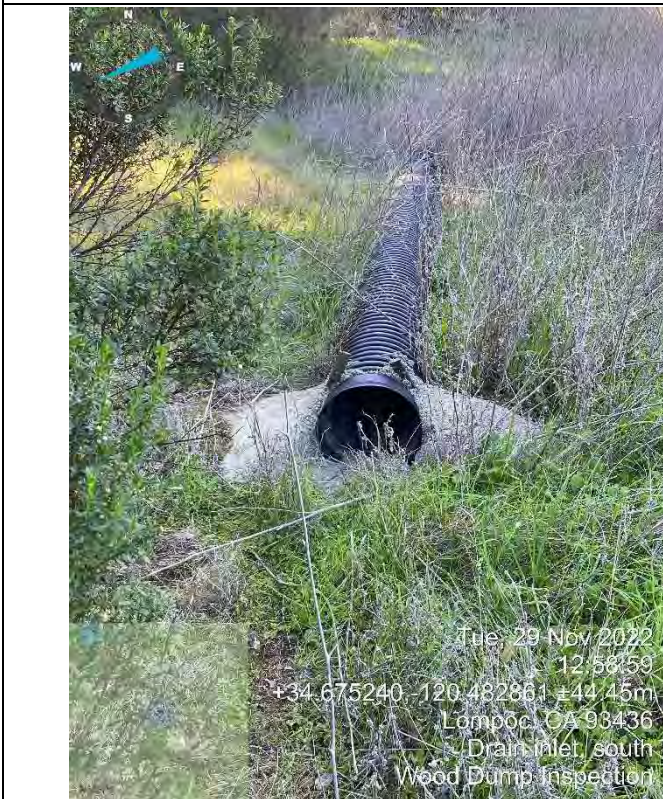
Photo 29: Southern 12" HDPE Pipe Inlet– pipe in good condition, well anchored, and unobstructed (facing southwest)

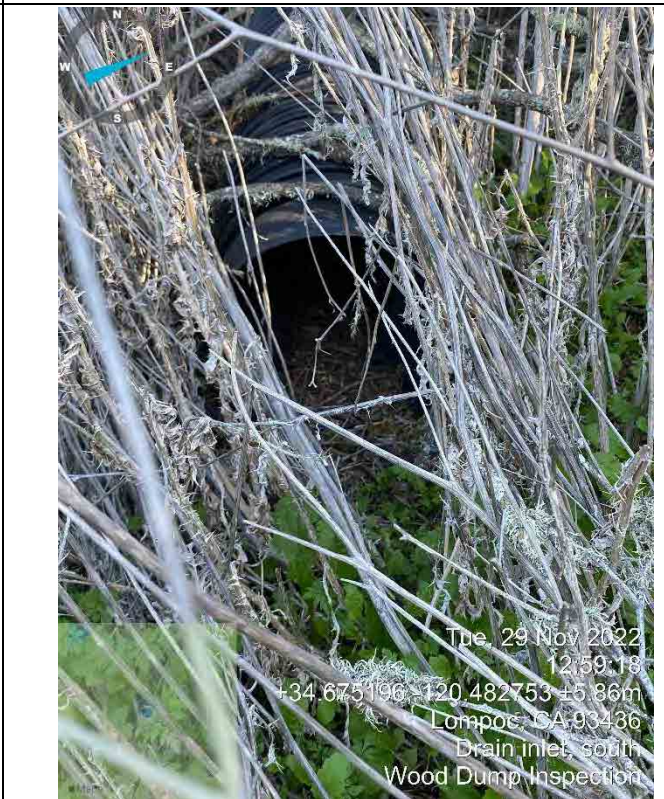
Photo 30: Southern 12" HDPE Pipe Outlet– pipe in good condition but obstructed with vegetation and debris buildup (facing northeast)

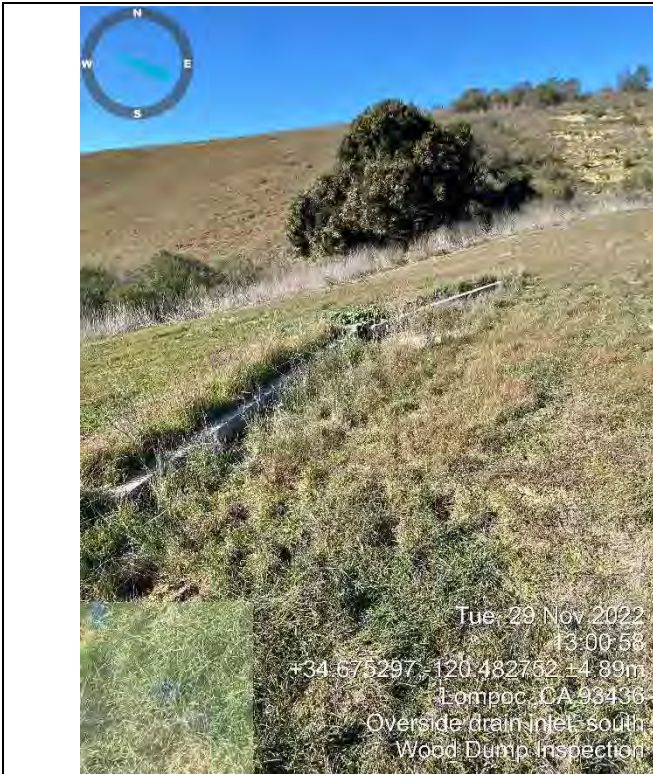
Photo 31: Southern Oversight Drain Inlet and Wingwall unobstructed and undamaged (facing northwest)

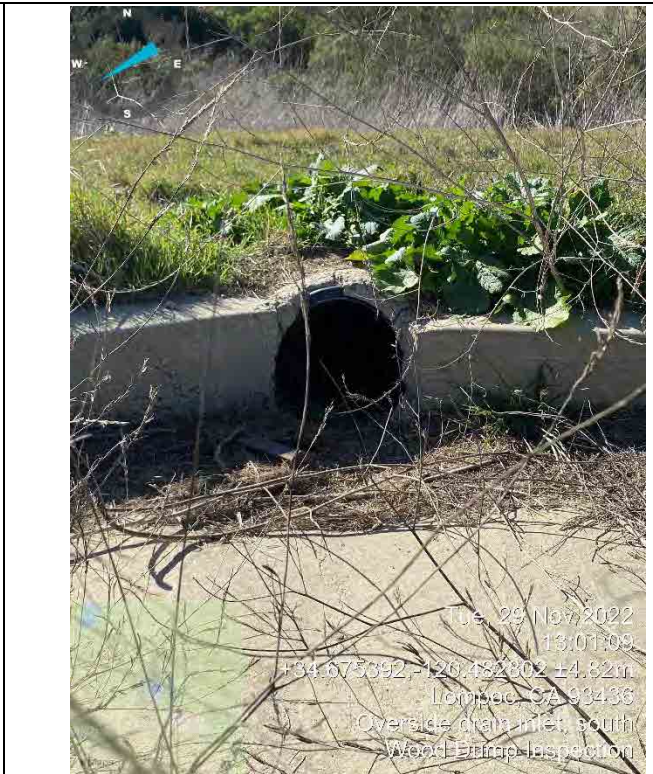
Photo 32: Southern Oversight Drain Inlet and Concrete Apron unobstructed and undamaged (facing southwest)

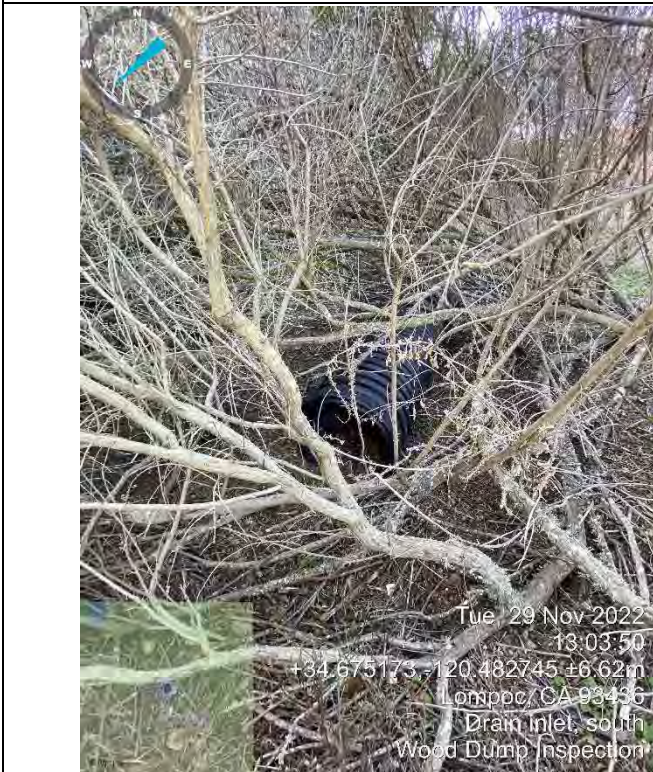
Photo 33: Southern 12" HDPE Pipe Inlet - pipe in good condition but obstructed with vegetation and debris buildup (facing southwest)

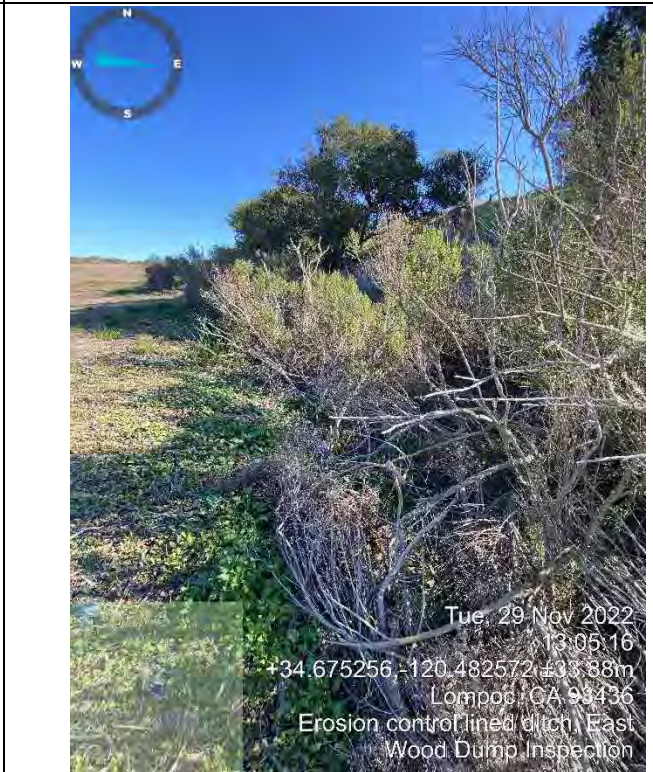
Photo 34: Eastern Erosion Control Lined Ditch - southern portion of the ditch is overgrown with woody vegetation (facing east)

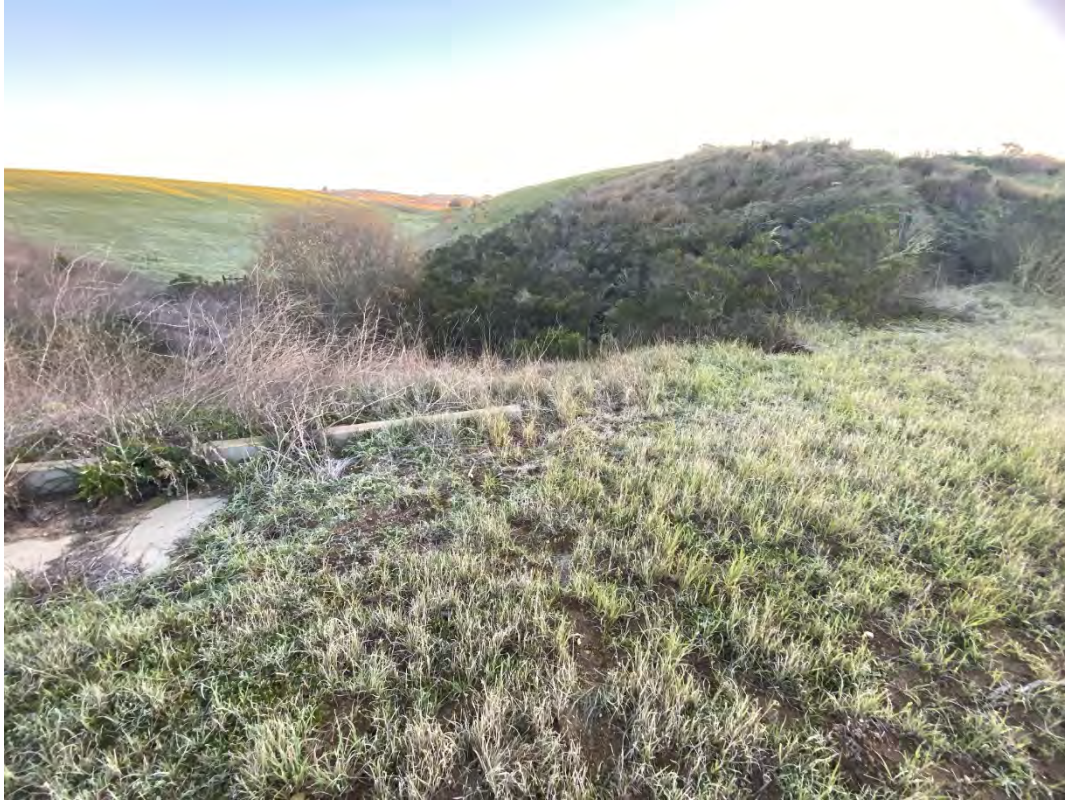
Photo 1: Overview of erosion observed at the north side of the Wood Dump Area. January 2023

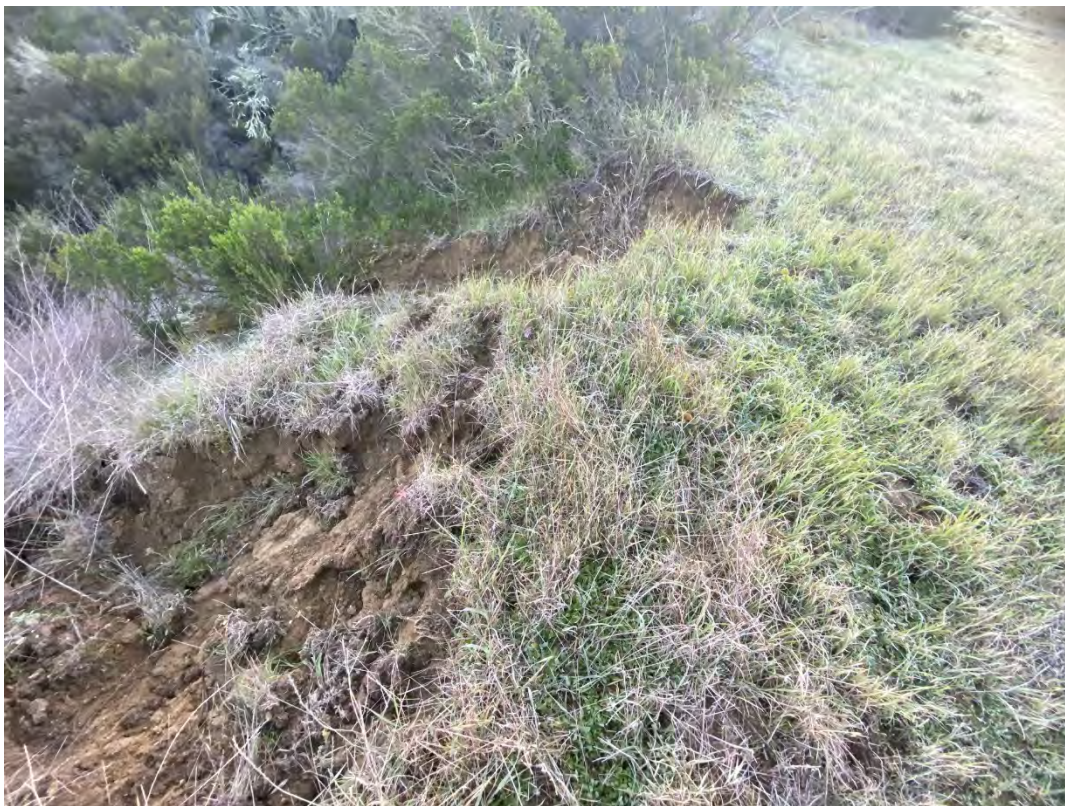
Photo 2: Close-up view of erosion on slope at the Wood Dump Area. January 2023
