Reducing Risk of H Street Italian Stone Pines

Ken Knight

November 16, 2017

H St Italian Stone Pine Study Objectives

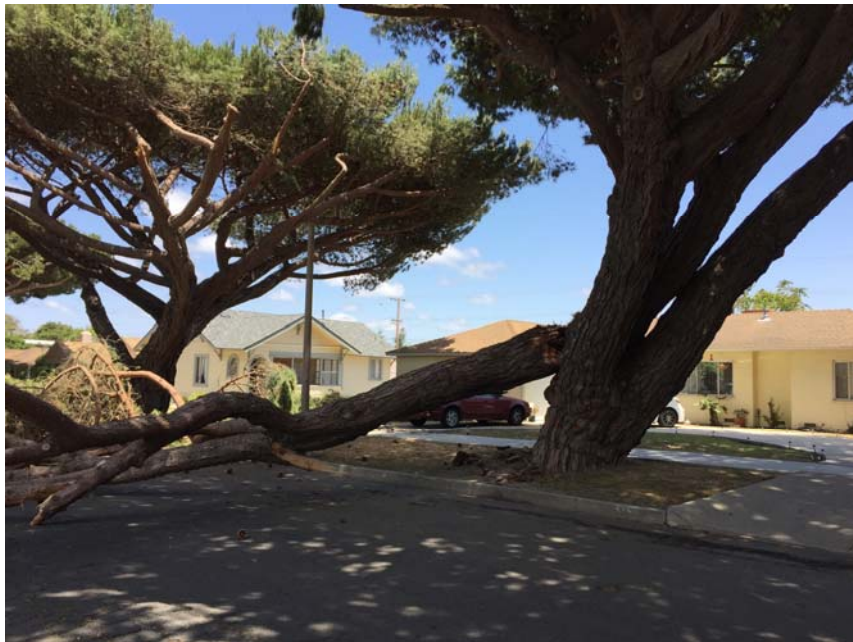
5-23-16 limb failure – Tree 49 - 330 S. H St.

Overextended limb failure

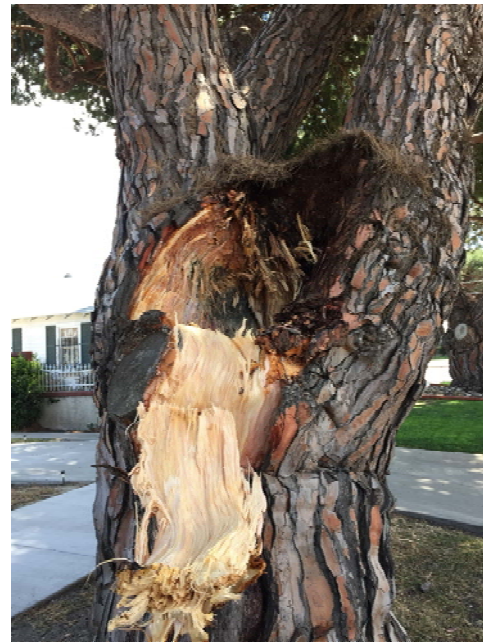
Note pocket of decay on the NE quadrant
