INDEPENDENT CONSULTANT - SPECIALIST IN ARBORICULTURE AND URBAN FORESTRY
425 30TH STREET, SUITE 28 • NEWPORT BEACH, CALIFORNIA 92663 • 949.673.5199 • FAX 949.673.5197

SEPTEMBER 12, 2003

RE: H STREET PINE TREE ASSESSMENT

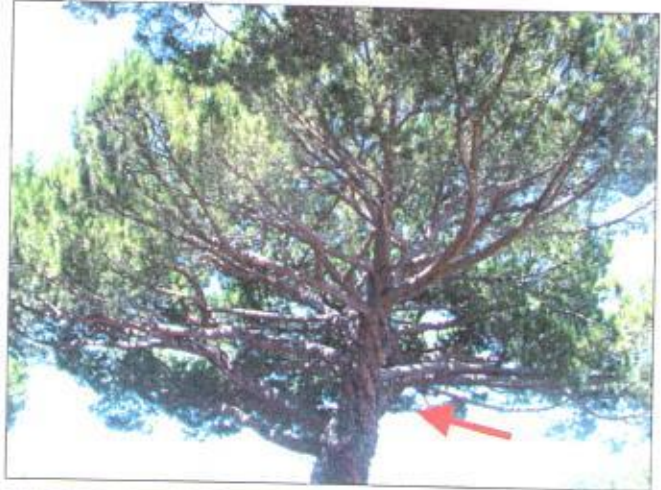
Above right: the tree located at 200 H Street (north tree). The upper canopy of this tree is somewhat atypical - shorter and stubbier than others. Note the twisted growth of the trunk (red arrow)

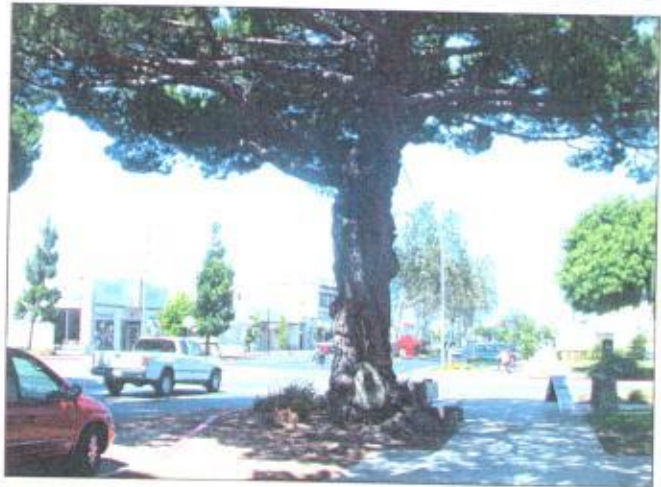
Middle right: the tree located at 200 H Street (north tree). The twisting pattern extends for the entire length of the trunk.

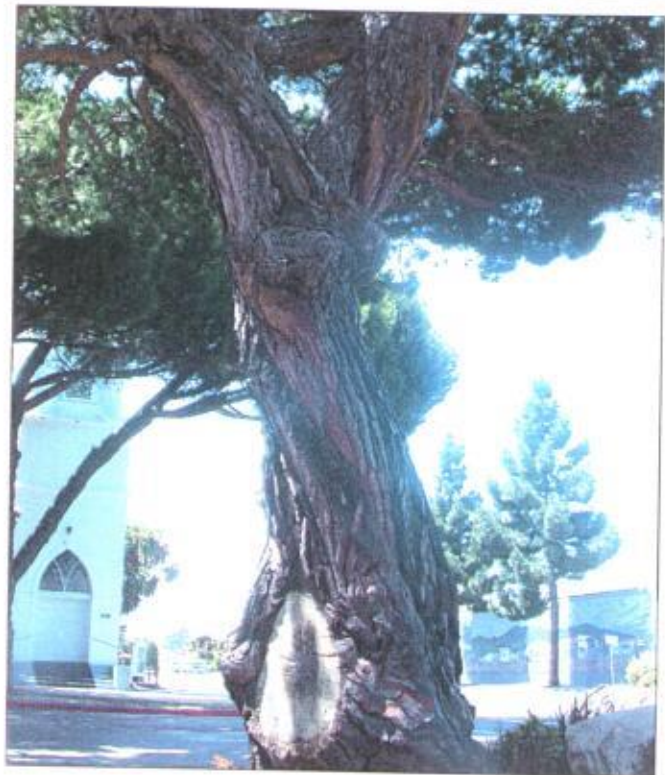
Below right: the tree located at 200 H Street (north tree). In addition to the twisting pattern, the trunk has significant kinks, and a large wound low in the bole. These and some of the other characteristics found in other trees along H Street are not equivalent to the conditions that led to tree failure at 228 H Street, but they merit monitoring.

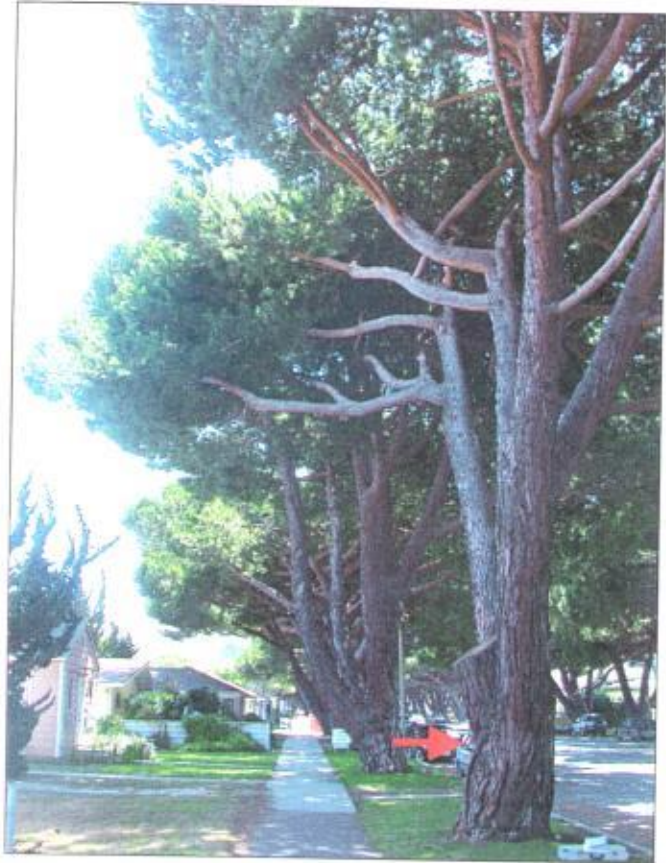
Above right: the tree located at 210 H Street. Resistograph measurements were taken of this tree at the location indicated (red arrow). Note the lopsided canopy occurring as a result of removal of one of the major scaffold limbs. That treatment has to some extent mitigated potential limb failure in the manner of 228 H Street.

Seven trees exhibit characteristics indicating that harmful conditions are progressing. These trees might be treated, if desirable, or the trees may also be considered for removal. These are: 210, 214, 231- south tree, 303, 310- north tree, and 322 H Street. In addition, several trees measured with the Resistograph do not appear to be significantly impacted by these conditions at this time. These are: 306, 320, 331- south tree, and 430.

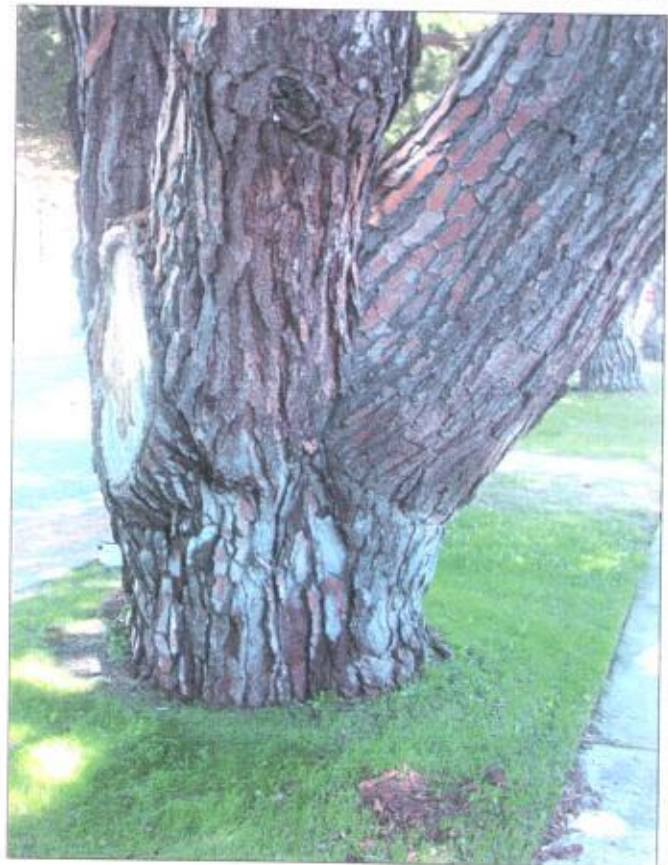
Below right: the tree located at 214 H Street. The soil is excessively moist here and other challenging factors exist in addition to the presence of those conditions similar to 228 H Street.

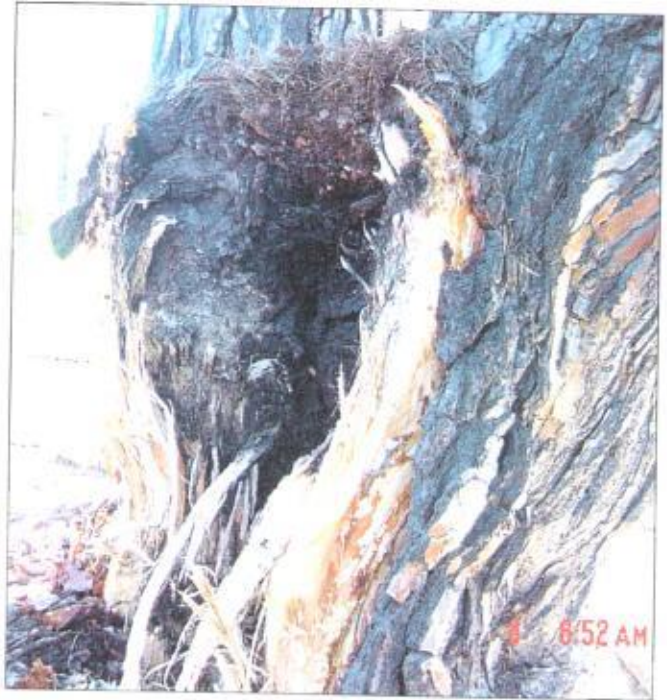
The study arises from an incident occurring in August of 2003. In the early morning hours on a calm day one of three major scaffold limbs of the large Italian stone pine located in the public right of way at 228 H Street broke off and fell into the street. The wound produced by this broken limb exposed a combination of characteristics that appear to have predisposed the limb failure. These characteristics include:

- An external pocket that formed at the junction or bifurcation of the three codominant major scaffold limbs
- Bark extending down from the bifurcation so as to be included deep within the internal woody tissues of the tree bole (lower trunk portion)
- A cavity of decay beneath the pocket and within the bole that is associated with cracks and included bark

It may also be inferred that long horizontal limbs and heavy limb end weight intensified the condition by exerting a load amount that exceeded the mechanical 'holding capacity' of this multi-stemmed tree.

Above right: the tree
located at 228 H Street.
Photo provided by city
staff.

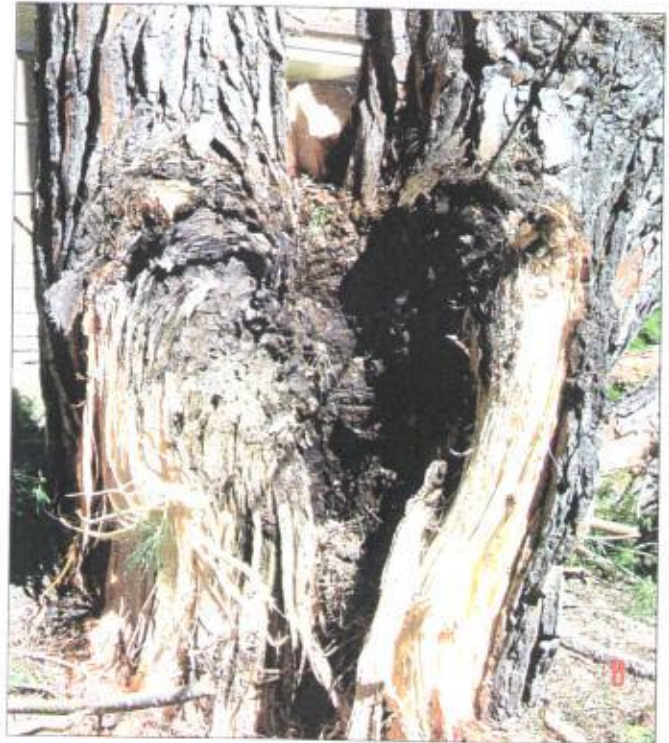
Below right: the tree
located at 228 H Street.
Additional photo provided
by city staff.

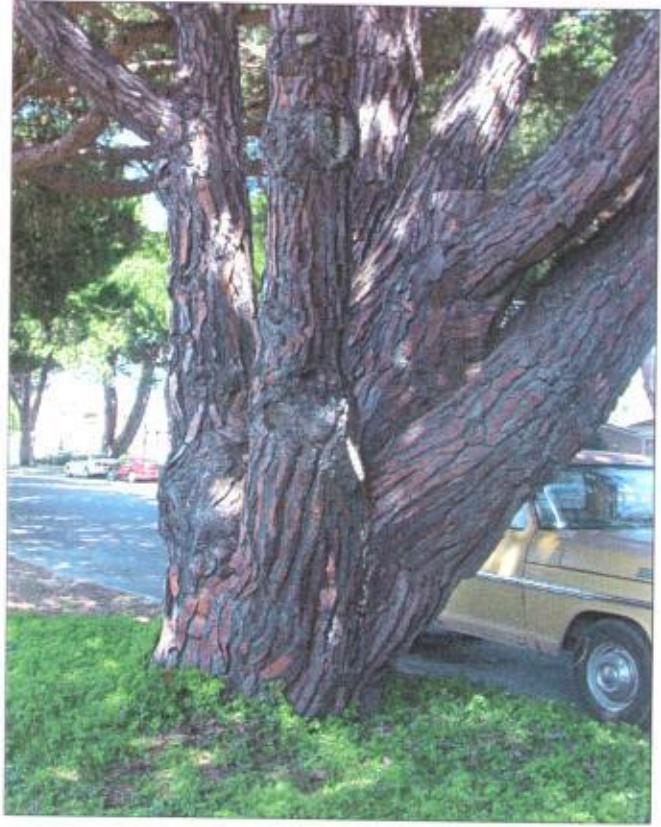
Above right: the tree located at 231 H Street (north tree). This tree has many of the challenging characteristics of the tree that failed at 228 H Street.

* Three of the trees (located at 231 H Street- north tree, 236, and 326- north tree) have been found to exhibit external and internal conditions that are very similar to those of the tree at 228 H Street prior to its failure. I believe that no reasonable treatments can be performed to adequately diminish the potential risk and preserve the health, stability, and the aesthetic appeal of the tree, and that these trees should be removed to preserve public safety. 2013 FAILURE

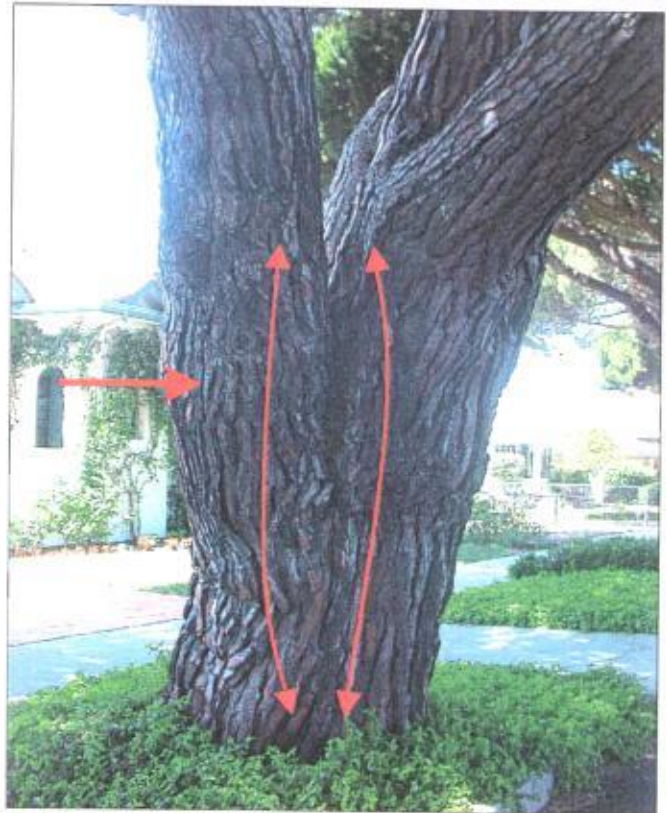
Below right: the tree located at 231 H Street (south tree). The long vertical seam (long vertical arrows) is associated with a pocket of decay. One Resistograph measurement was taken

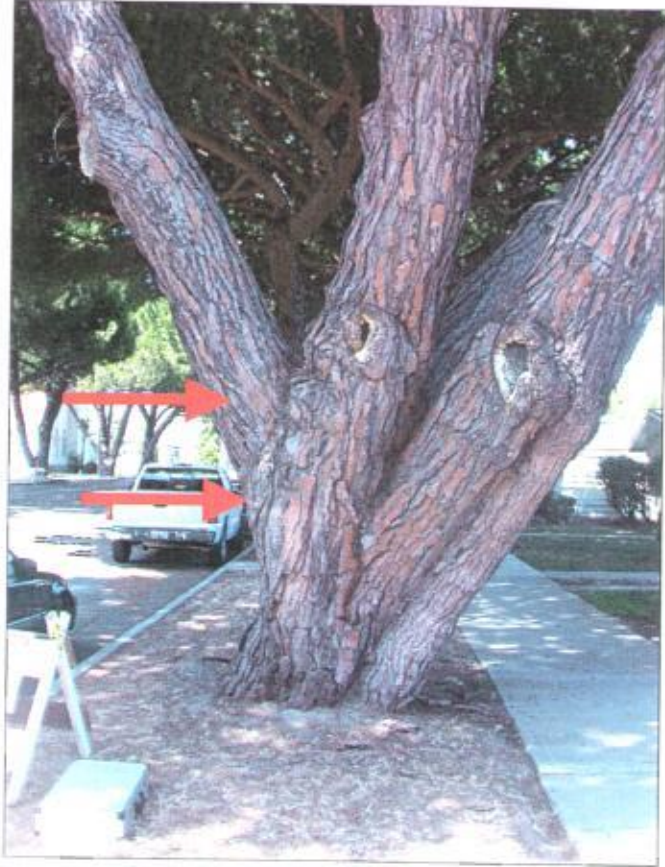
Above right: the tree located at 236 H Street (south tree). Two Resistograph measurements were taken, as indicated.

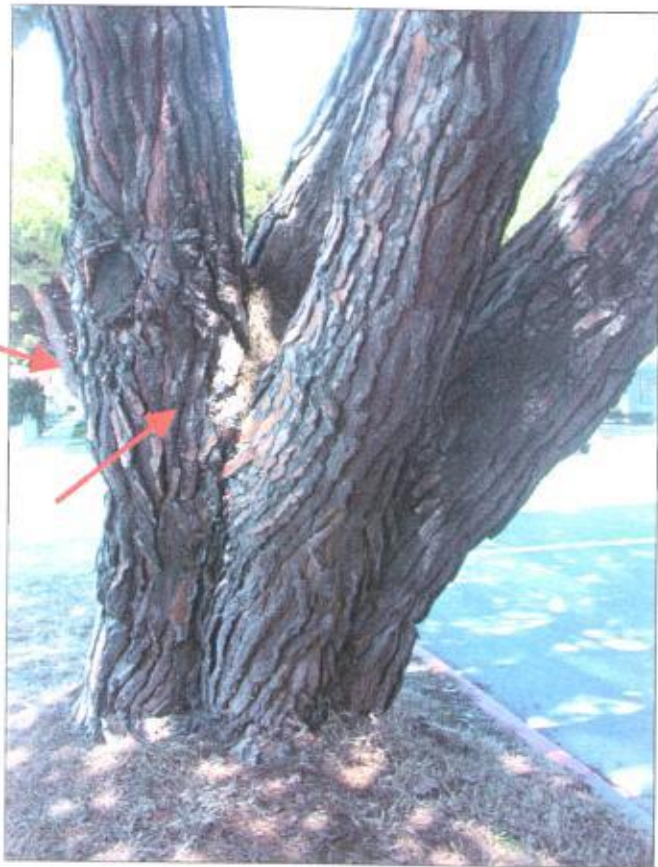
Below right: the tree located at 303 H Street. Two Resistograph measurements were taken, as indicated.

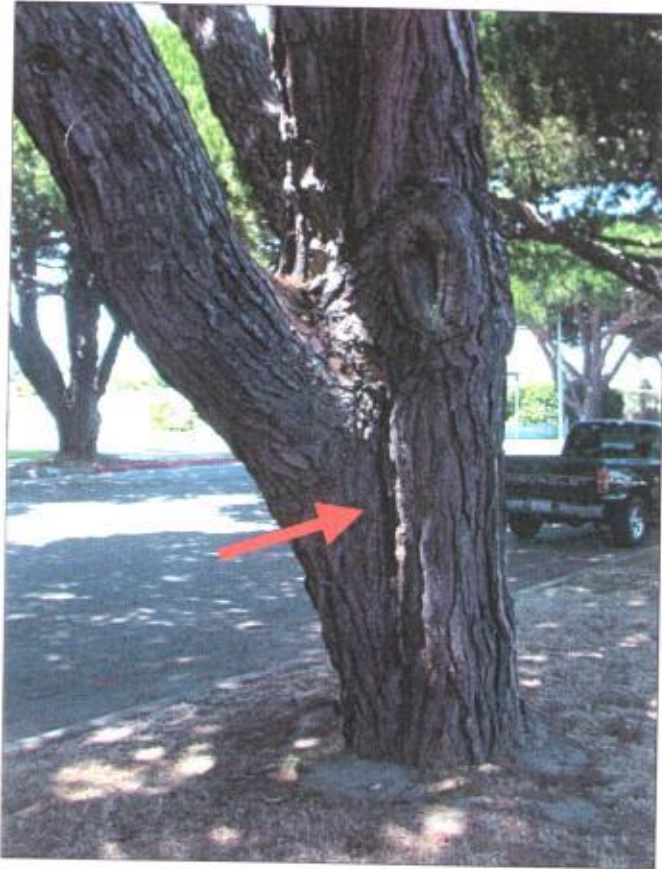
Above right: the tree located at 306 H Street. Note the large vertical seam (red arrow). A measurement was taken to determine if an internal crack has formed. None was found.

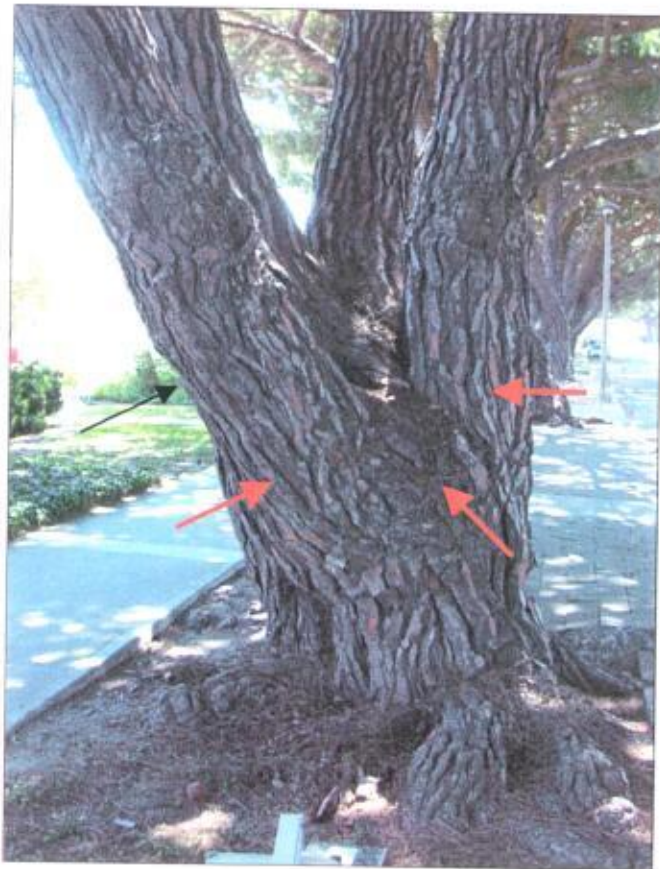
Below right: the tree located at 310 H Street (north tree). This tree has a significant pocket of decay and 3 Resistograph measurements (red arrows) indicate that conditions are developing that are similar to those at 228 H Street.

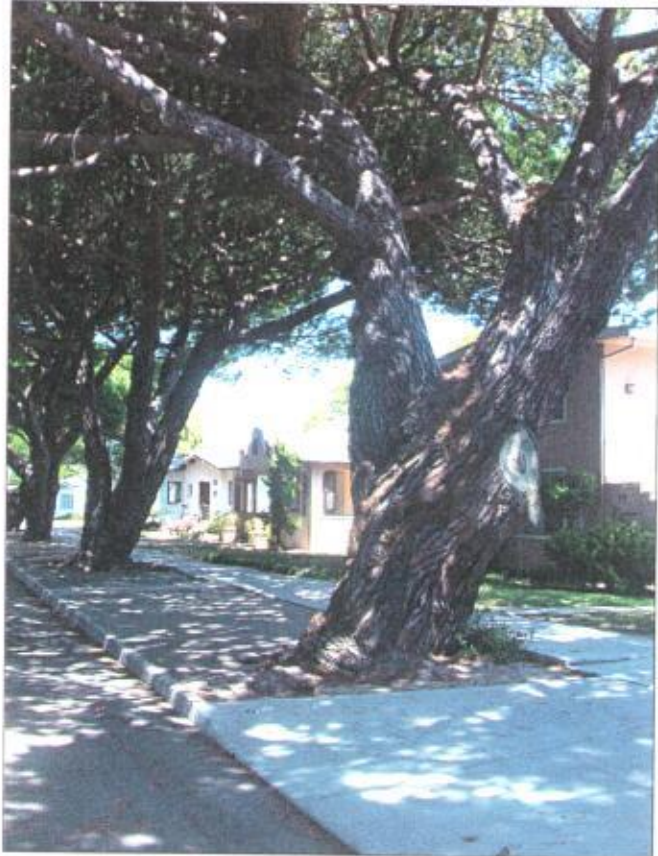
Above right: the tree located at 310 H Street (south tree). This tree leans precariously toward the driveway. While no pocket of decay was found, it should be monitored regularly for potential root failure and other physical attributes that appear challenging.

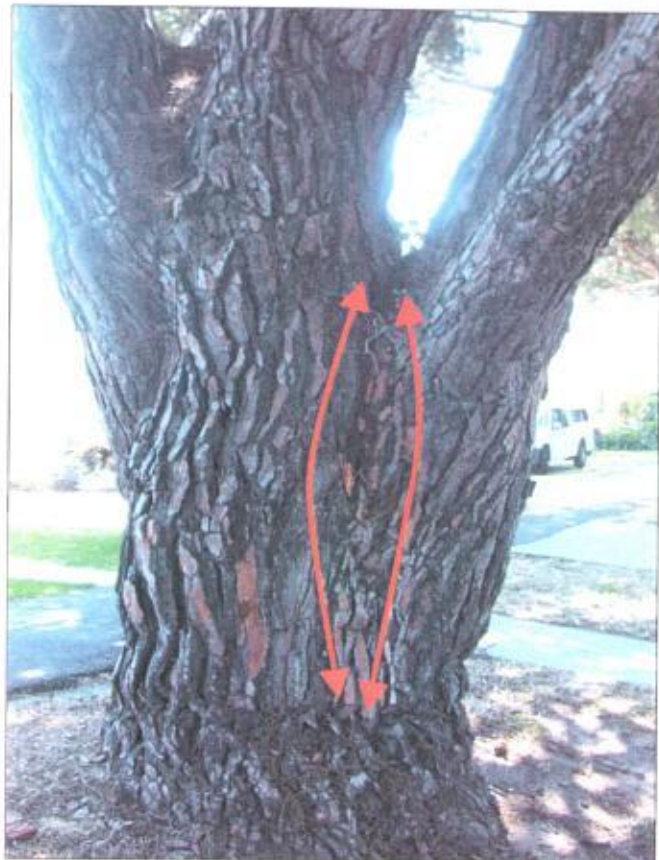
Below right: the tree located at 322 H Street. This tree is too large to take meaningful measurements with the Resistograph. Note the suspicious seam with a pocket at its upper junction - several Coast live oak seedlings are growing in the pocket.

One tree (322 H Street) has many of the suspect characteristics, but was too large for investigation using the Resistograph. Measures should be taken to significantly 'unload' this tree, and artificial support mechanisms might be considered to mitigate its apparent poor structure. Consideration may also be warranted for its removal even though visible proof that the destructive features have manifested has not been provided in this study.

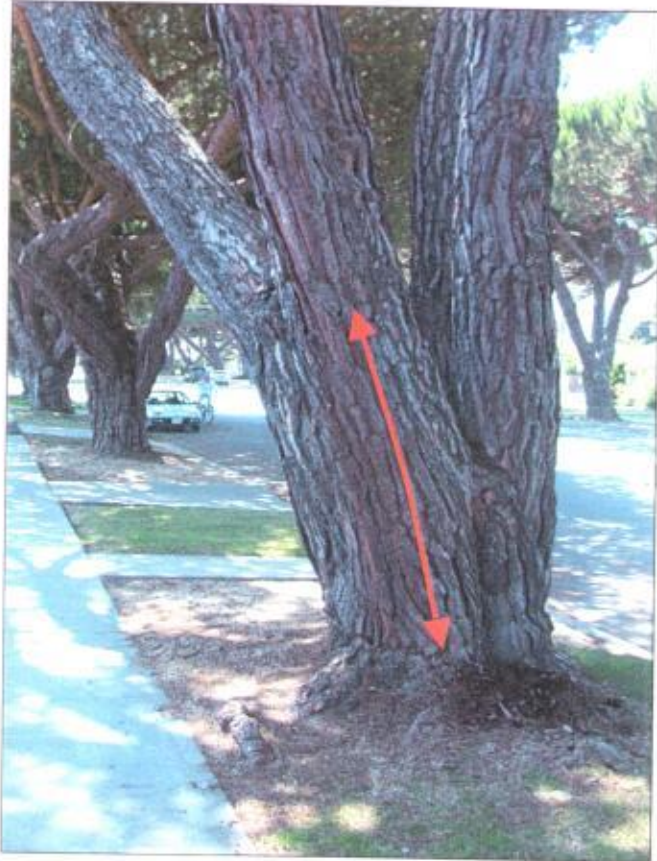
Above right: the tree located at 326 H Street (south tree). Several of these major limbs have narrow crotches that have apparently grafted together. The associated seams in the bark pattern suggest alignment of force flow through the tree and into the root crown.

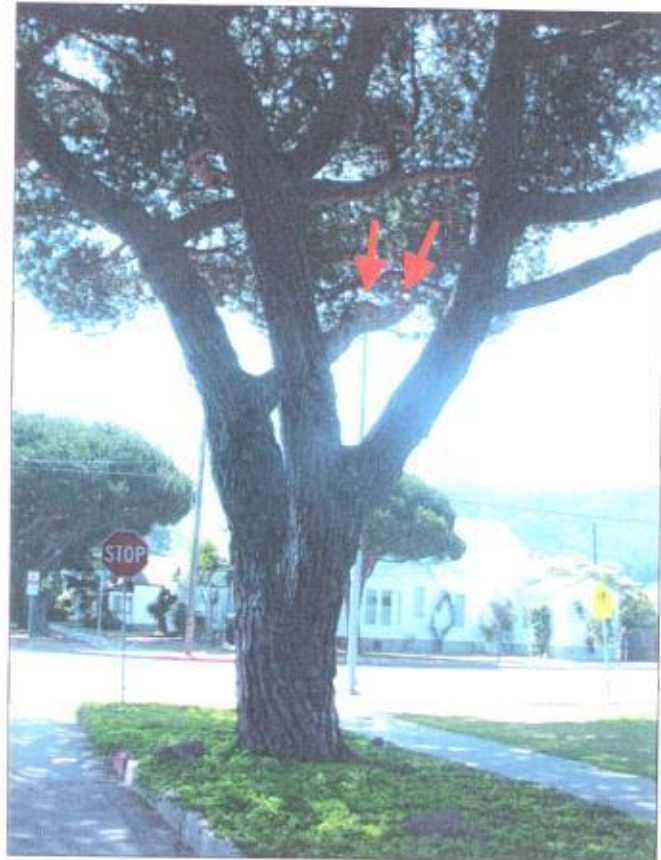
Below right: the tree located at 335 H Street. Several limbs recently broke away in the canopy of this tree. (red arrow)

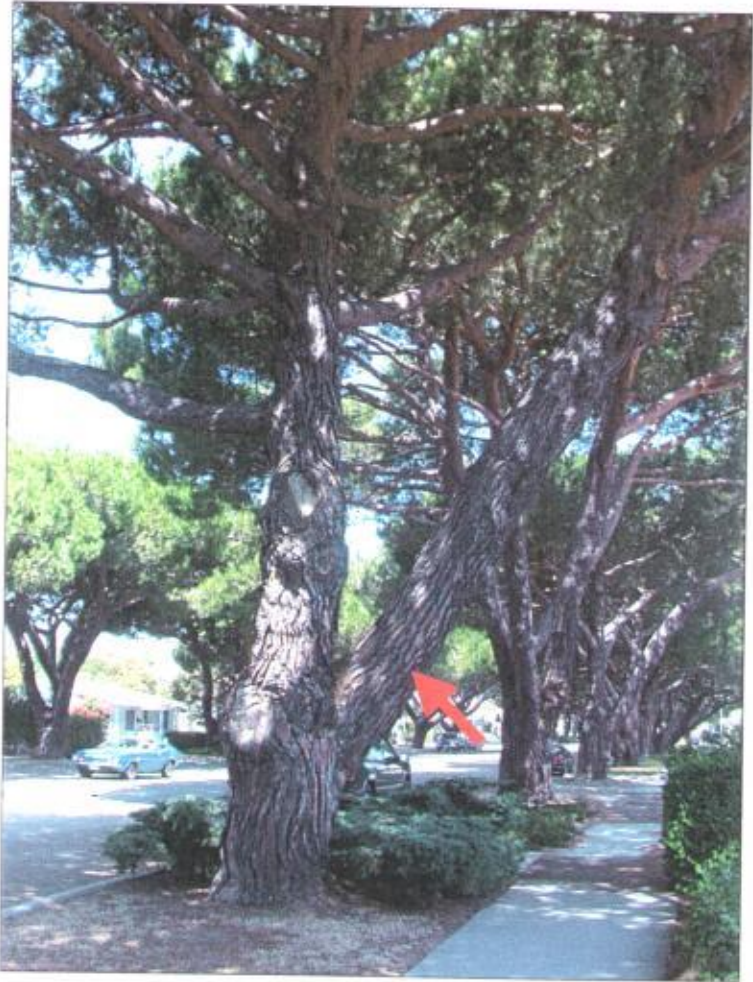
Above right: the tree located at 434 H Street and several in a row beyond, looking north. The long limb (red arrow) appears menacing as it rises toward the adjacent residence. Long limbs such as this can become destabilized when weight increases due to end weight and their cantilever away from the point of attachment.

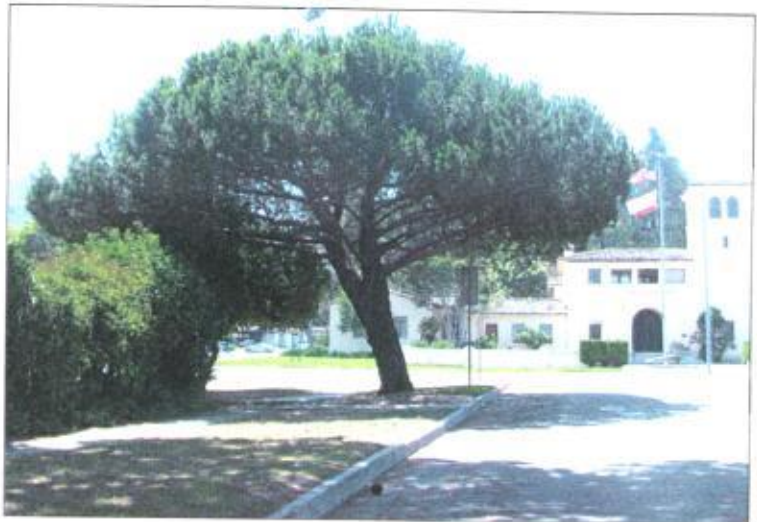
Below right: the tree located at 436 H Street (south tree). This younger tree is somewhat unstable - pruning treatments to mitigate potential wind-throw are warranted.
