INDEPENDENT CONSULTANT - SPECIALIST IN ARBORICULTURE AND URBAN FORESTRY

CITY OF LOMPOC - URBAN FORESTRY

September 2, 2013

This report summarizes my study and re-evaluation of 9 trees selected from the collection of 56 Italian stone pines currently remaining in the city-owned easement along South H Street in the City of Lompoc.

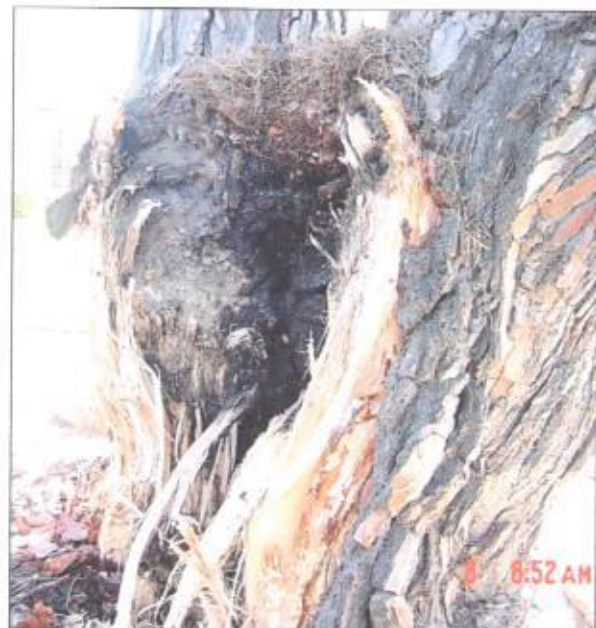
A protocol was developed following the August 2003 failure of pine located adjacent to 228 South H Street. A fundamental structure of the tree was its multiple large scaffolds originating from a low bifurcation point with a hidden pocket of decay in the center of the scaffold junction. The tree's four tall scaffold limbs supported heavy end weight from lateral branches and the canopy. Load (weight of wind and water? weight from normal canopy growth?) was applied at the end of these the scaffold limbs, which acted as long lever-arms to overburden a weakened point of attachment.

The image, right, is the first tree failure in this 10 year study. It shows the base of a tree at 228 South H Street shortly after it failed in 2003.

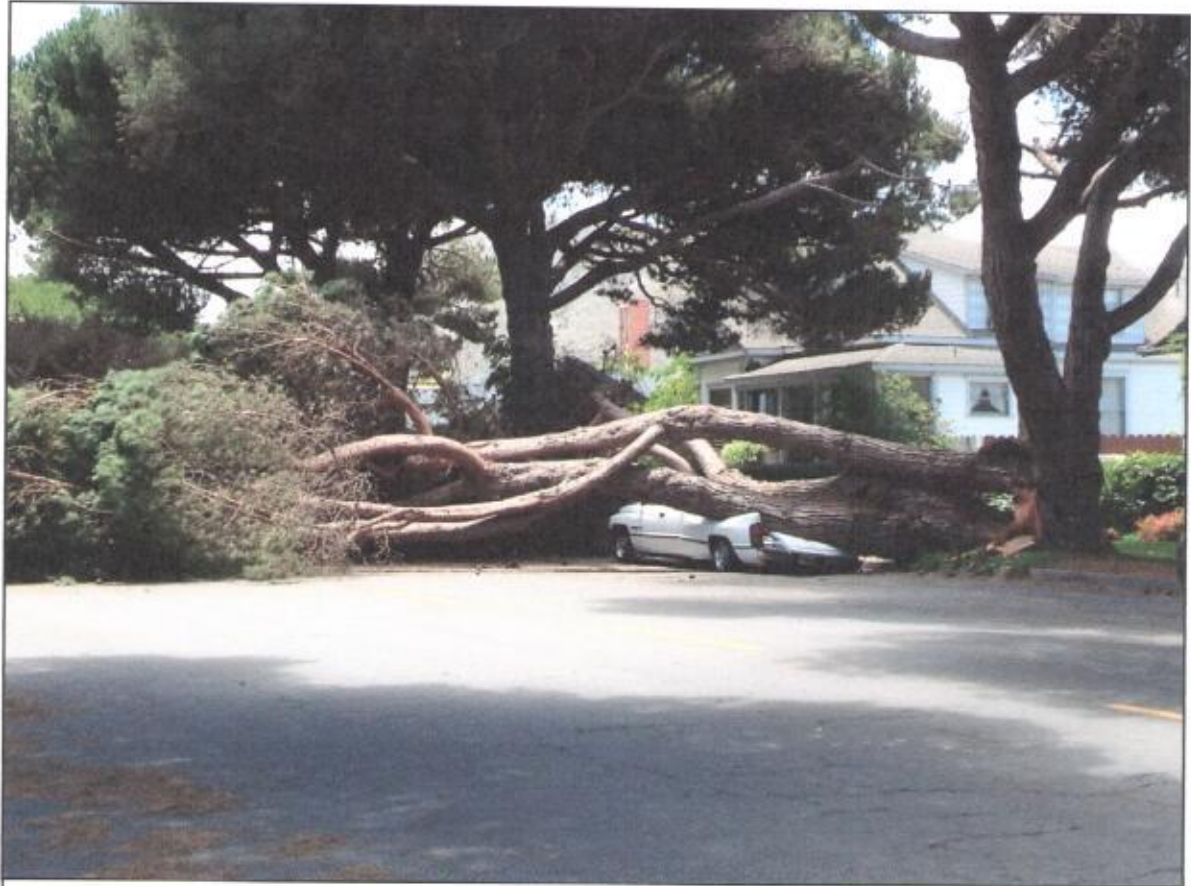
231n South H Street June 18, 2013
Photo by Cinda Price via Lompoc Record

The image, below, is the most recent tree failure in this 10 year study.
