Kenneth A. Knight Consulting LLC

December 1, 2015

City of Lompoc H Street Italian Stone Pines Level Two Tree Risk Assessment

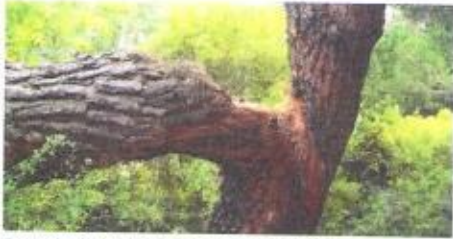
Figure 2. Many Italian stone pine branch failures occur at the attachment, rather than along the branch. Heavy lateral limbs (end weights), dense crown, and multi-stem structure were reported to be associated with branch failures. Photo: C. Rippey

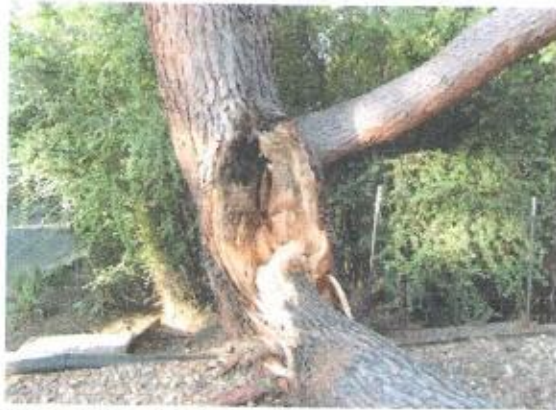
Figure 3. (Above) Codominant stems and multiple trunks were the most commonly reported defect causing trunk failure in Italian stone pine. Here, a large codominant stem failed at the point of attachment. Embedded bark is not commonly found in such failures in *P. pinea*.

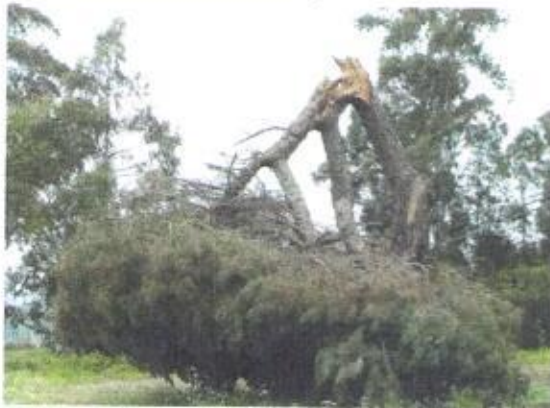
Figure 4. (Below) Decay was not present in 78% of trunk failures, but dense crown was reported to be a key factor. Here, an Italian stone pine with a dense crown failed at a point high on the trunk. No decay was evident.

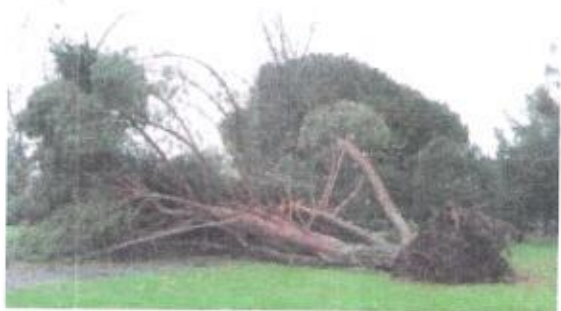
Figure 5. (Above) The most common type of failure in Italian stone pine is uprooting. Although dense crown is frequently associated with root failures, decay is not. Photo: C. Liata.

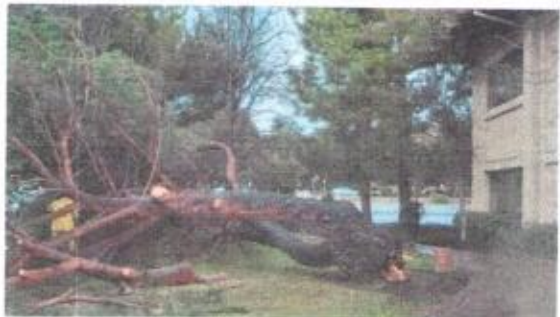
Figure 6. (Below) Girdling roots are reported to contribute to a number of failures in Italian stone pine. Here, a girdling root occurring at ground line was linked to the failure of this Italian stone pine. Photo: C. Rippey.

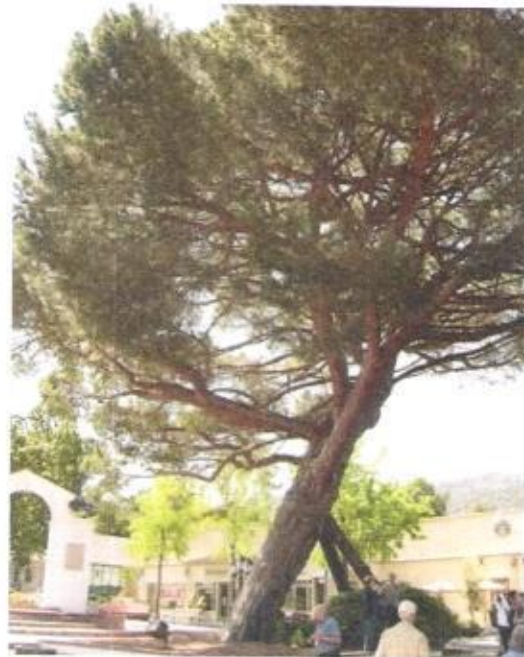
Fig. 7. Lean has been reported as a key factor contributing to root failure of Italian stone pine. Here, large props have been installed to reduce the failure potential of this leaning specimen. Photo: T. Kipping.

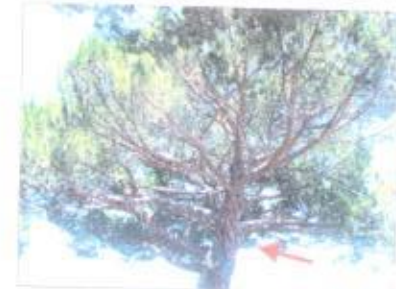
Above right: the tree located at 200 H Street (north tree). The upper canopy of this tree is somewhat atypical - shorter and stubbier than others. Note the twisted growth of the trunk (red arrow)

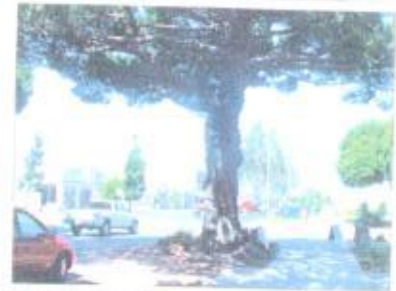
Middle right: the tree located at 200 H Street (north tree). The twisting pattern extends for the entire length of the trunk.

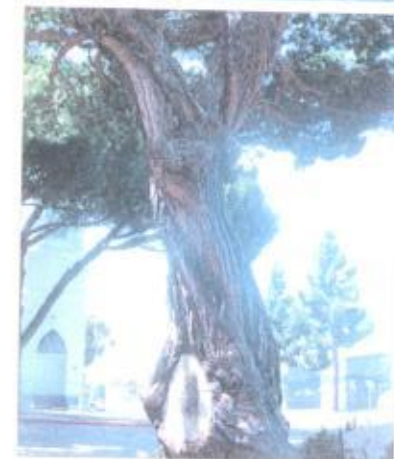
Below right: the tree located at 200 H Street (north tree). In addition to the twisting pattern, the trunk has significant kinks, and a large wound low in the bole. These and some of the other characteristics found in other trees along H Street are not equivalent to the conditions that led to tree failure at 228 H Street, but they merit monitoring.

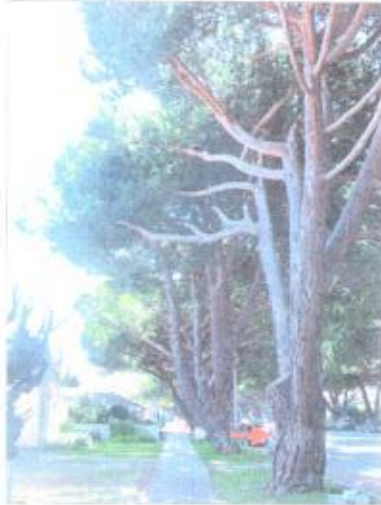
Above right: the tree located at 210 H Street. Resistograph measurements were taken of this tree at the location indicated (red arrow). Note the lopsided canopy occurring as a result of removal of one of the major scaffold limbs. That treatment has to some extent mitigated potential limb failure in the manner of 228 H Street.

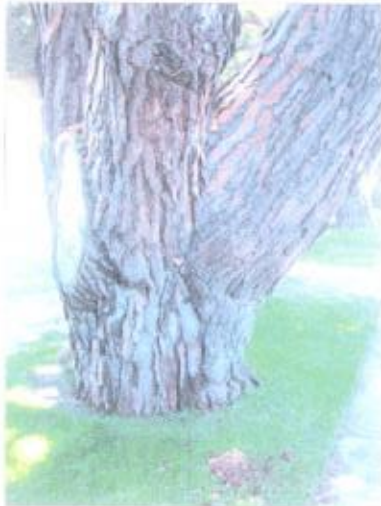
Below right: the tree located at 214 H Street. The soil is excessively moist here and other challenging factors exist in addition to the presence of those conditions similar to 228 H Street.

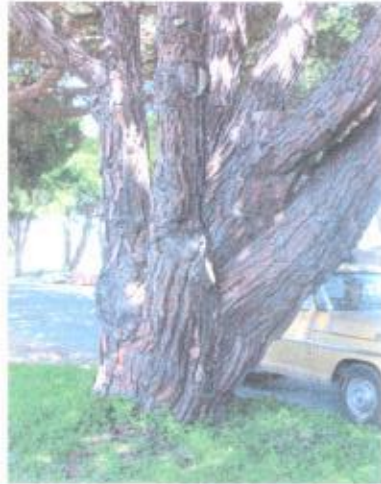
Above right: the tree located at 231 H Street (north tree). This tree has many of the challenging characteristics of the tree that failed at 228 H Street.

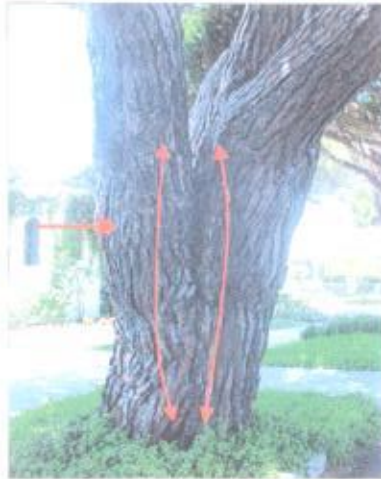
Below right: the tree located at 231 H Street (south tree). The long vertical seam (long vertical arrows) is associated with a pocket of decay. One Resistograph measurement was taken.

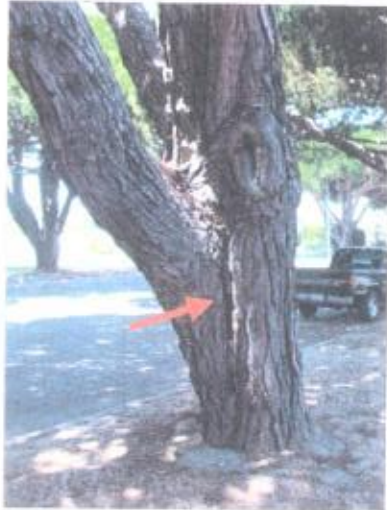
Above right: the tree located at 306 H Street. Note the large vertical seam (red arrow). A measurement was taken to determine if an internal crack has formed. None was found.

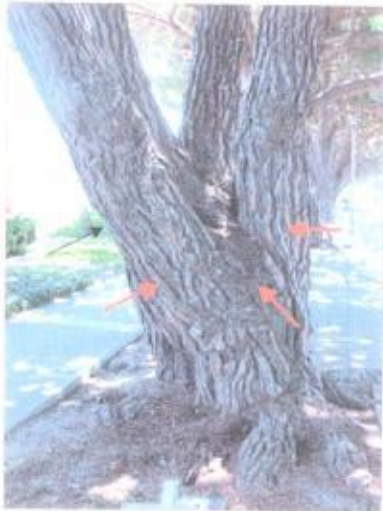
Below right: the tree located at 310 H Street (north tree). This tree has a significant pocket of decay and 3 Resistograph measurements (red arrows) indicate that conditions are developing that are similar to those at 228 H Street.

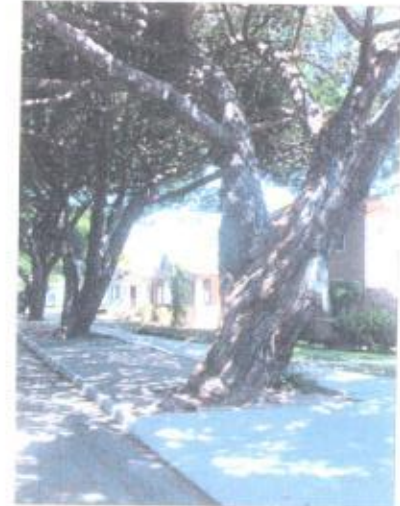
Above right: the tree located at 310 H Street (south tree). This tree leans precariously toward the driveway. While no pocket of decay was found, it should be monitored regularly for potential root failure and other physical attributes that appear challenging.

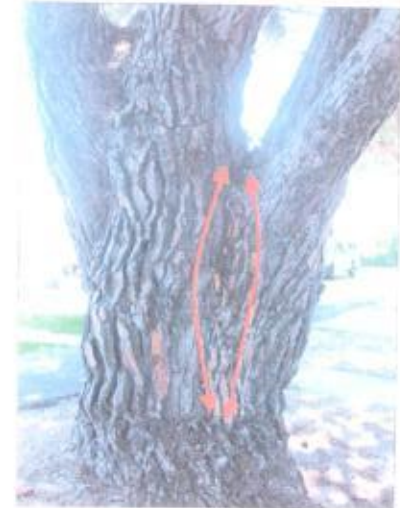
Below right: the tree located at 322 H Street. This tree is too large to take meaningful measurements with the Resistograph. Note the suspicious seam with a pocket at its upper junction - several Coast live oak seedlings are growing in the pocket.

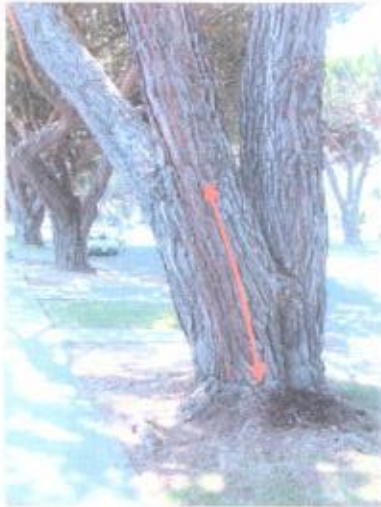
Above right: the tree located at 326 H Street (south tree). Several of these major limbs have narrow crotches that have apparently grafted together. The associated seams in the bark pattern suggest alignment of force flow through the tree and into the root crown.

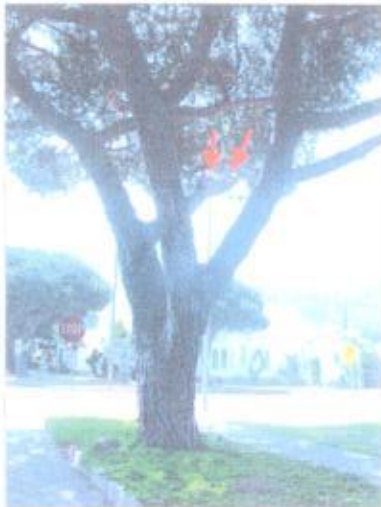
Below right: the tree located at 335 H Street. Several limbs recently broke away in the canopy of this tree. (red arrow)

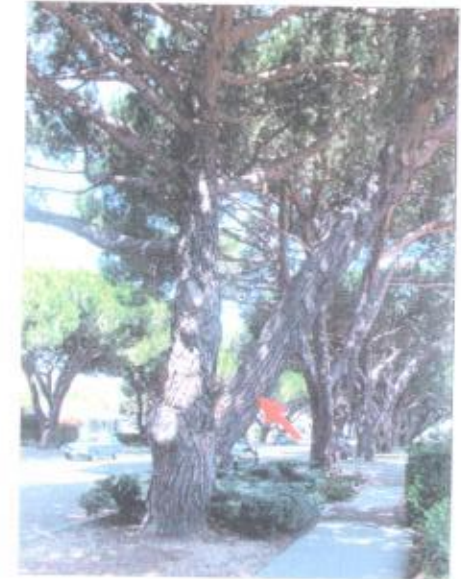
Above right: the tree located at 434 H Street and several in a row beyond, looking north. The long limb (red arrow) appears menacing as it rises toward the adjacent residence. Long limbs such as this can become destabilized when weight increases due to end weight and their cantilever away from the point of attachment.

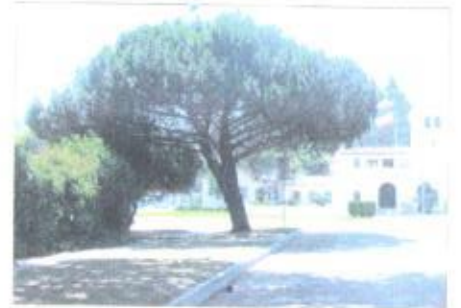
Below right: the tree located at 436 H Street (south tree). This younger tree is somewhat unstable - pruning treatments to mitigate potential wind-throw are warranted.
