Reducing Risk of H Street Italian Stone Pines

Ken Knight

October 26, 2017

H St Italian Stone Pine Study Objectives

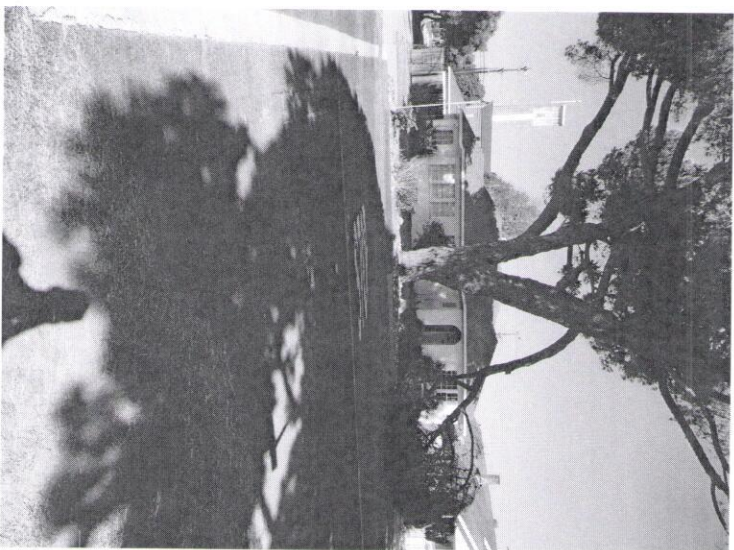
9-15-17 Branch failure Tree 11 339 S H & Olive

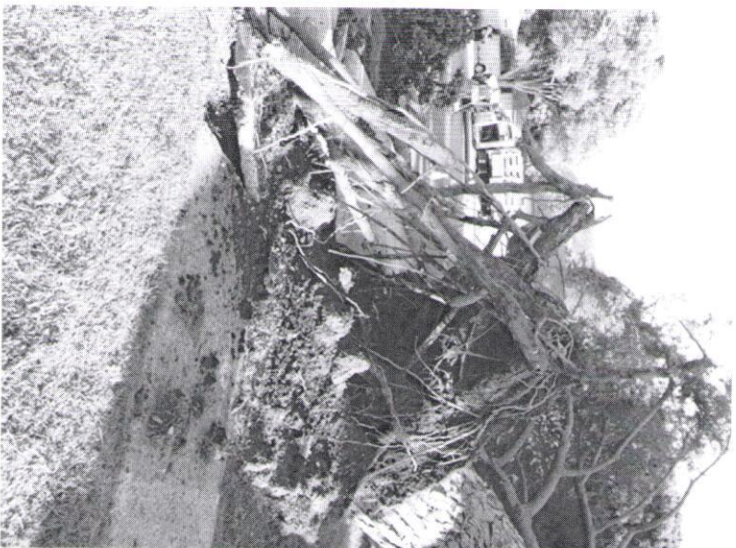
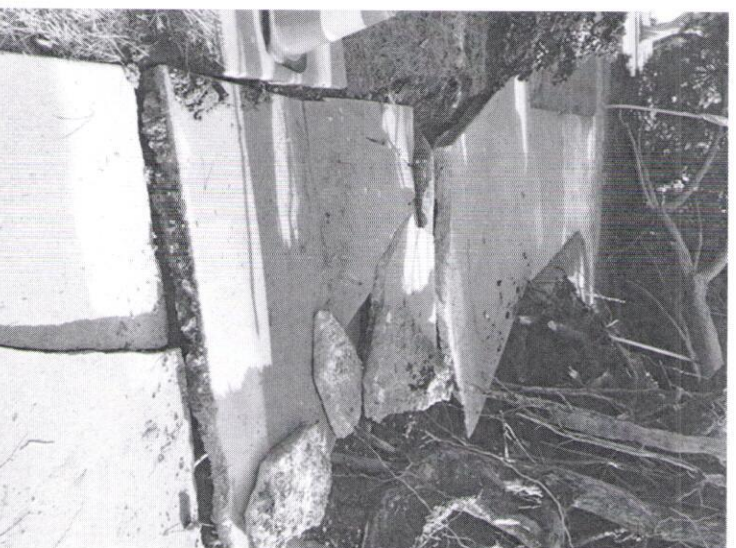
- 8-31-17 Tree 40 238 S. H St Whole tree failure- root failure –Not replaced
- 2-22-17 Tree 43 306 S. H St -Whole tree root failure-soil saturation/wind - Not replaced

8-31-17 Tree 40 failure 238 S. H St

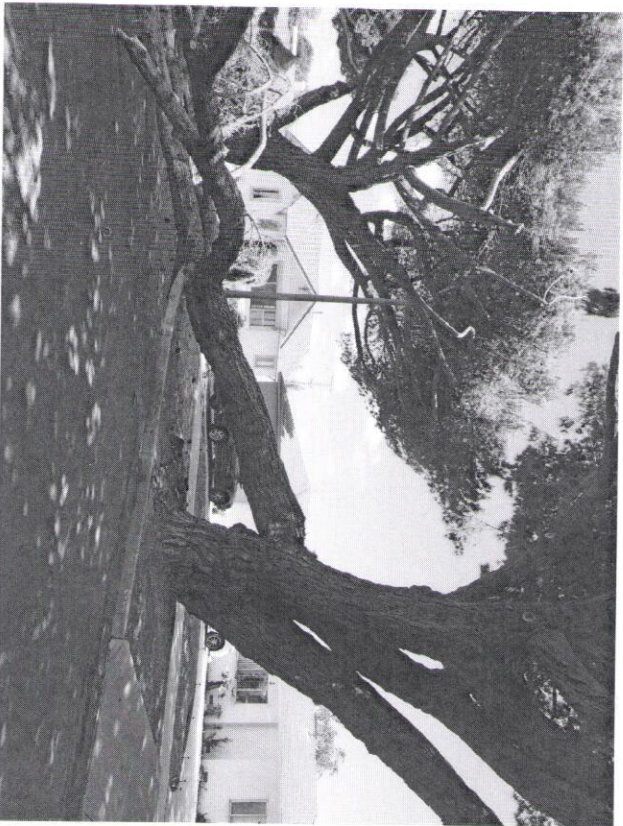
5-23-16 limb failure - address?

Overextended limb failure

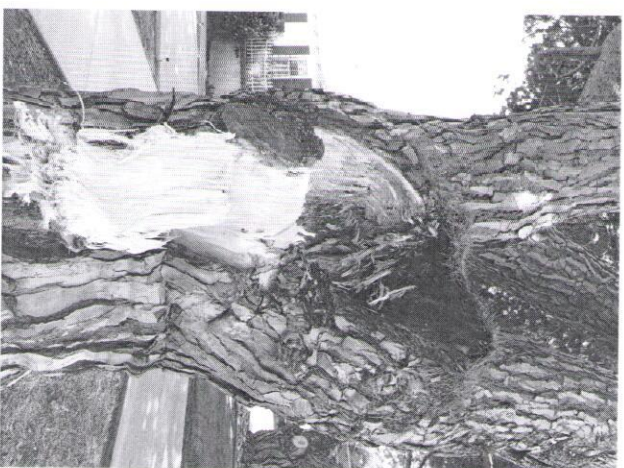
Note pocket of decay on the NE quadrant
