SUBJECT: Restoration of Site Conditions at the Former Army Landfill, Former U.S. Disciplinary Barracks, Lompoc California

The Army has prepared this Technical Memorandum to describe restoration activities performed at the Former Army Landfill (FAL) site, former United States Disciplinary Barracks (USDB) in Lompoc, California (Enclosure 1) in July 2005. This work was performed in response to BRAC Cleanup Team (BCT) agreements that conditions leading up to the issuance of a No-Further-Action (NFA) letter for the site should be restored and maintained.

PHOTO INDEX  
FAL Restoration Activity  
Former U.S. Disciplinary Barracks, Lompoc California

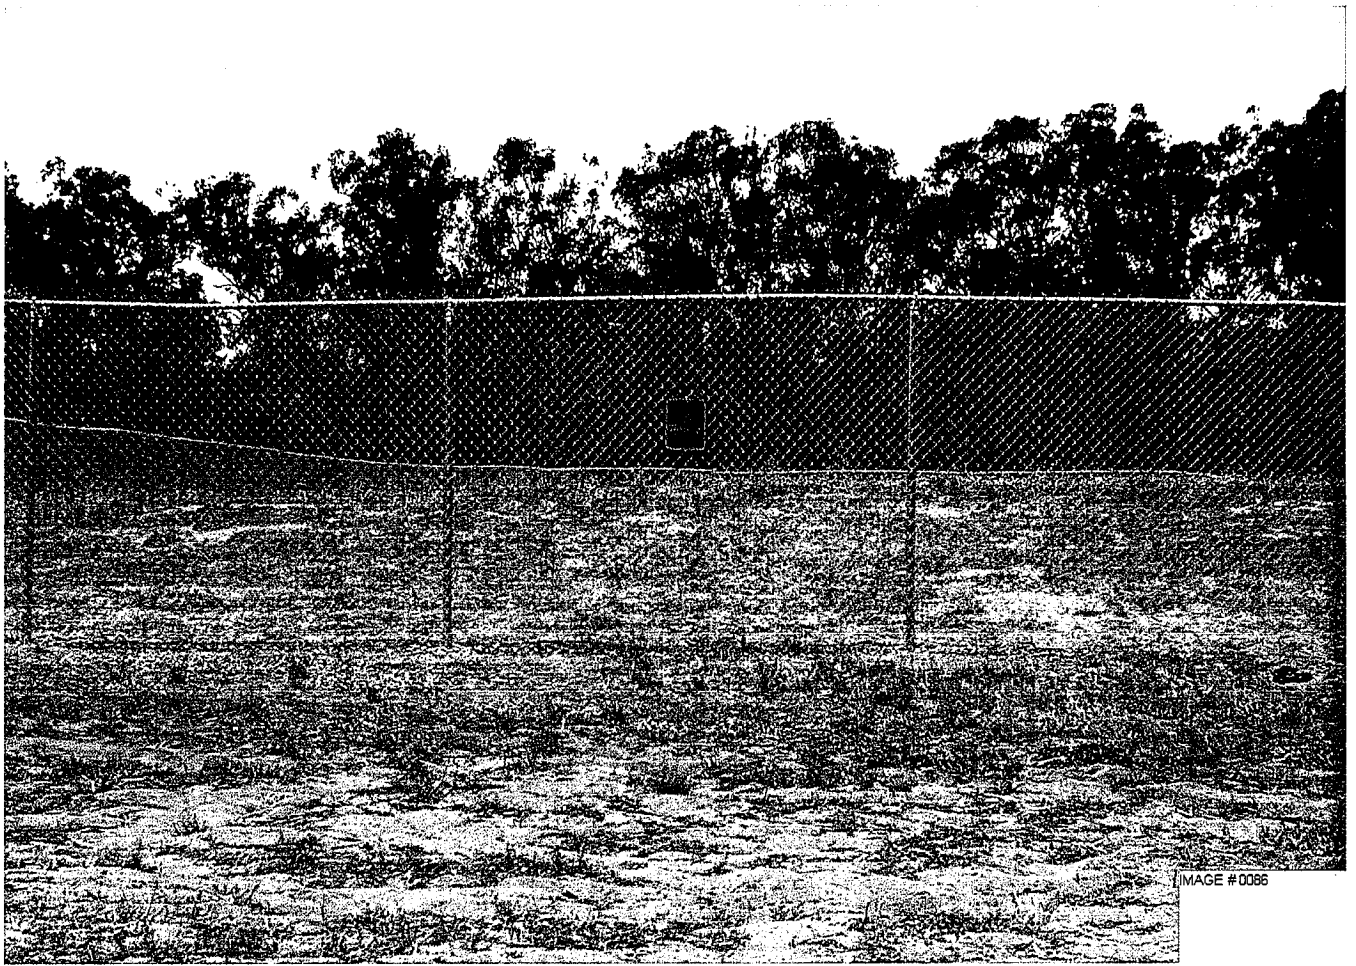
IMAGE #0086

1. Photo #0078: Erect fence, showing gate
2. Photo #0086: No Trespassing sign posted on fencing
3. Photo #0863: Miscellaneous waste debris at borrow opening
4. Photo #0864: Debris raked into pile
5. Photo #0866: Debris placed back into borrow
6. Photo #0868: Borrow backfilled with surrounding soil and raked smooth

b. The restoration activities began in early 2005 with the process of backfilling squirrel burrows and procuring fencing material. Restoration work picked up in the last week of June with the delivery of 1200 feet of chain link fence. The fence was installed over the next four weeks. Once completed, "no trespassing" notices were placed on the fence. The fence's gate was equipped with a lock and keys were placed with the security office for checkout by Prison staff needing access to the FAL site. Prison staff, with security clearance, initiated the rodent control measure over the period of 3 to 11 August 2005. Subsequent visits to the site by Anthony Nelson, Jim Hamlin of Santa Barbara County and on-site Prison staff verified that the squirrel population had indeed been removed. However, since the site is situated in a large open field many ground squirrels inhabit the surrounding area. Subsequent site visits by Anthony S. Nelson and James Hamlin observed an increase in squirrel activity between December 2005 to March 2006. Consequently, the rodent control program at the FAL will have to be conducted at least annually, if not more frequently.
