**SANTA YNEZ RIVER
BANK PROTECTION EVALUATION**

City of Lompoc, CA

January 20, 2011

PREPARED BY: Penfield & Smith
111 East Victoria Street
Santa Barbara, California 93101
(805) 963-9532

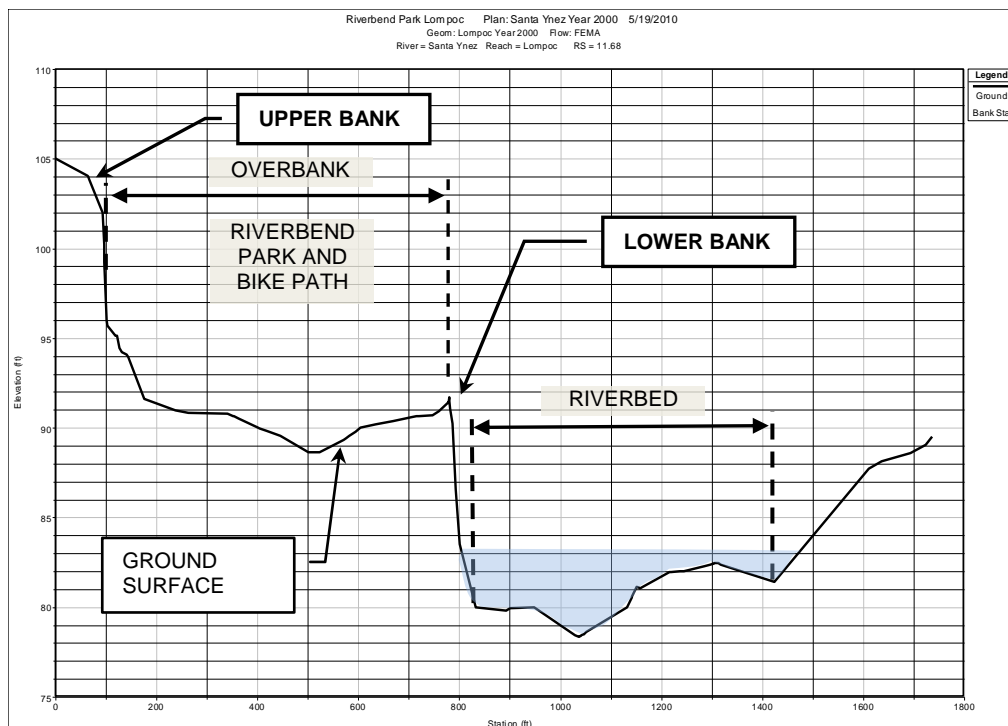
Figure C - Typical Channel Section (looking downstream)

The river channel at this location is composed of the river bed, which carries the storm flow from the smaller (10-year and smaller) events, and a wider overbank which carries any larger flows. The river bottom is composed of coarse sand and gravel while the overbanks are composed of sand and silty sand. Indeed, most of the Lompoc Valley is composed of alluvial sediments. See Figure C.

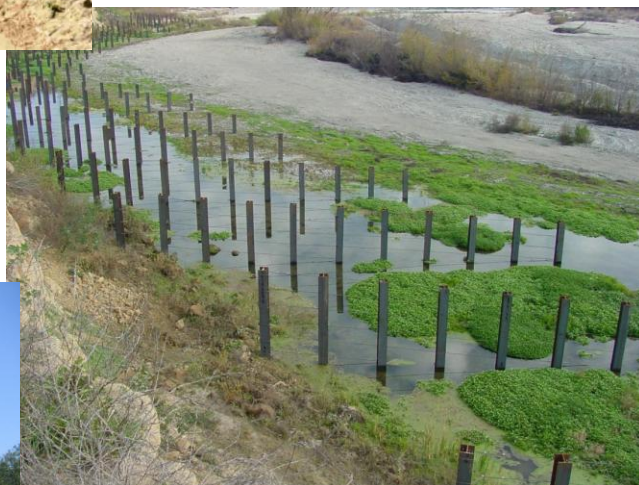
Photo 9 - Same location immediately after pile installation (2002)

function as described above. Another RVBP system was installed on the Santa Ynez River near Buellton in 2001/2002 to protect the Central Coast Water Authority pipeline which was threatened by bank erosion during the large storm of 2001. See Photos 7 – 9. This system has also performed as intended, not only surviving the large storm of 2005, but allowing the riverbank to begin to be rebuilt by the action of the storm flows depositing sediment in the area of the RVBP system.
