**RIVERSIDE DRIVE BANK
EROSION EVALUATION**

Lompoc, California

January 20, 2011

CLIENT: City of Lompoc

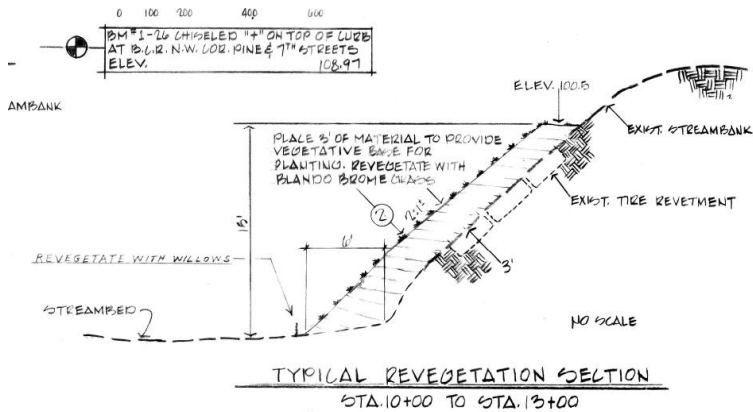
Figure C - 1979 Revegetation Detail

1. Placing about 3 feet of fill over an automobile tire bank revetment and planting that soil with grass. The toe of the slope was then planted with willows. See Figure C below.
