Technical Memorandum

Date: December 21, 2023
To: Project File (Project No. 21044.006.01.000)
From: Sommer Carter/Ahtna Program Manager
Subject: **Technical Memorandum – Site Maintenance Work Plan, Former USDB, Lompoc, California**

Site Maintenance Work Plan
 Environmental Long-Term Monitoring
 Former USDB
 Lompoc, California

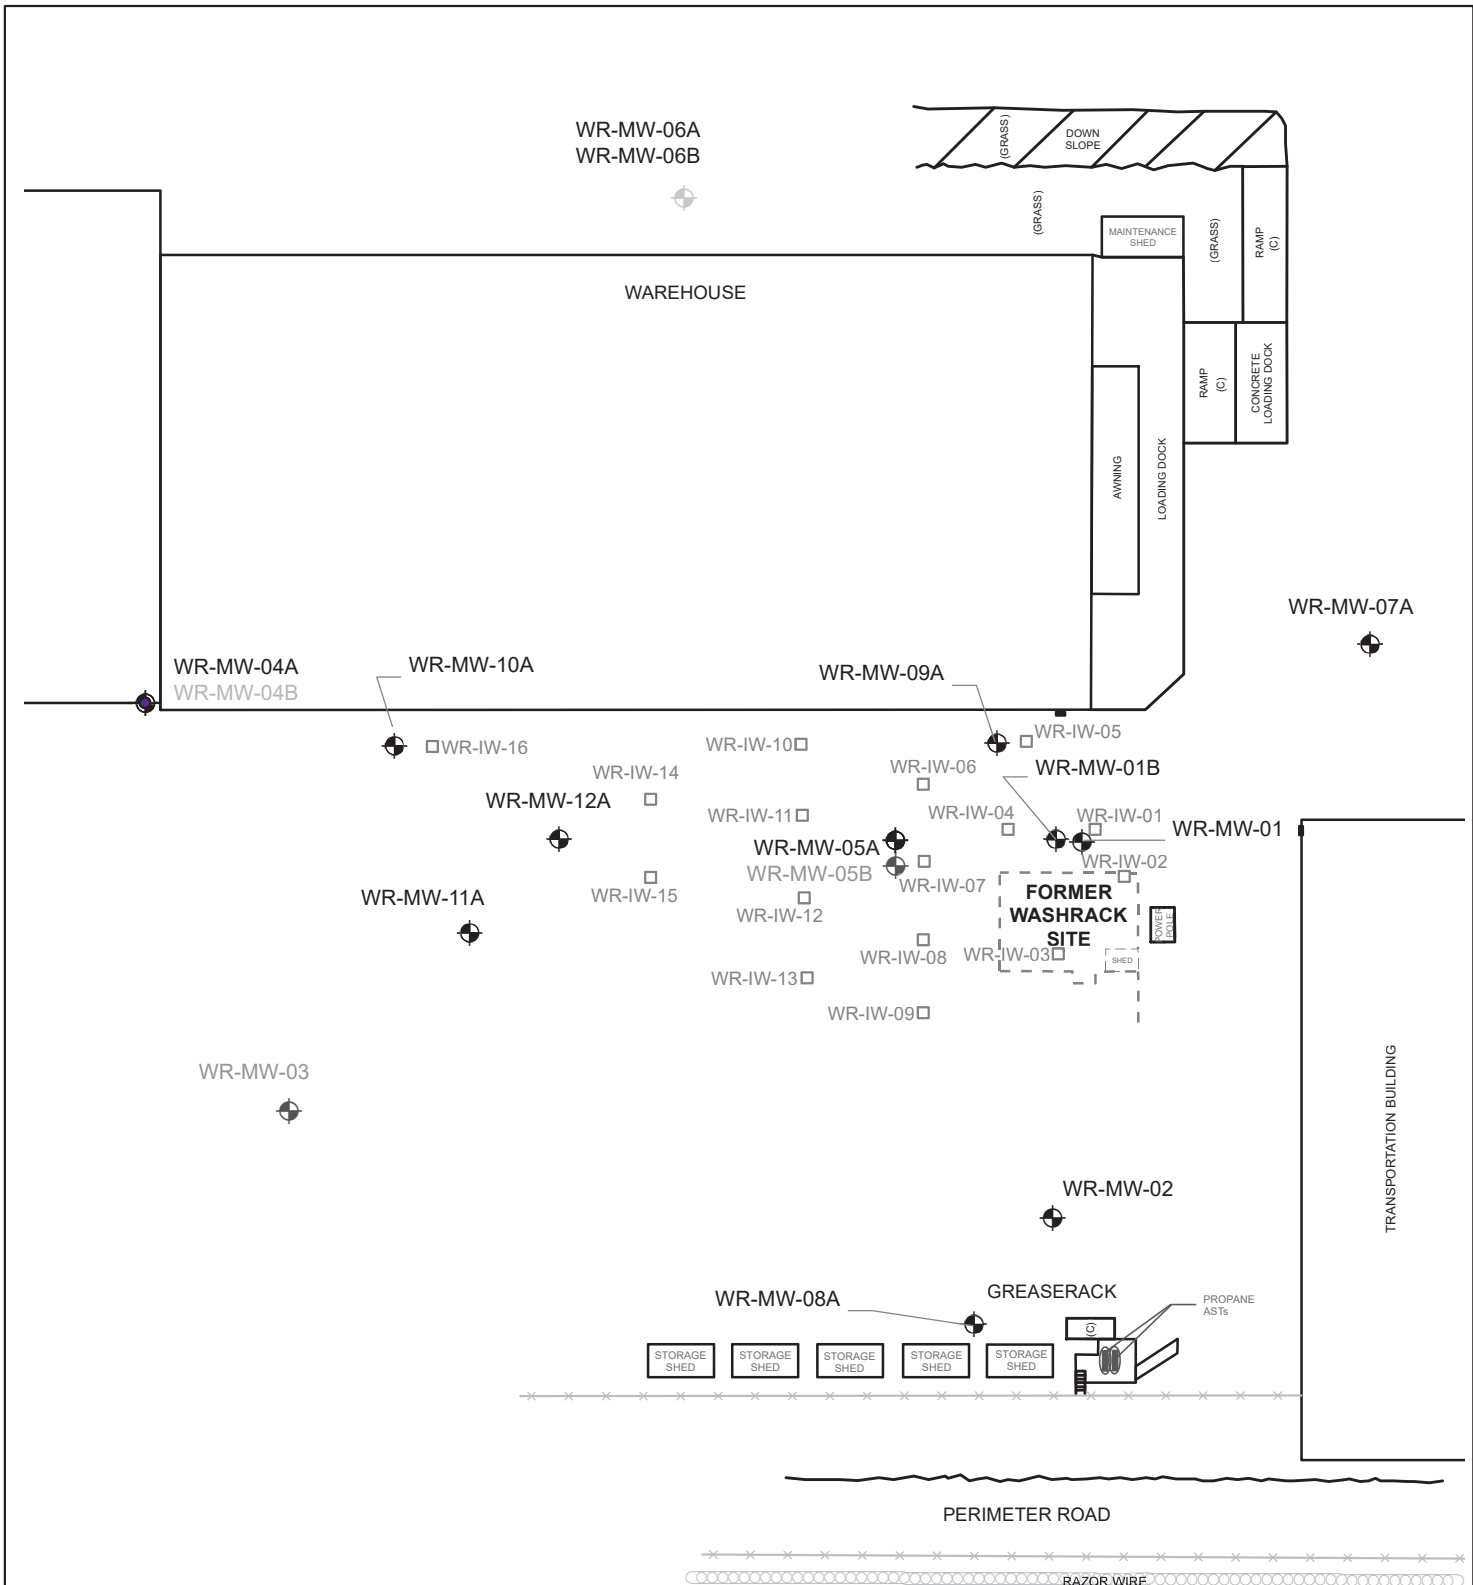
Based on the age of the existing groundwater monitoring well network, well maintenance will be performed at 11 locations (Figure 3). Before maintenance activities commence, a downhole camera will be placed in each well location, and video will be recorded to document the well condition and identify obstructions. The downhole condition of each well location will be documented in daily field reports for potential future rehabilitation efforts if deemed necessary.

Upon completion of video logging, 11 groundwater monitoring well locations will undergo surface completion rehabilitation, including complete new well box kit installation, which includes well boxes, lids, gaskets, and bolt replacement. Construction debris (e.g., well casings, concrete, bollards, etc.) and general trash will be disposed of offsite as non-hazardous solid waste.
