Kenneth A. Knight Consulting LLC

December 1, 2015

City of Lompoc H Street Italian Stone Pines Level Two Tree Risk Assessment

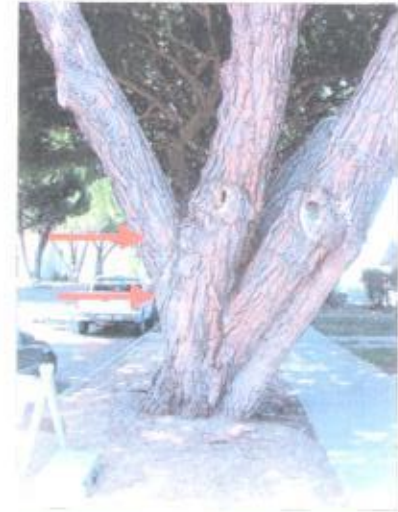
Above right: the tree located at 236 H Street (south tree). Two Resistograph measurements were taken, as indicated.

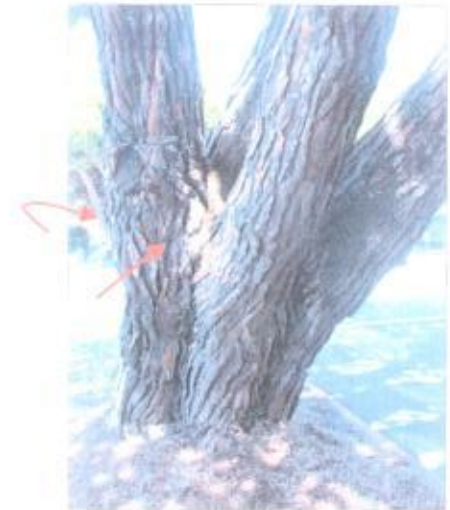
Below right: the tree located at 303 H Street. Two Resistograph measurements were taken, as indicated.

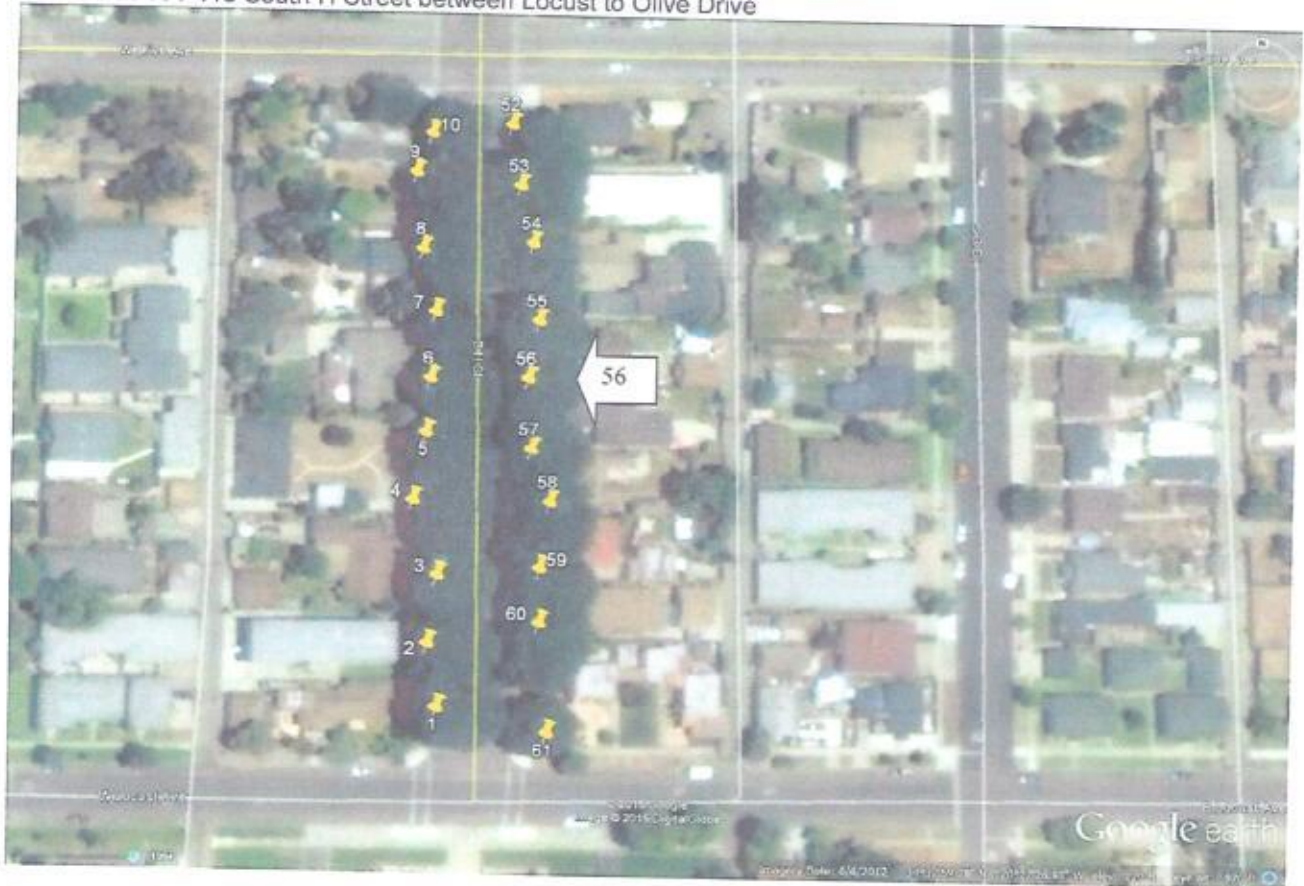
Tree 56 at 414-416 South H Street between Locust to Olive Drive

History: In my December 1, 2015 Level Two Assessment of the 50 Italian Stone Pines in the 200-400 blocks of South H Street, this tree was listed as tree 56, as shown on the aerial map below. Tree 56 has a 51" Diameter at Breast Height, a 68-foot crown and is 35 feet tall. The branches in the crown of tree 56 are integrated with tree 55 to the north and tree 57 to the south. The 28" branch leaning at a 45-degree angle over the H Street toward the west is touching the canopy of the tree across the street in front of 415 H Street. I assessed the risk of this tree as moderate due to the heartwood decay, unbalanced crown, overextended branches and weak attachments. Please see my December 1, 2015 report for a discussion of the risk ratings and their limitations.

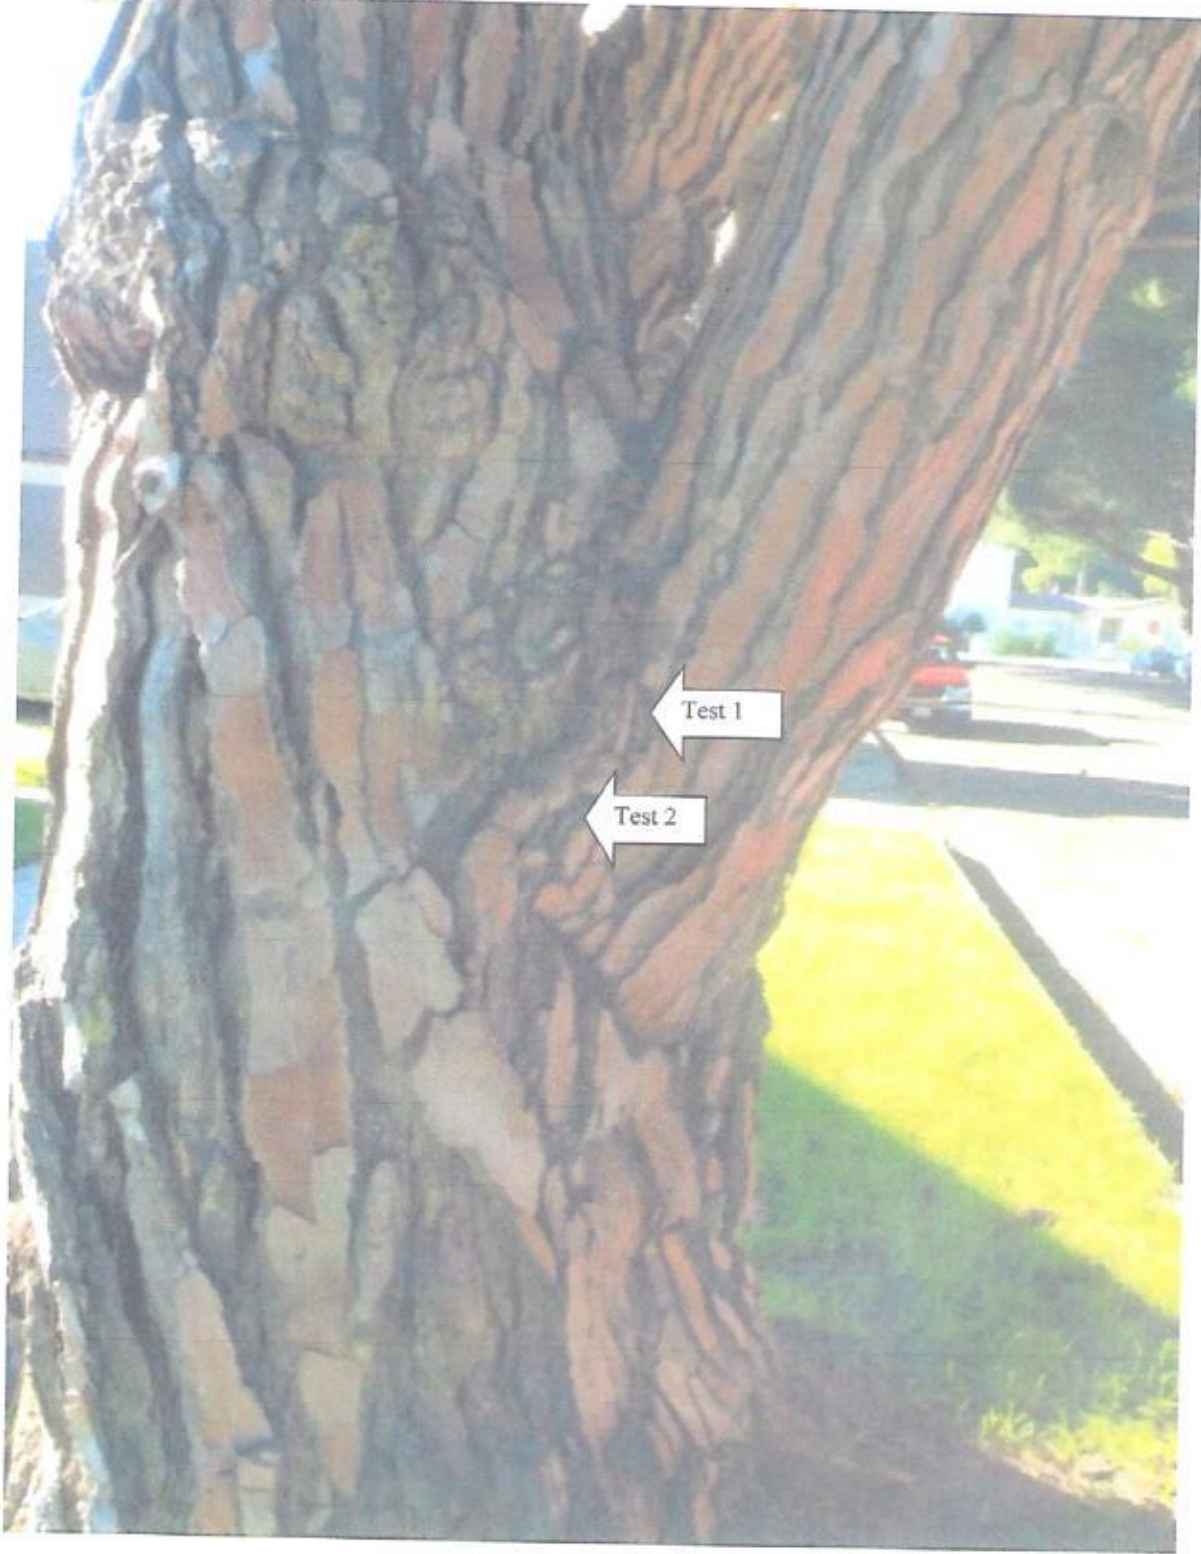
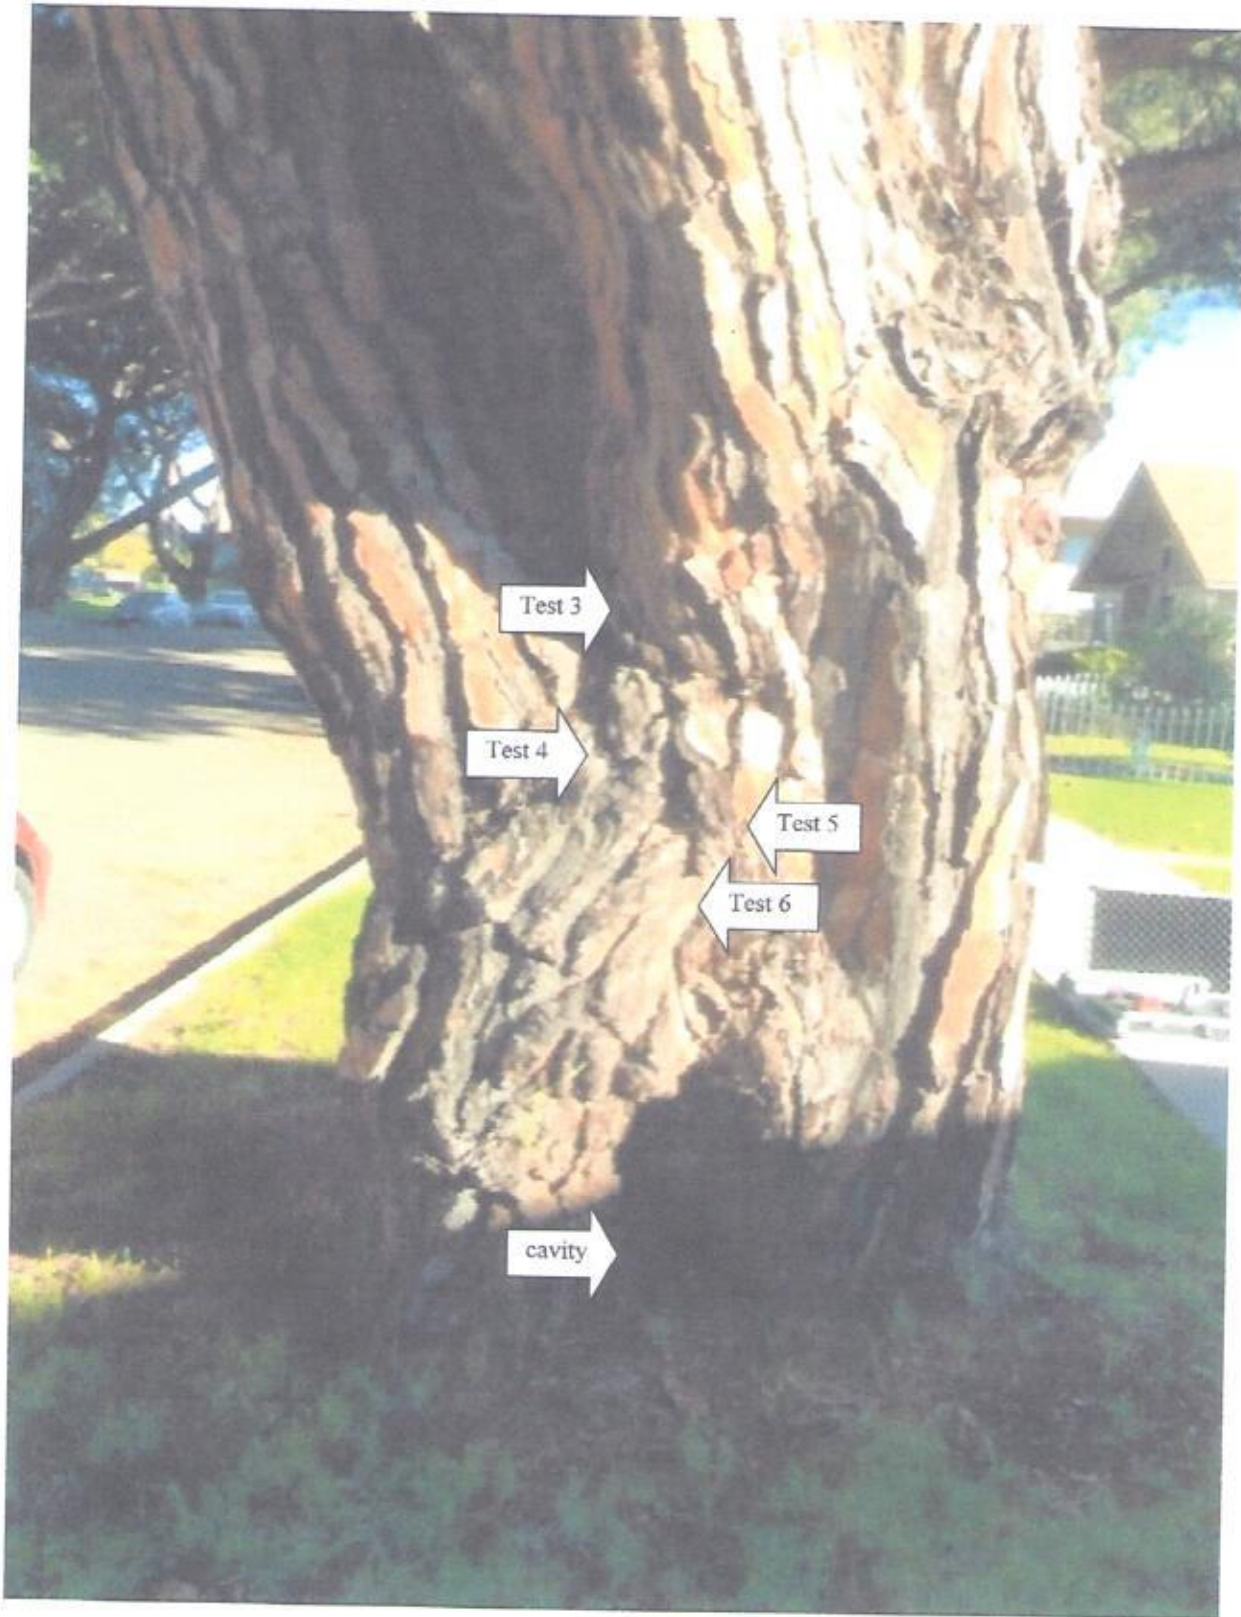
Test sites 1 and 2 on north side of tree

I used a resistance drill to drill 19" into the trunk to detect decay, cracks and/or cavities at the crotch between the 28" branch and the main trunk. The readouts are included as an attachment to this report.

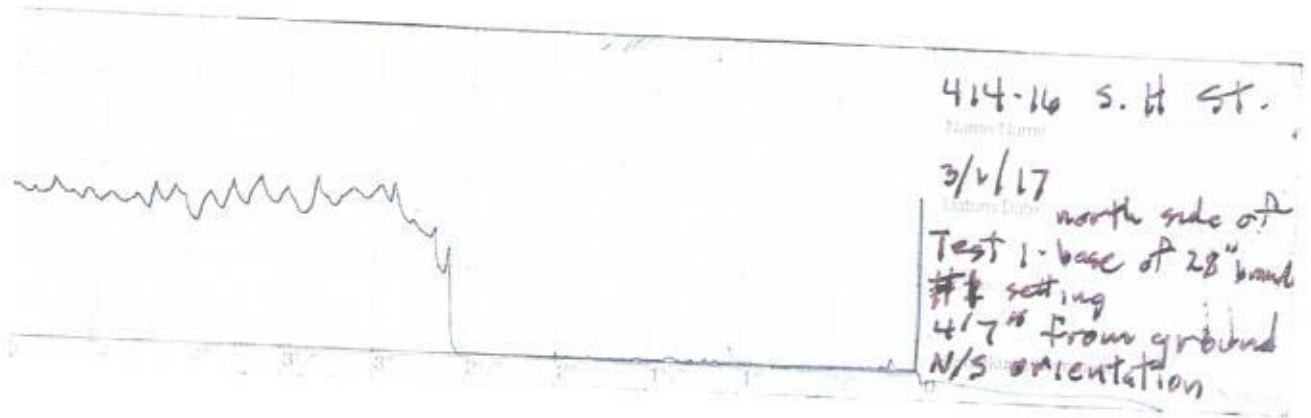
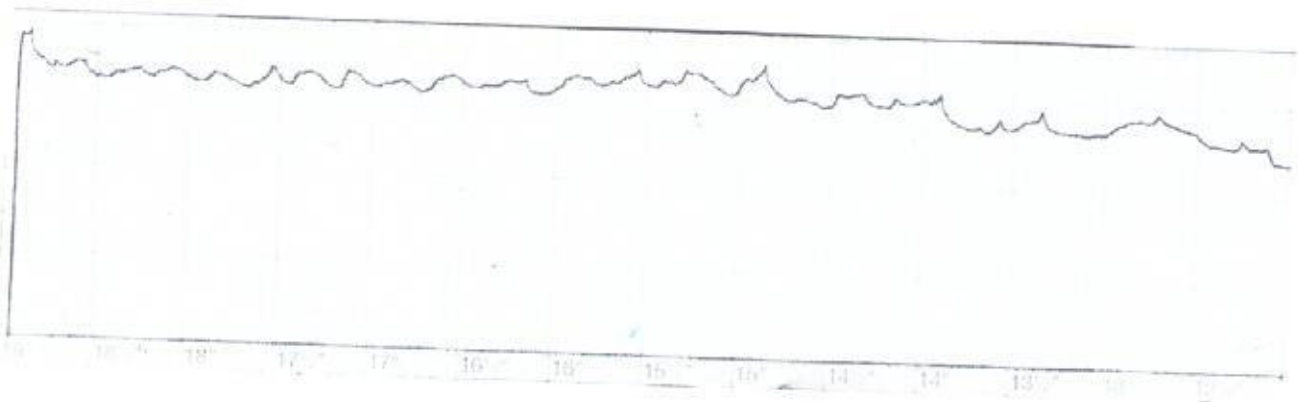
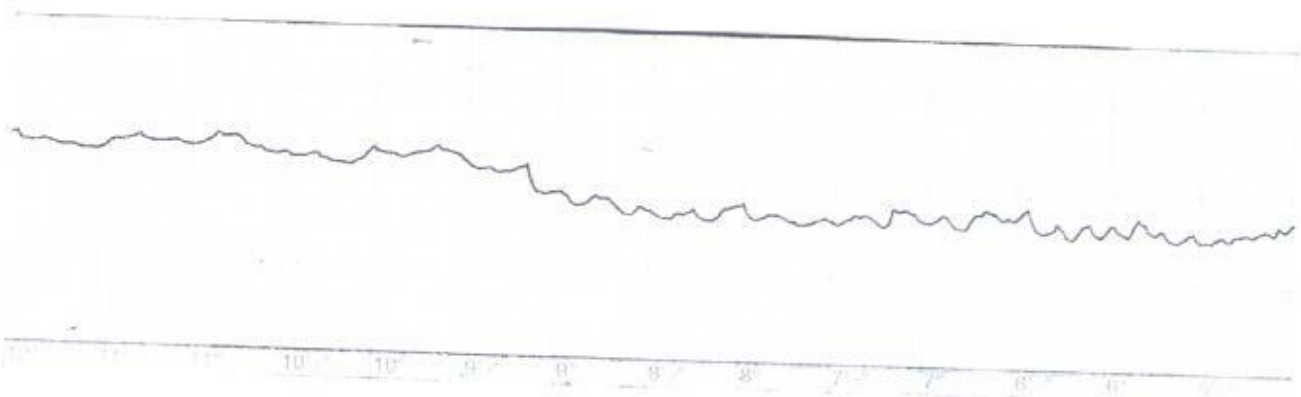
Resistograph drilling results for tree 56. Continuous strip measured in 0.5 inch increments reads right to left.
Strip one zero to 5", strip two 5" to 12", strip 3 12" to 19"
Test one -

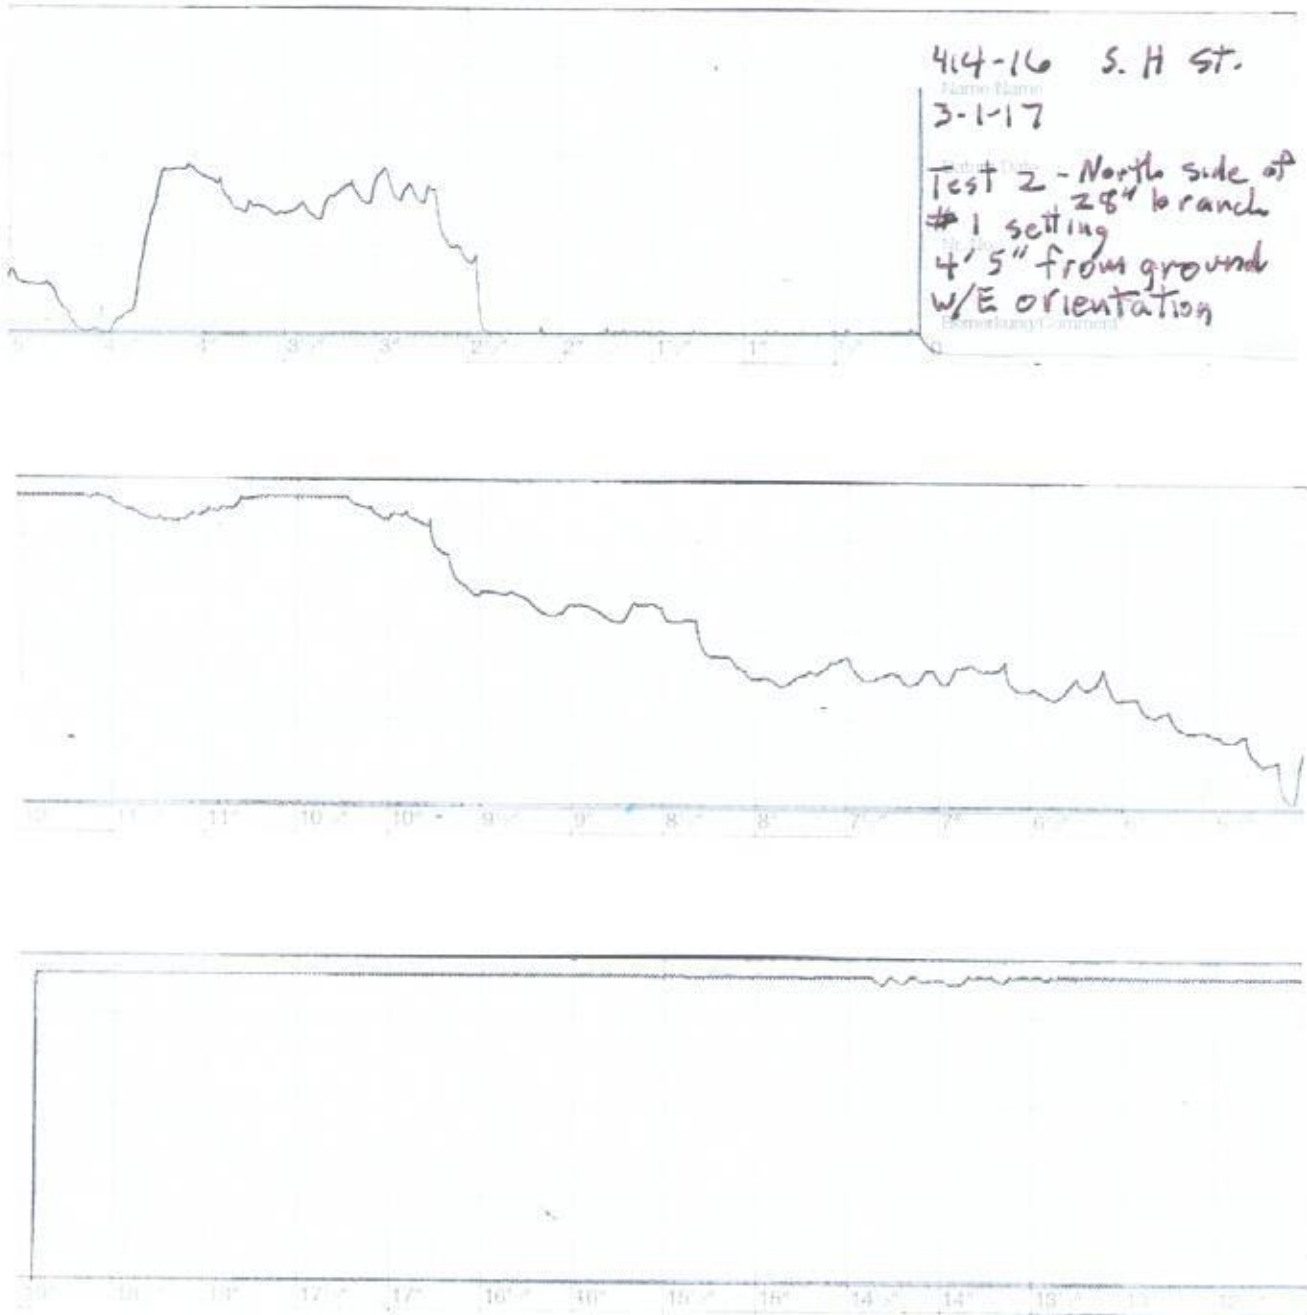
Resistograph drilling results for tree 56. Continuous strip measured in 0.5 inch increments reads right to left. Strip one zero to 5", strip two 5" to 12", strip 3 12" to 19"
Test two -

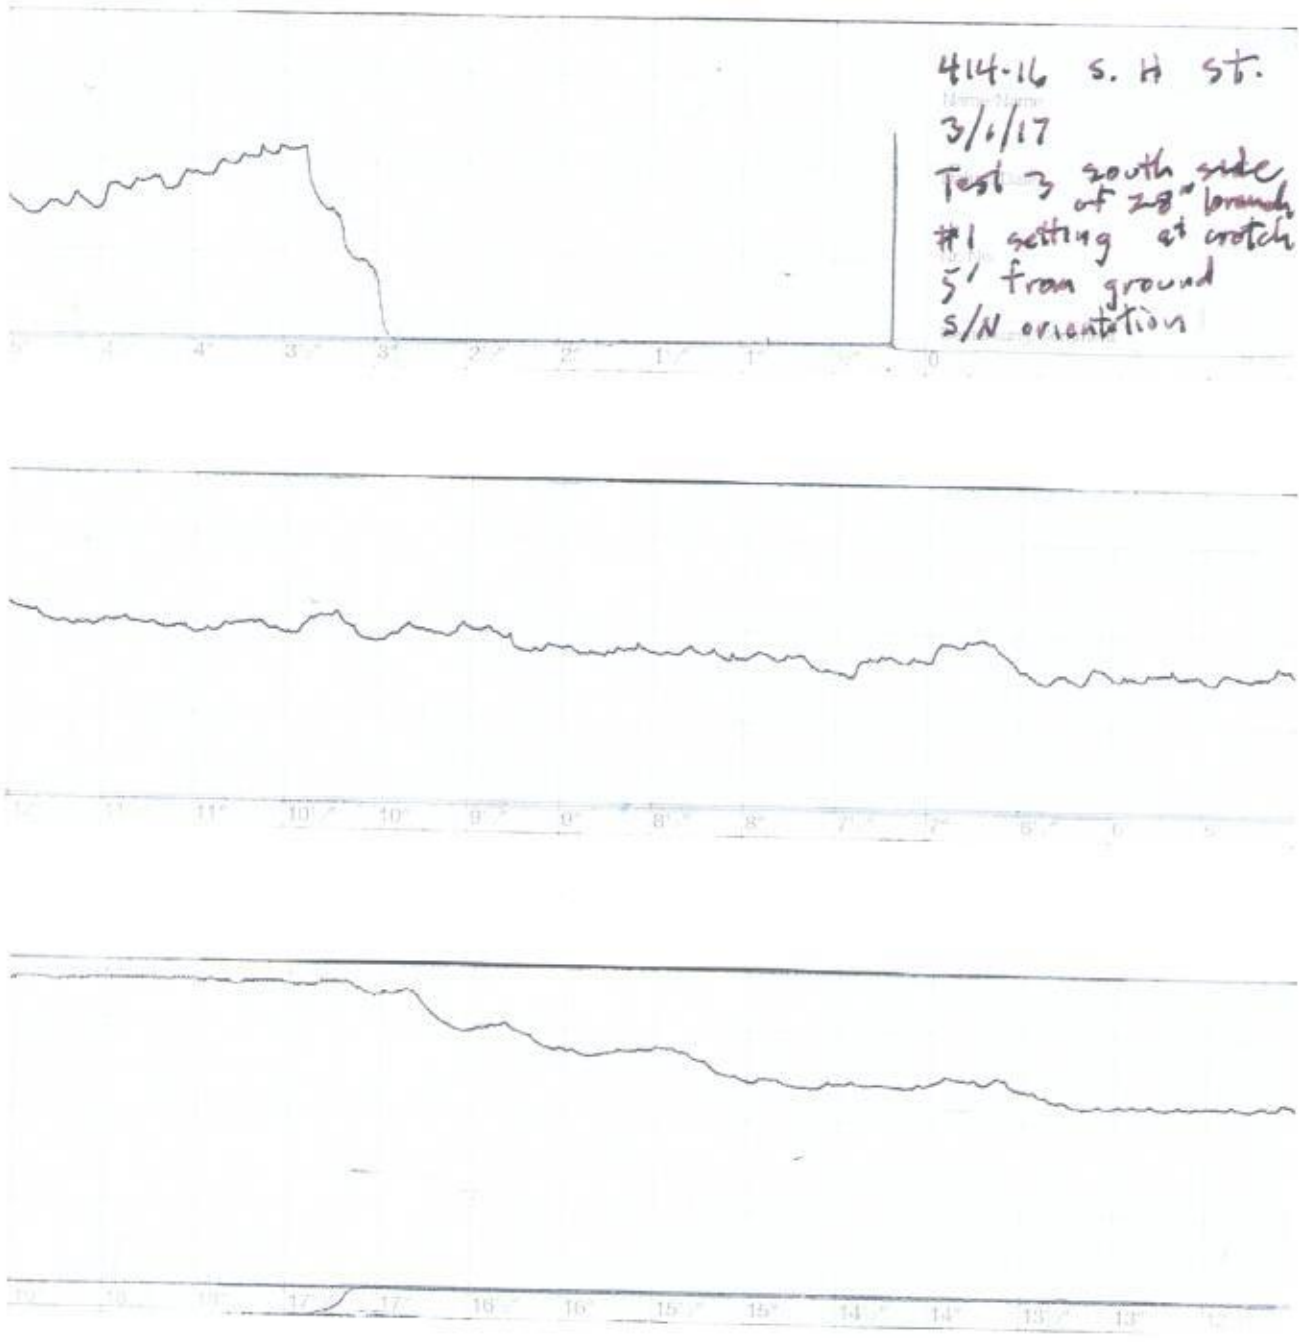
Resistograph drilling results for tree 56. Continuous strip measured in 0.5 inch increments reads right to left.
Strip one zero to 5", strip two 5" to 12", strip 3 12" to 19"
Test three -

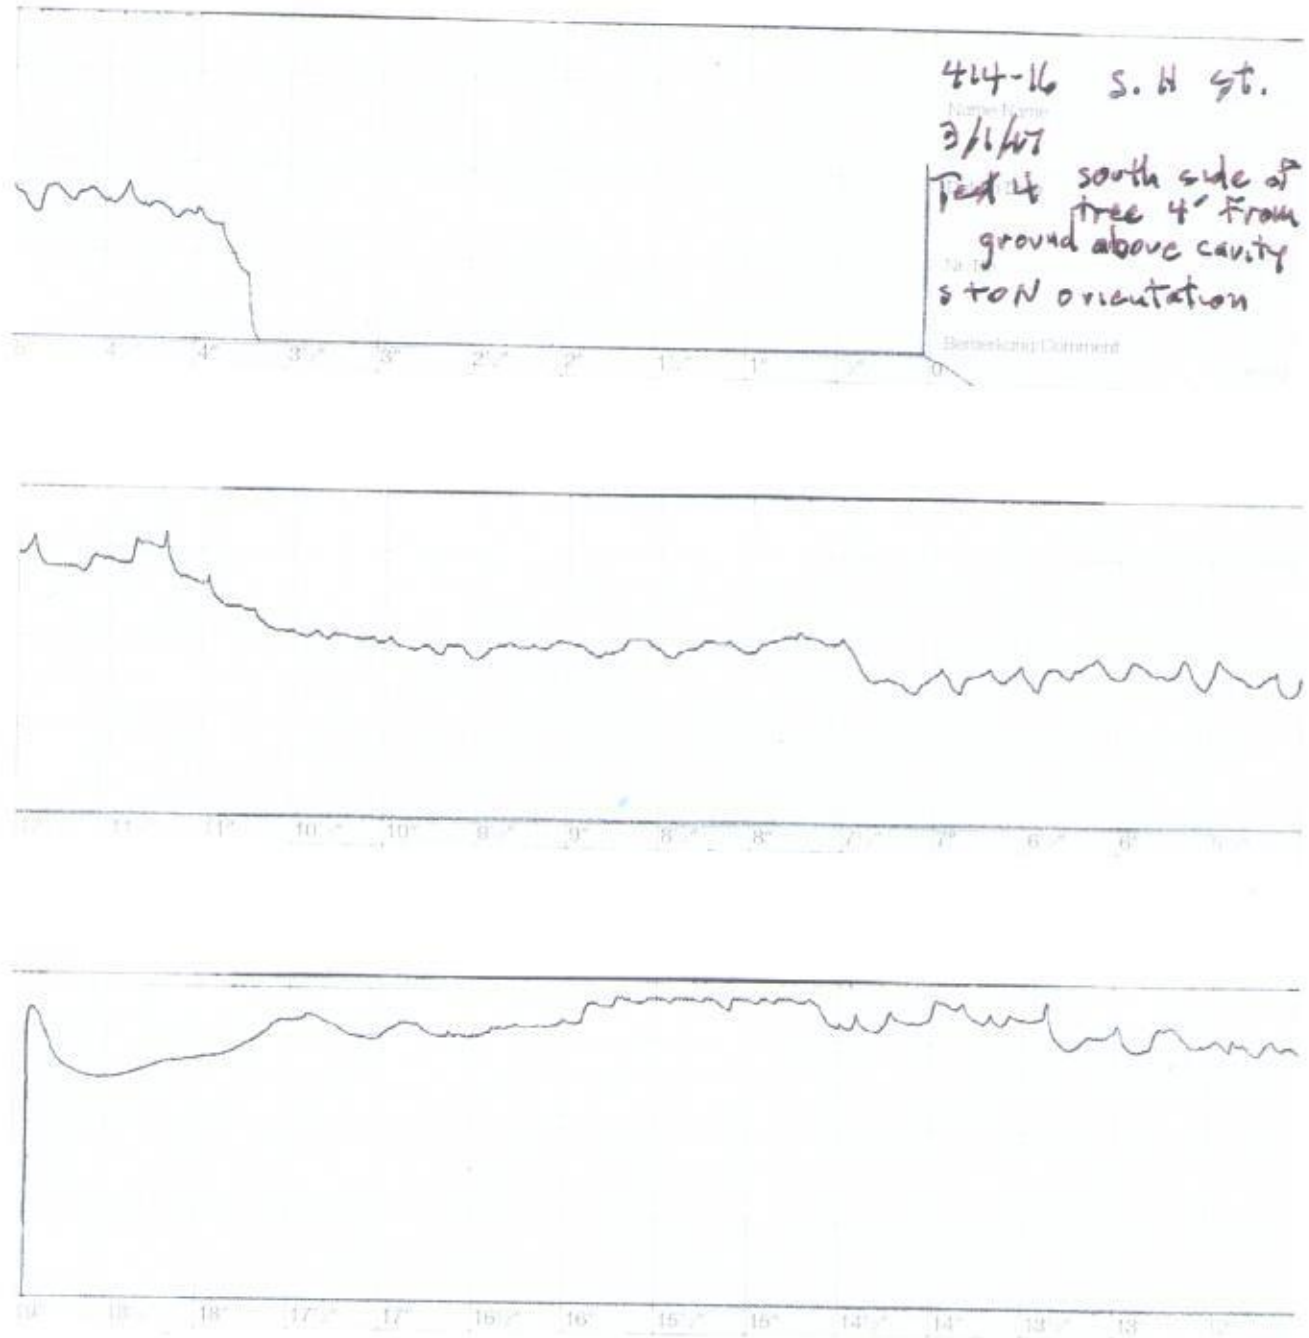
Resistograph drilling results for tree 56. Continuous strip measured in 0.5 inch increments reads right to left.
Strip one zero to 5", strip two 5" to 12", strip 3 12" to 19"
Test four -

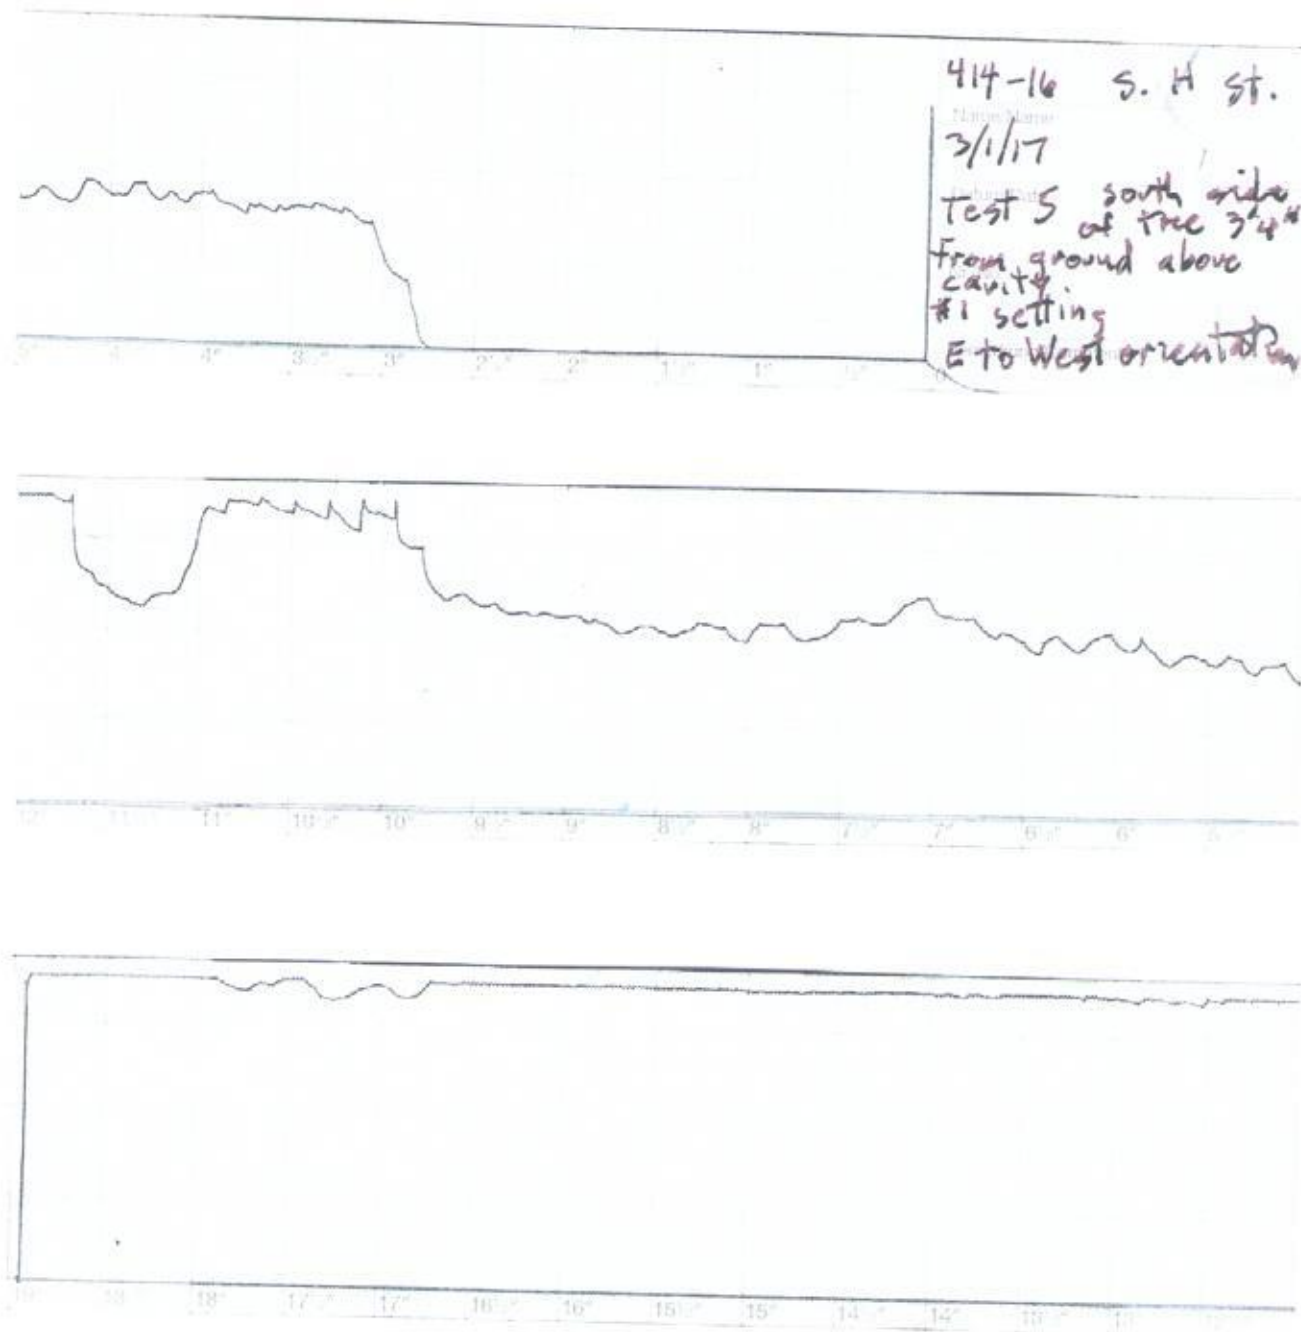
Resistograph drilling results for tree 56. Continuous strip measured in 0.5 inch increments reads right to left.
Strip one zero to 5", strip two 5" to 12", strip 3 12" to 19"
Test five -

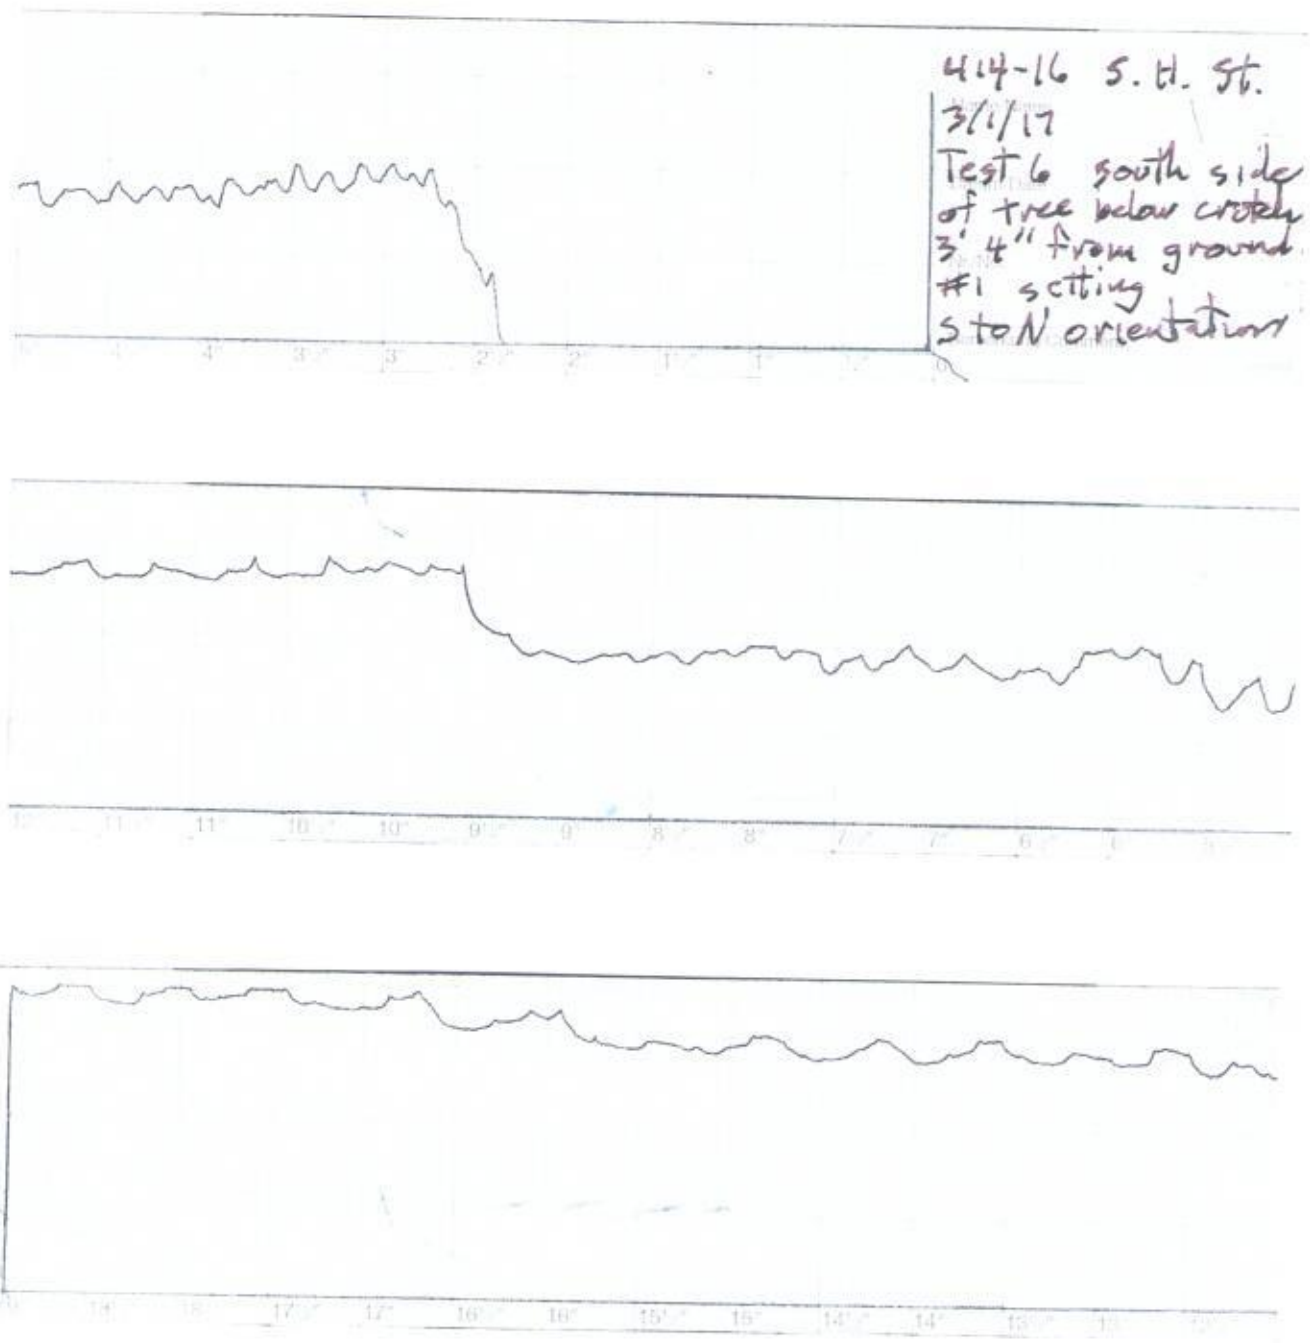
Resistograph drilling results for tree 56. Continuous strip measured in 0.5 inch increments reads right to left.
Strip one zero to 5", strip two 5" to 12", strip 3 12" to 19"
Test six -
