Reducing Risk of H Street Italian Stone Pines

Ken Knight

October 26, 2017

H St Italian Stone Pine Study Objectives

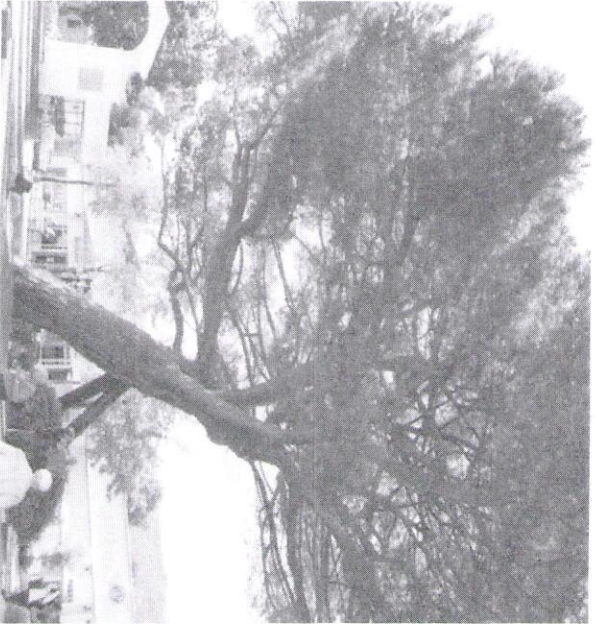
Fig. 7. Lean has been reported as a key factor contributing to root failure of Italian stone pine. Here, large props have been installed to reduce the failure potential of this leaning specimen. *Photo: T. Kipping.*
